Memo

To: Brandon Smith (West Bay Development Group, LLC)
From: Troy Bussey, P.E., L.G. L.H.G. and Joel Hecker, L.G. (PIONEER Technologies Corporation [PIONEER])
Date: October 13, 2020
Subject: Due Diligence Investigation Status Update
Hardel Mutual Plywood Corporation Site
1210 West Bay Drive NW, Olympia, Washington

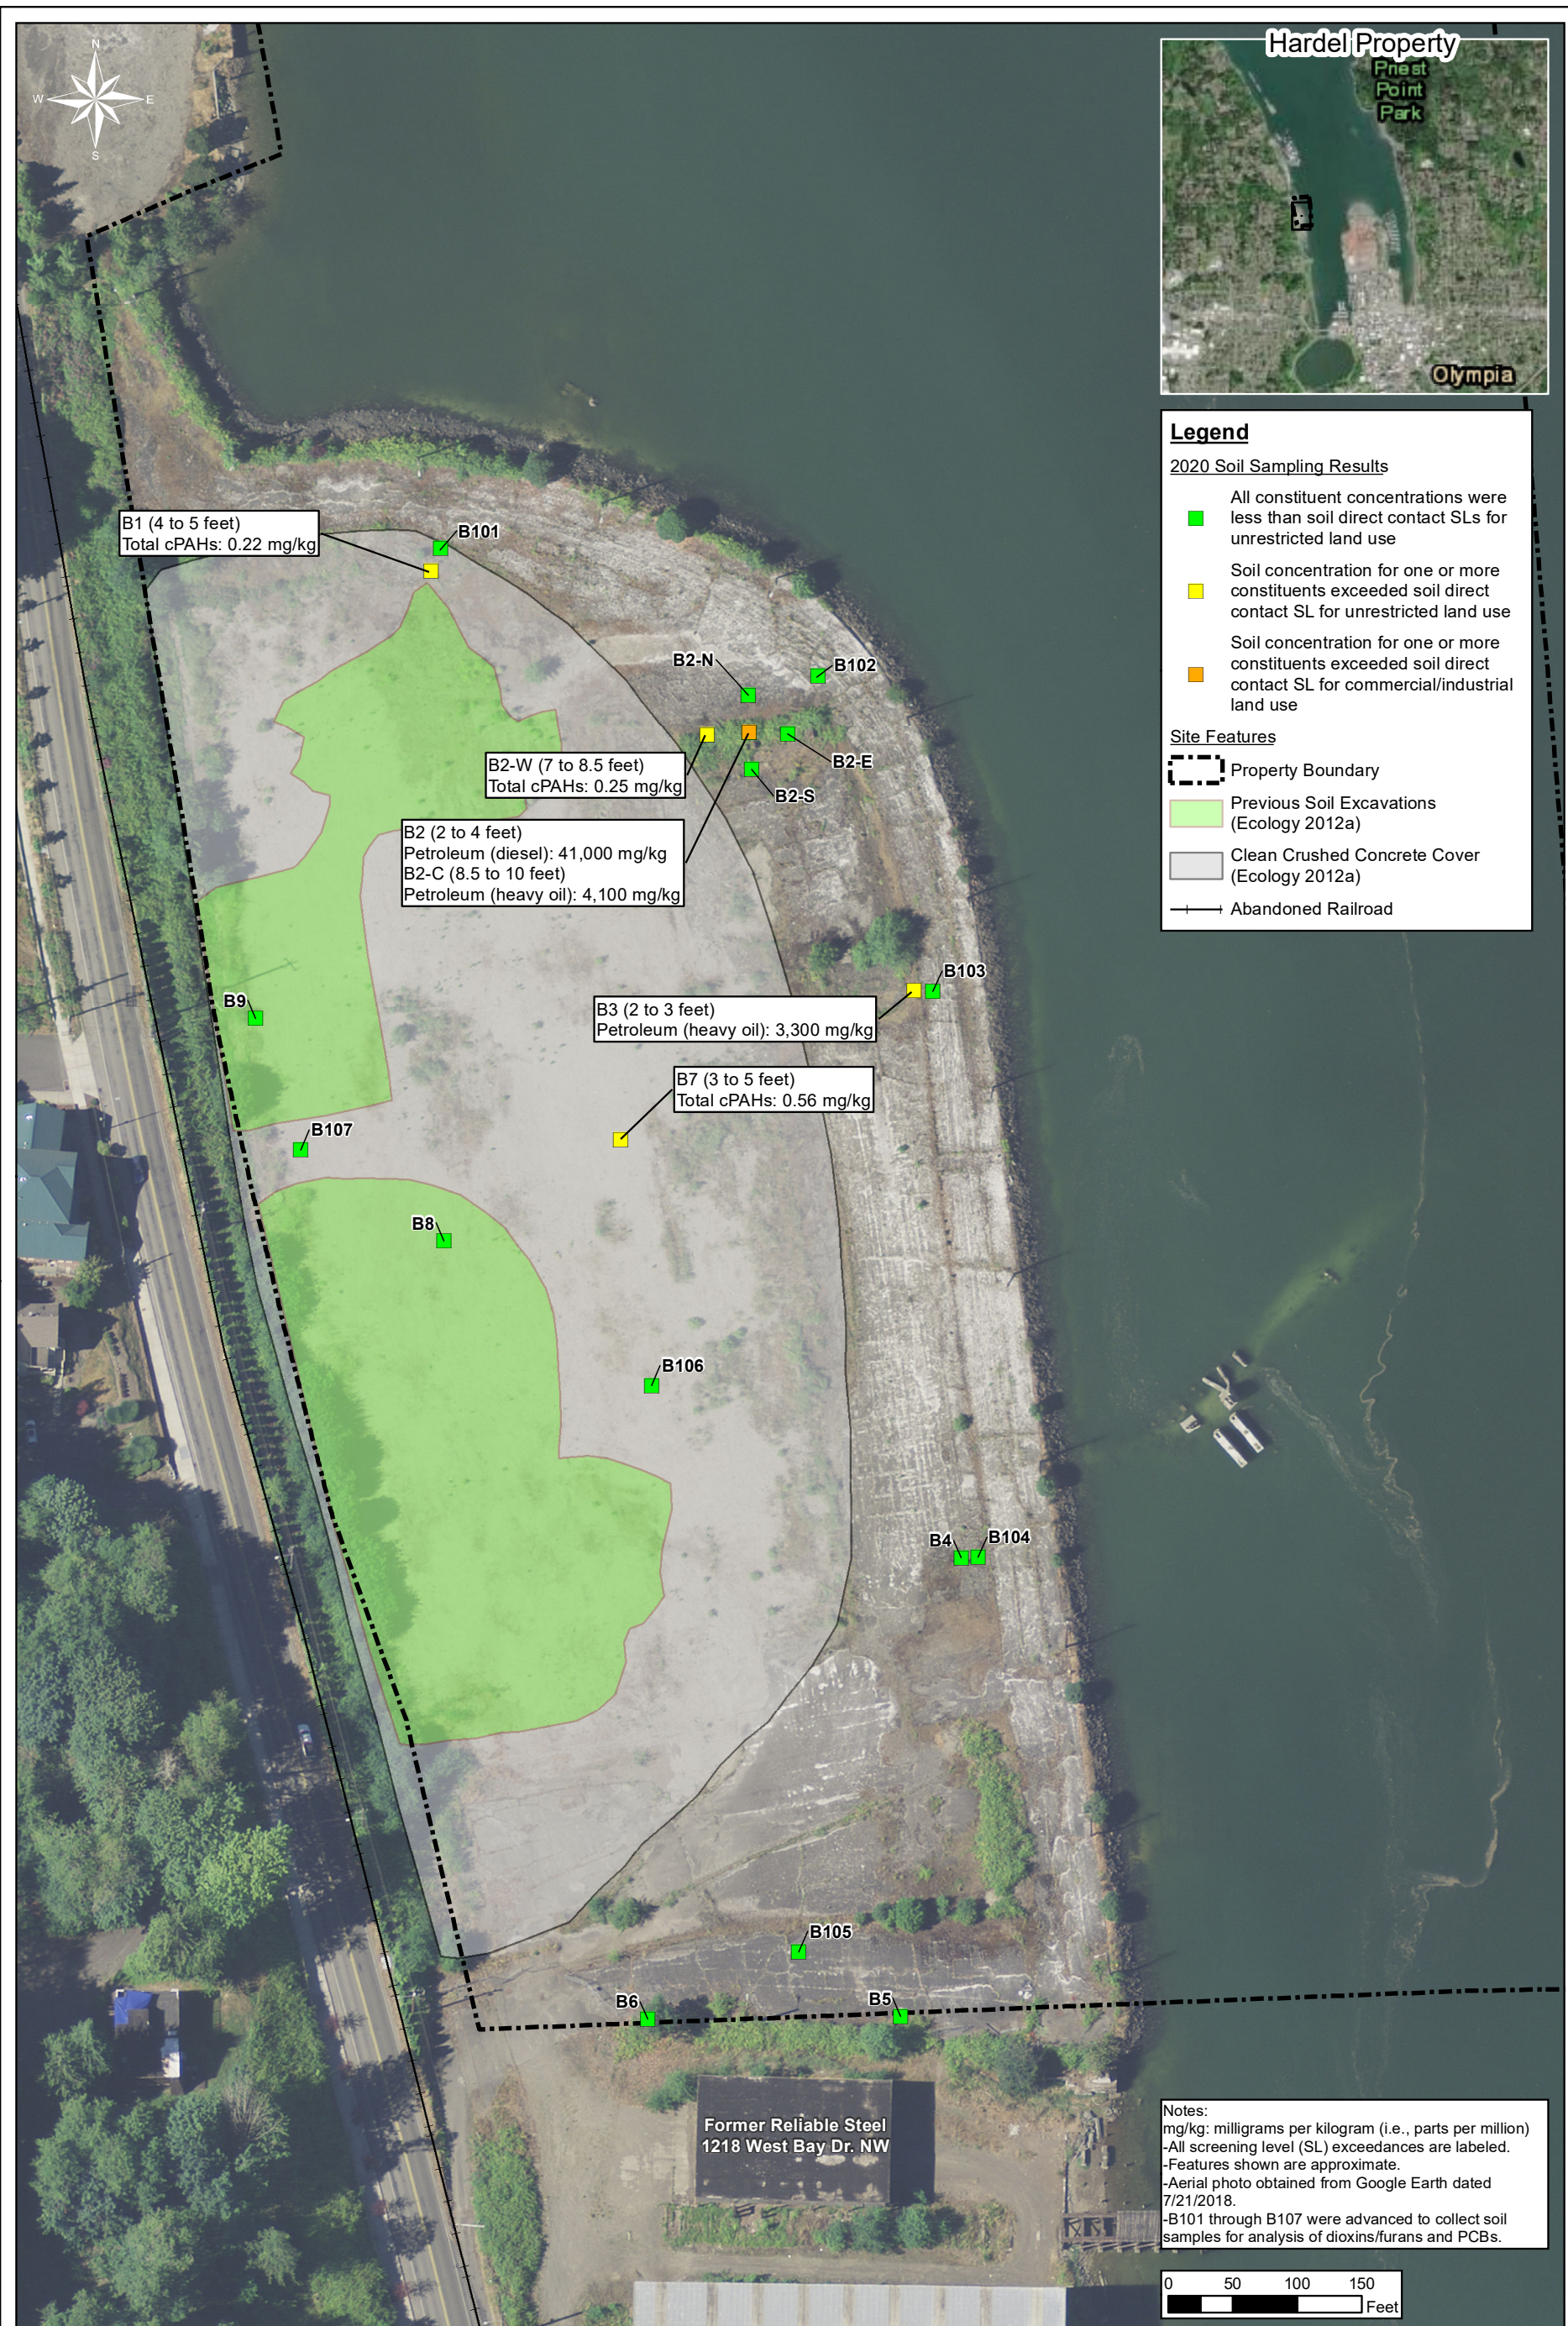
Figure 1

A conservative screening of the investigation results from the June and August 2020 samples was performed. Constituent concentrations in soil samples were compared to default MTCA direct contact SLs for an unrestricted land use (e.g., residential) scenario and a commercial/industrial land use scenario.¹ A summary of the soil SL exceedances is presented in Figure 1. Constituent concentrations in groundwater samples were compared to default MTCA groundwater SLs that are protective of drinking water use and potential surface water receptors. A summary of the groundwater SL exceedances is presented in Figure 2.

The few minor soil SL exceedances in the 2020 samples do not pose a significant concern and can be remedied relatively easily. The only exceedances of default MTCA direct contact SLs for an unrestricted land use scenario soil were diesel, heavy oil, and/or total carcinogenic PAHs (cPAHs) concentrations in five soil samples, and the only exceedance of default

MTCA direct contact SLs for a commercial/industrial land use scenario was a diesel concentration in a B2 soil sample. The spatial distribution of the diesel, heavy oil, and total cPAHs exceedances suggests that there could be other minor diesel, heavy oil, and/or total cPAHs soil SL exceedances at other Site locations. In addition, concentrations of total cPAHs may be present at various Site locations at concentrations that exceed its soil SL due to urban background (PIONEER 2010). Regardless of the source(s), these minor SL exceedances could be remediated relatively easily. One potential solution that could satisfy MTCA regulations and expectations would be to (1) remove the B2 diesel exceedance, (2) install, monitor, and maintain a cap/cover across the upland portion of the Site, and (3) record a land use covenant to monitor and maintain the cap/cover.

Summary of 2020 Soil Sampling Results
 Hardel Mutual Plywood Corporation
 1210 West Bay Drive NW
 Olympia, WA

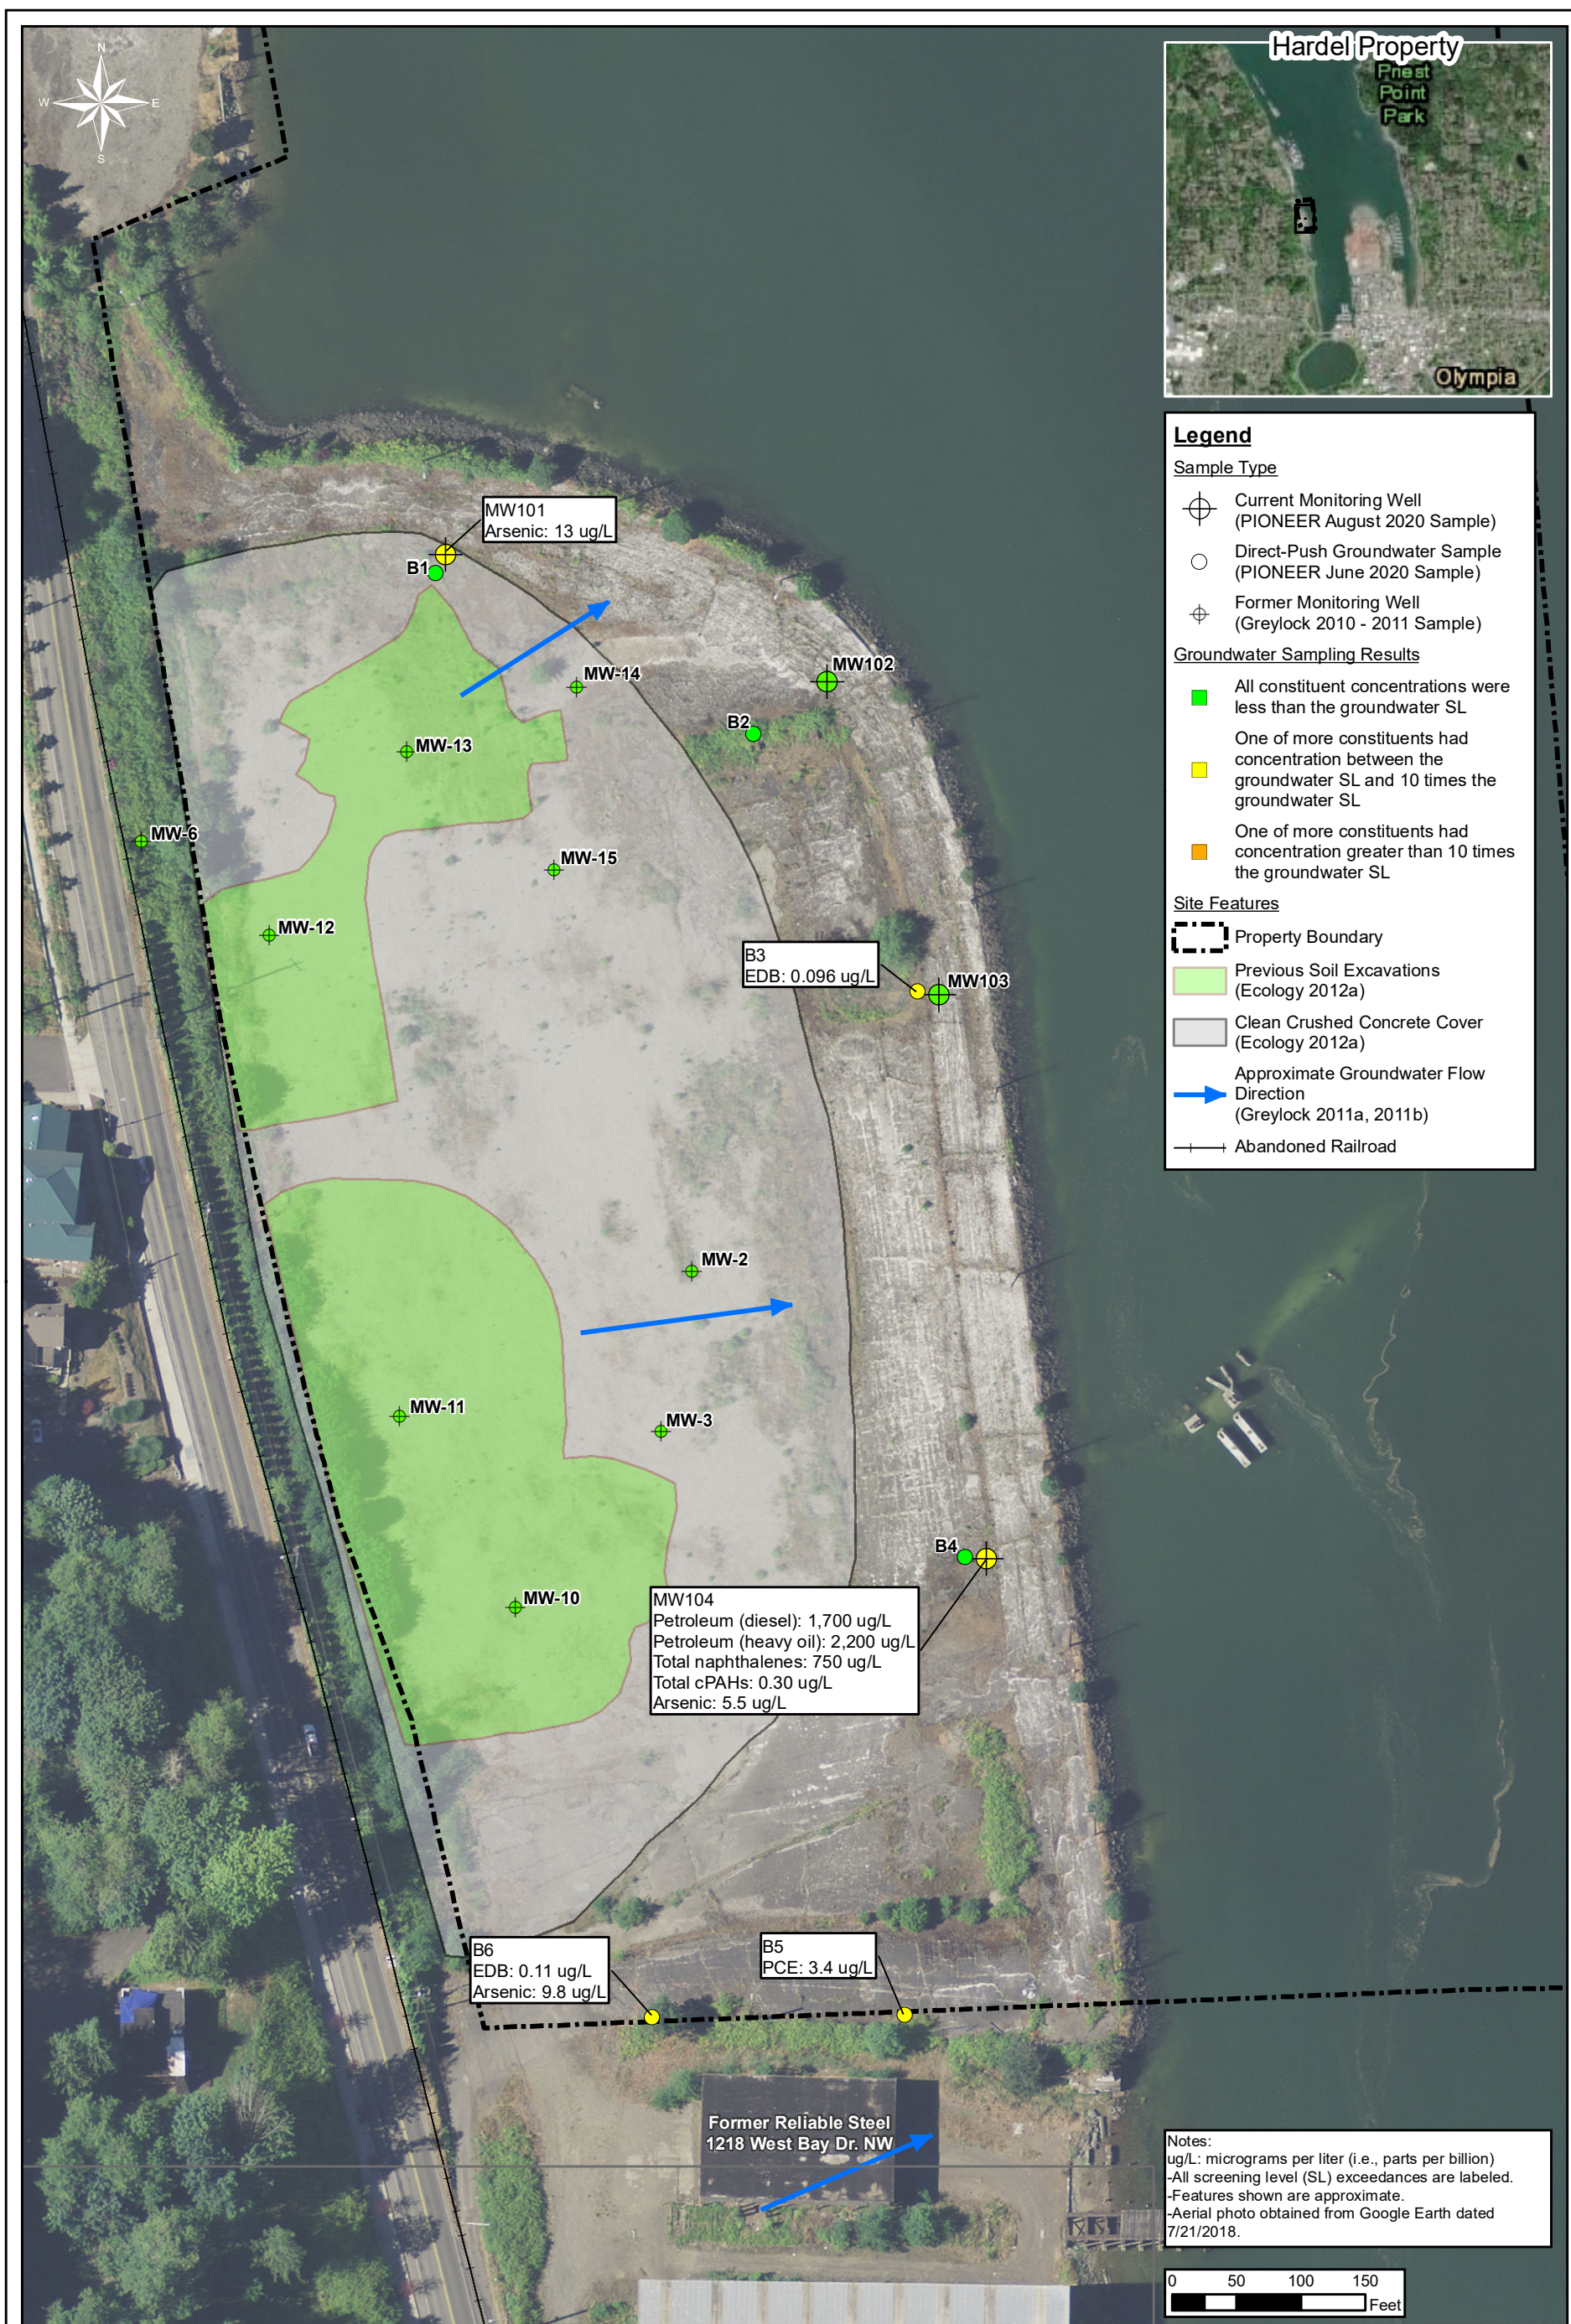
Figure 2

The few minor groundwater SL exceedances in the 2020 samples do not appear to pose a significant concern, and may not even be attributable to a Site release. The only exceedances of default MTCA groundwater SLs were slightly elevated concentrations of (1) tetrachloroethylene (PCE), ethylene dibromide (EDB), and arsenic in B5 or B6, (2) EDB in B3, (3) arsenic in MW101 and MW104, and (4) diesel, heavy oil, total naphthalenes, and total cPAHs in MW104. However, existing data suggest that most, if not all, of these GW exceedances are not attributable to a Site release. For instance, the B5 and B6 exceedances are attributable to the Reliable Steel site based on the groundwater flow direction near these samples (Greylock 2011a, 2011b). The EDB concentration in B3 may be an unrepresentative artifact from direct-push groundwater sampling since EDB was not detected in the August 2020 groundwater sample collected from adjacent MW103. Based on the nature of historical Site operations and experience at other Puget Sound shoreline sites, the arsenic SL exceedances in MW101 and MW104 are likely due to natural background and localized geochemical conditions. Localized treated wood debris may be responsible for the diesel, heavy oil, total naphthalenes, and total cPAHs SL exceedances in MW104 given the prevalence of wood debris in the subsurface (including within the MW104 boring) and the lack of groundwater SL exceedances in adjacent B4. Nonetheless, further investigation and evaluation activities (e.g., conducting additional groundwater sampling events) are necessary in order to further assess the existing groundwater SL exceedances.

Summary of Groundwater Sampling Results
 Hardel Mutual Plywood Corporation
 1210 West Bay Drive NW
 Olympia, WA
