**Drainage Evaluation**  
**for**  
**Bruce Titus, Chrysler Jeep**

Skillings Connolly, Inc.  
Thomas E. Skillings, PE

Bruce Titus Drainage Evaluation  
January 10, 2019

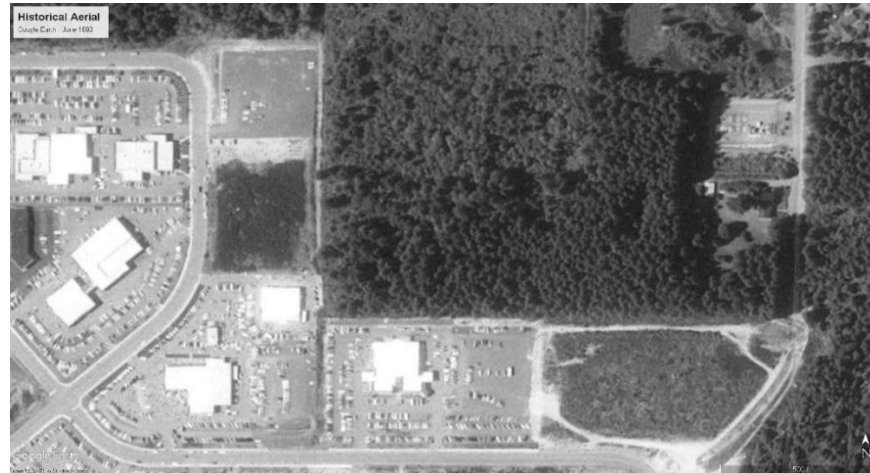
**Historical photo, dated June 1990**

It can be seen from the photos above, there was minimal development to the north of the Titus property in 1990. As developments were constructed, overflow drainage was directed to the toe of slope ditch on the Titus property. It was never designed for 44 cfs.

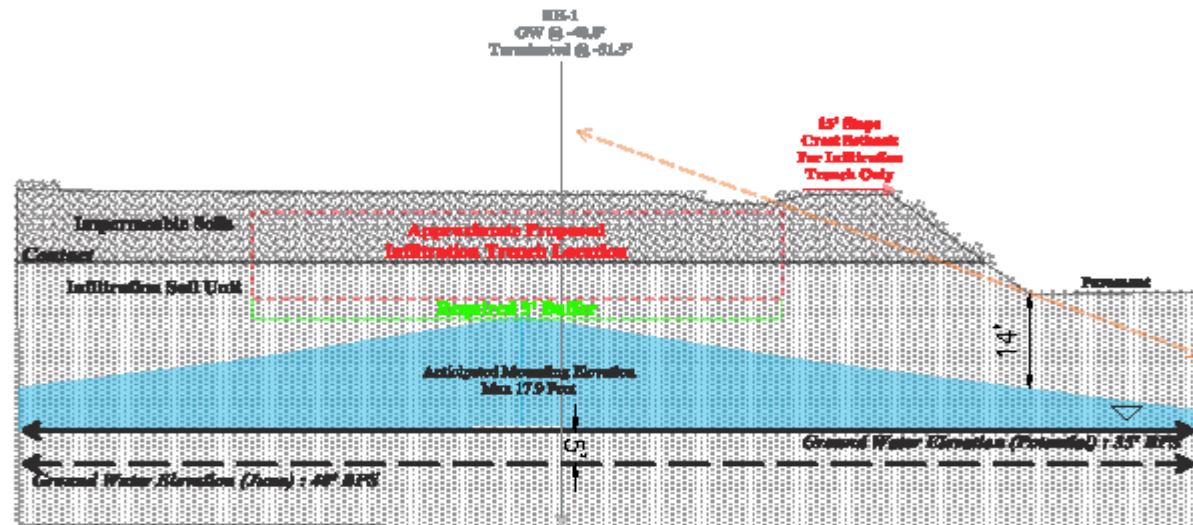
## Mound Exhibit with potential higher water table

This issue is the most concerning to me. The developer's design of the 100% infiltration for the stormwater generated from the site is based solely on one summer measurement of the groundwater. If the groundwater rises 5-feet from what was recorded, it does not meet standards. If the water table rises 8-feet above what was recorded, the system will begin to fail. It is critical the winter water table elevation be understood. Typically we would see at a minimum, a one-year analysis of the water table. In addition, because this design feature is so important, the design of the emergency overflow to prevent uncontrolled overflow, or uncontrolled lateral flow that would surface on the north slope of the Titus property. Should be design to provide 100% assurance it will not have an uncontrolled failure.

\*Mounding analysis shown published by MTC  
See attached MTC "SLOPE PROFILES"

- **The Developer should be required to conduct a thorough analysis of the seasonal water table variation found in the Qvr aquifer at this site. I would recommend approval of the proposed design be withheld until the winter water surface level below the proposed drainage facility is completely understood and quantified. If the water level in the aquifer is much higher in the winter than in the summer as measured, the likelihood of failure of the infiltration system is high, and the potential impacts resulting from a failed infiltration basin can be difficult to remedy.**

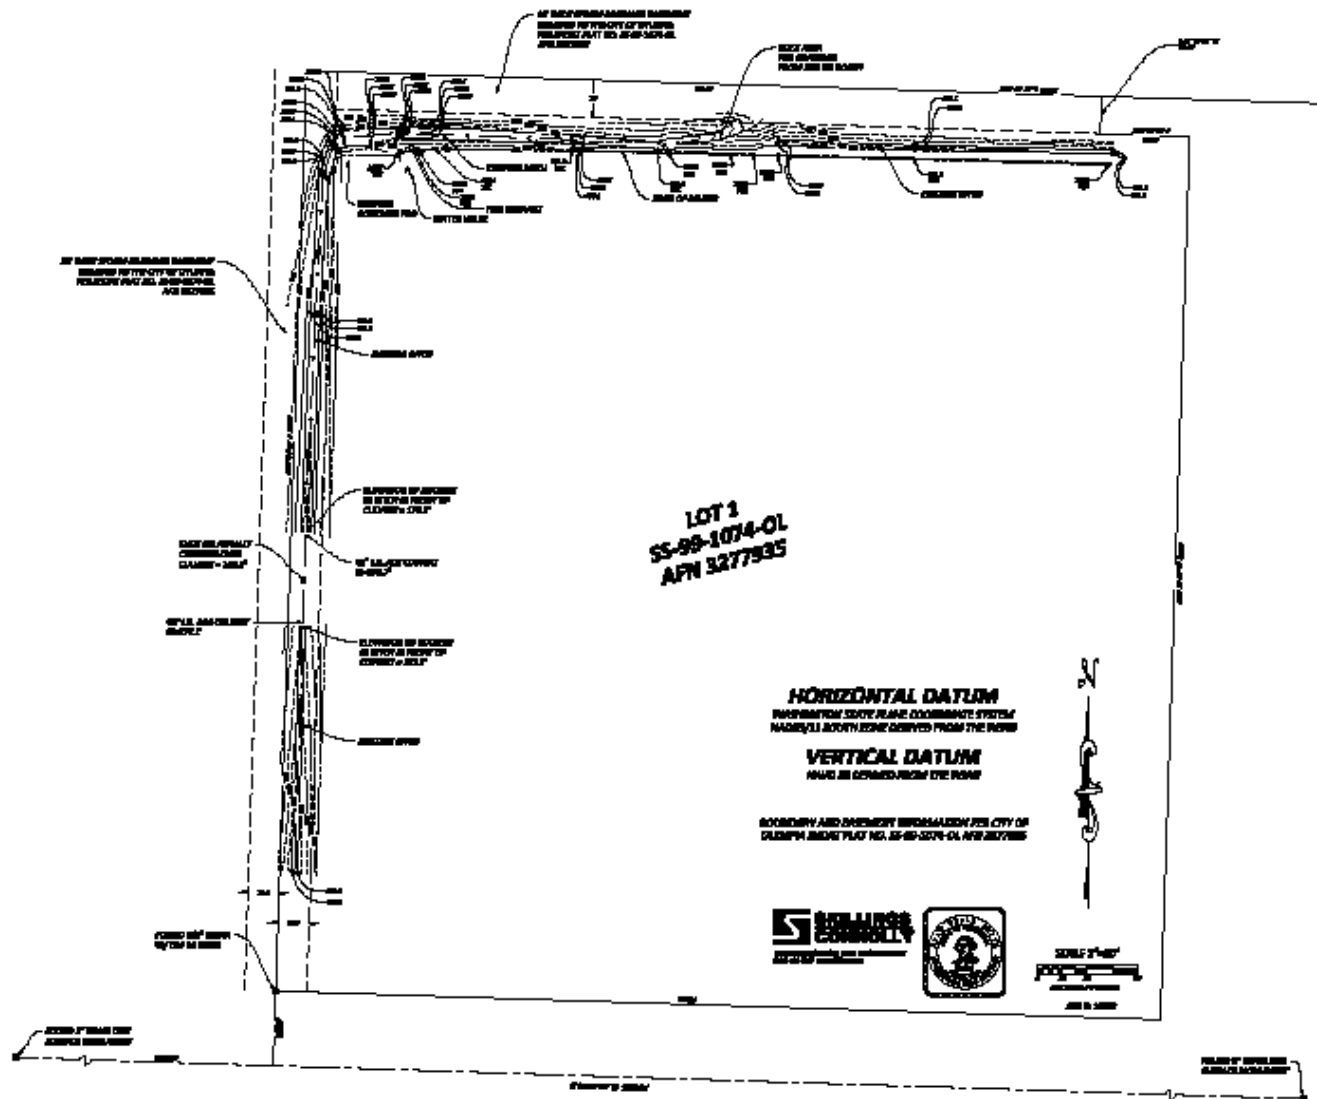
Topographic Map Exhibit

The above referenced documents indicate the ditch along the bottom of the slope was not built per the original Anderson and Boone design, dated February 2, 1987. I have attached a copy of the ditch sections enlarged from the original plan sheet. I have also had my crew survey the ditches. A copy of the topography map of the subject area is included as an exhibit. I don't find any significant variation from the 1987 plans from what exist today, with the exception of the fill that was placed in the Dealership's ditch. This fill was apparently placed when the overflow ditch from the developments to the north of the Wellington Heights project was installed. The riprap and fill totally fill the existing ditch. The ditch section upstream and downstream of the fill is fairly consistent. I would disagree with Olympic Engineering assessment that the ditch was not constructed per the original plan. (see attached ditch sections) The ditch bottom varies in width of 2-4 feet; the back slope varies from 1.5:1 – 2:1 and the front slope varies from 1:1 – 2:1. This variation is pretty normal for a ditch that was constructed over 30-years ago.
