**Re: Geologic Hazards Assessment
West Bay Mixed-Use Development
Olympia, Washington
Project No. 1912001.020.021**

West Bay Mixed-Use
Development
Geologic Hazards Assessment
Olympia, Washington

Geologic Hazard Map

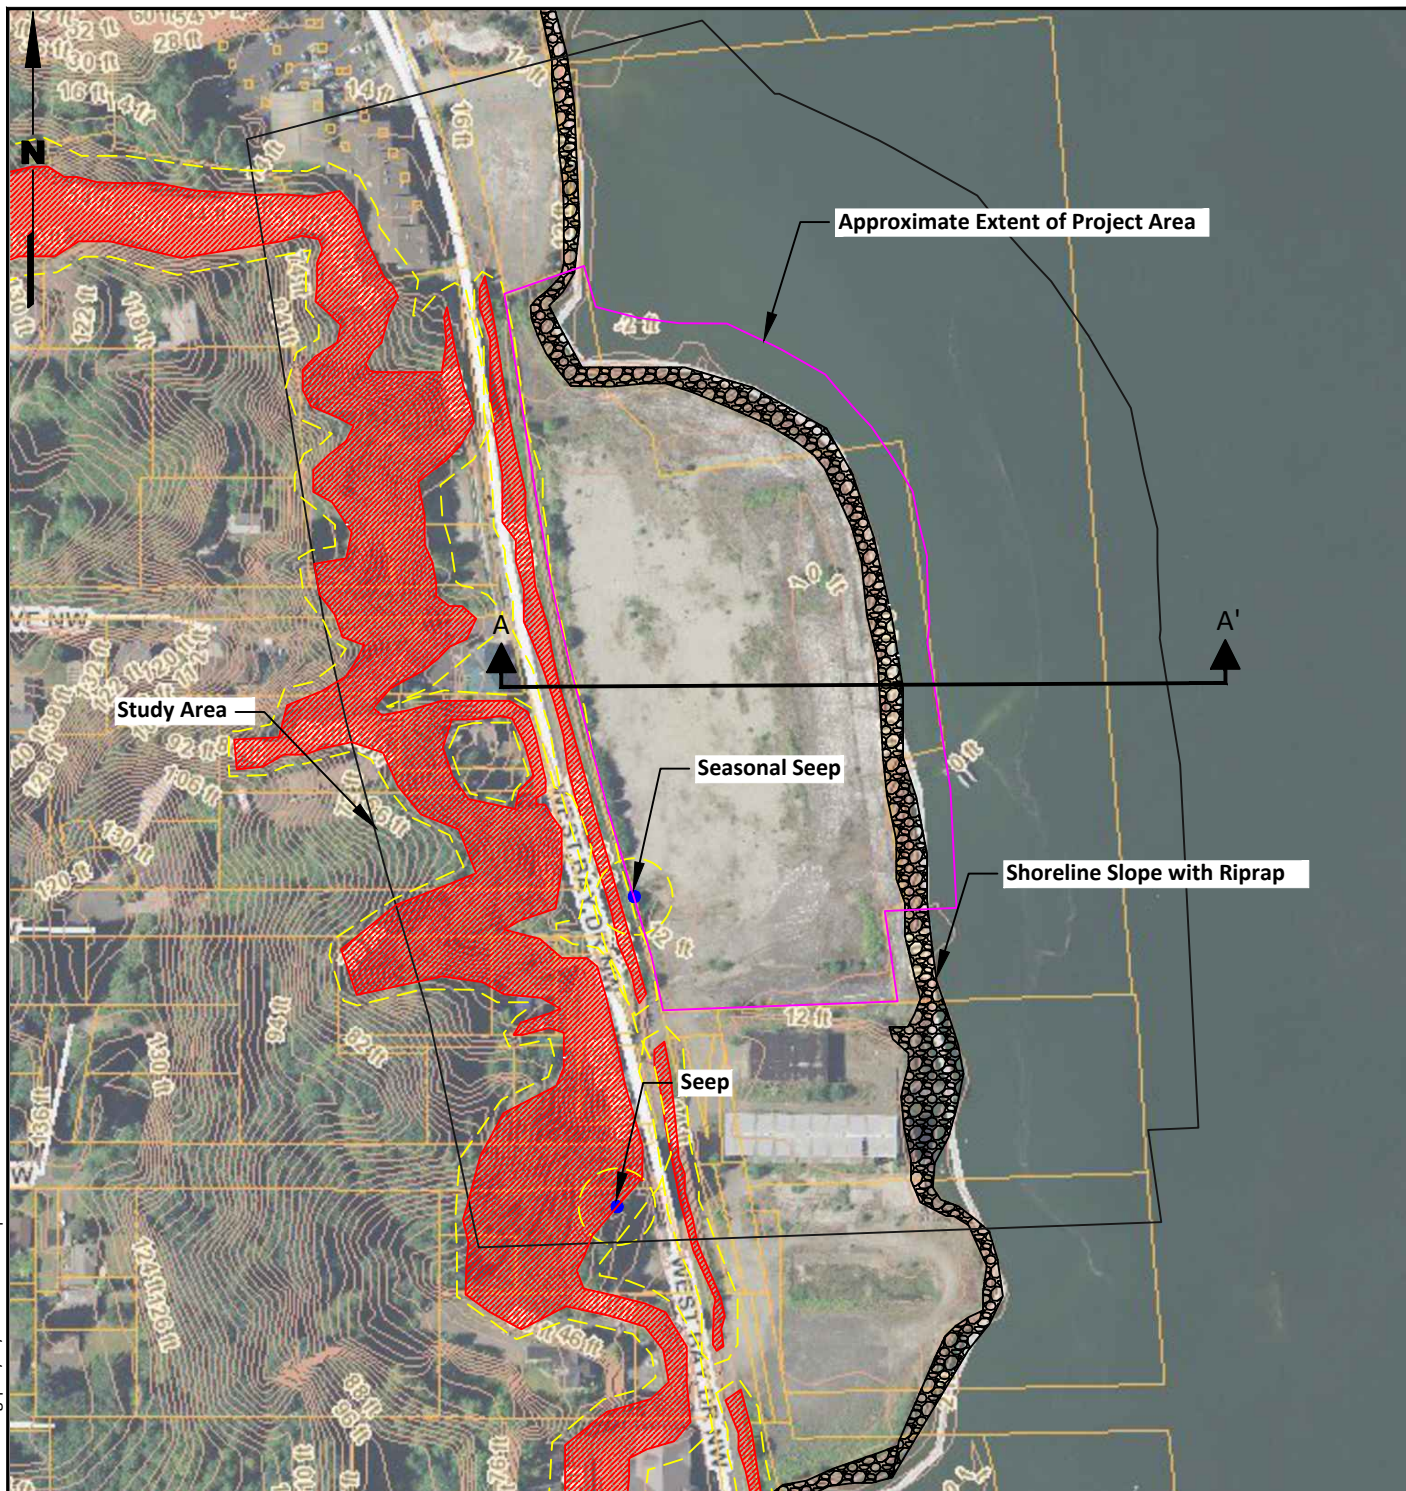
LAI's geologic hazard assessment was completed in accordance with Section 18.32.600 of the OMC. Steep slopes and landslide hazard areas are mapped within 300 feet (ft) of the proposed development. The site is a seismic hazard area and may constitute an erosion hazard area. The approximate locations of pertinent surface features are shown on Figure 1.

must be equal to one-half of the slope height. As shown on Figure 1, the project area is located outside of the buffer zone for the steep slope west of West Bay Drive. Therefore, no engineering controls are required.

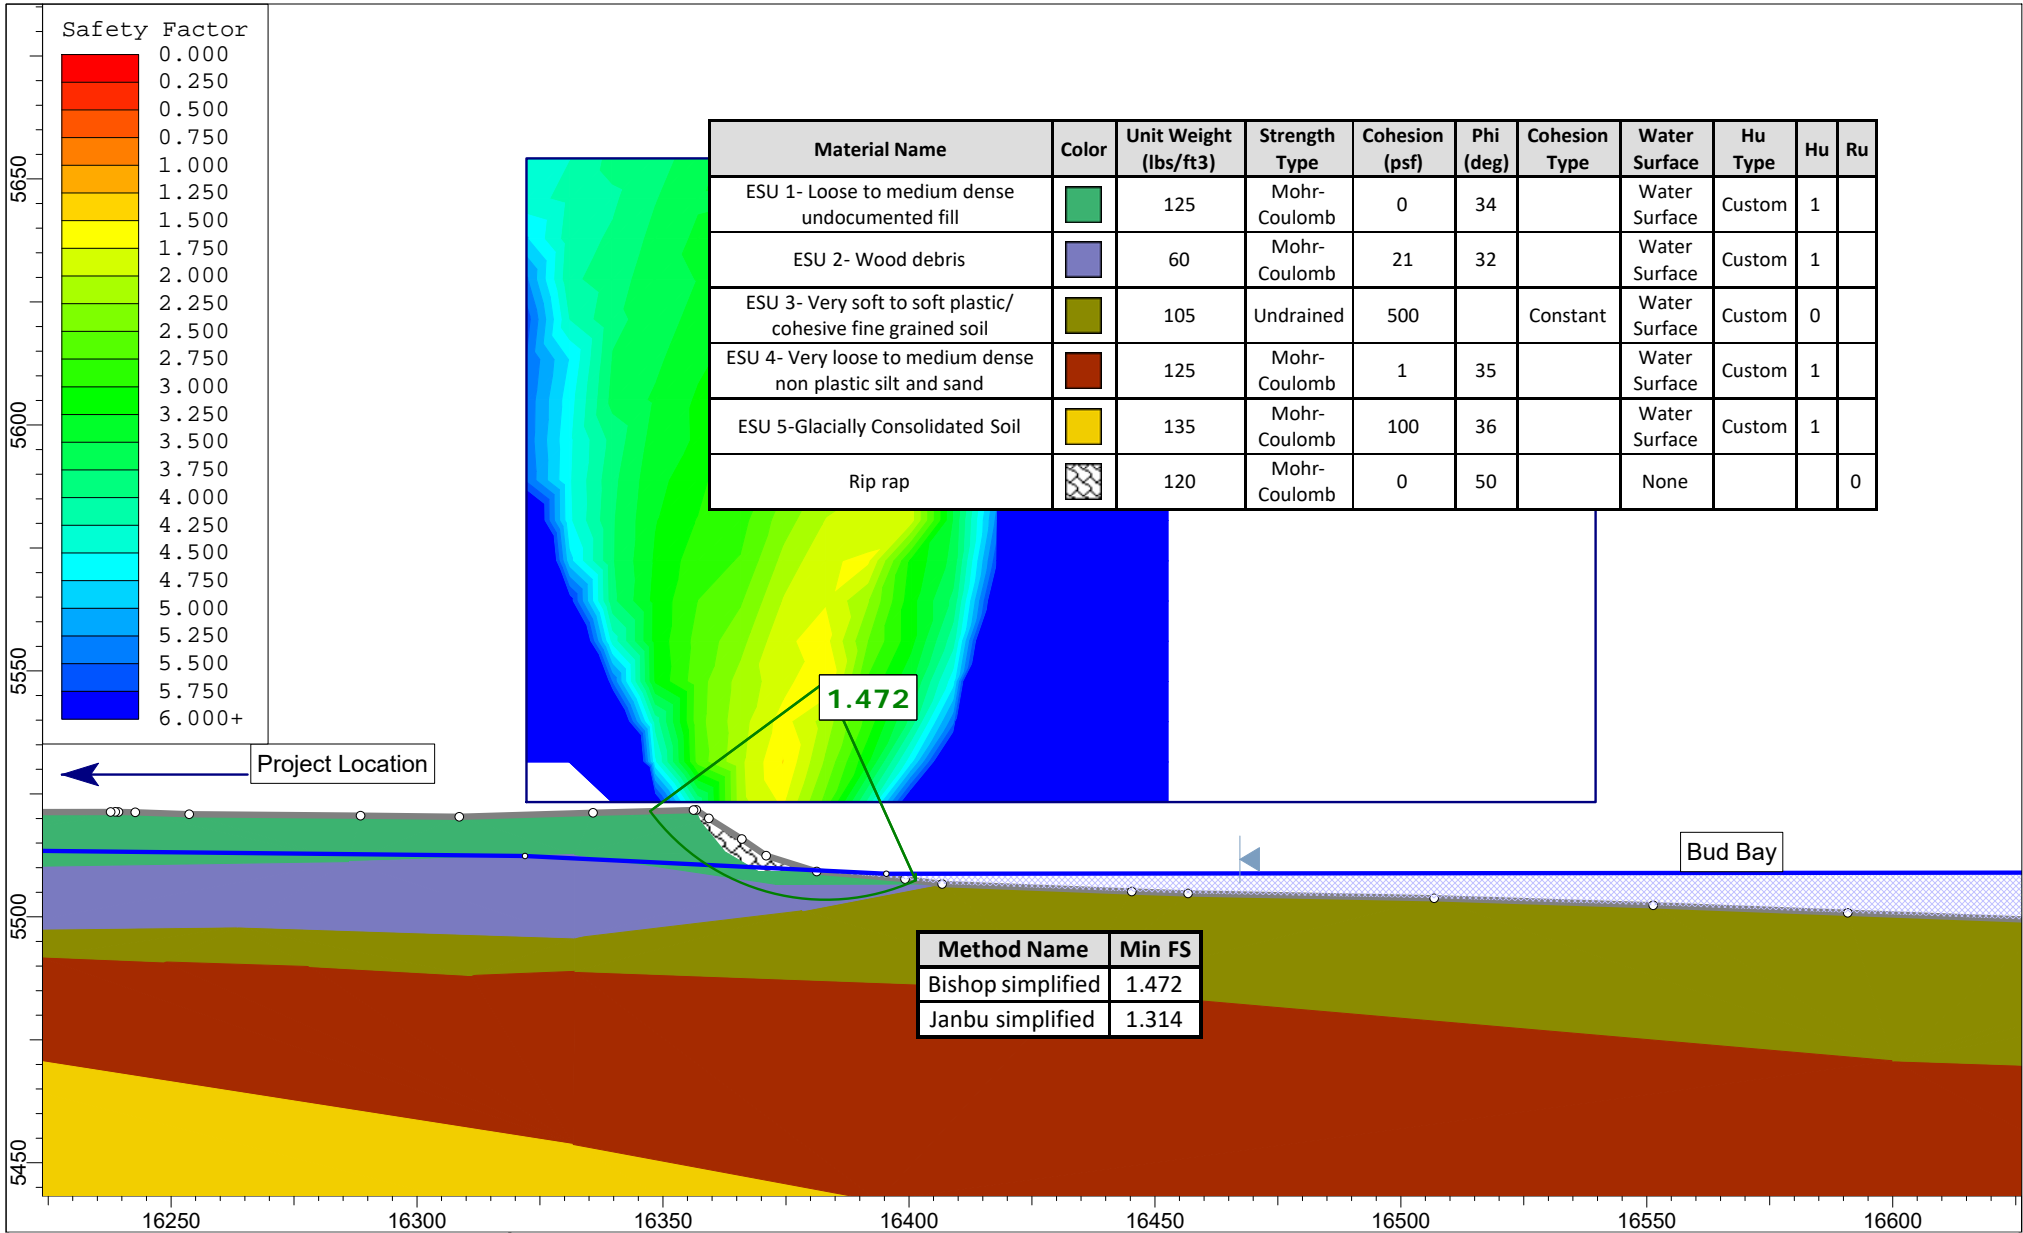
- Existing slope, static conditions, with riprap (FS = 1.5).
- Existing slope, static conditions, without riprap (FS = 0.7).
- Proposed slope configuration, static conditions (FS = 3.0).

<i>Project</i> West Bay Mixed-Use Development Critical Areas Review	
	<i>Group</i> Group 1	<i>Scenario</i> Existing slope, static conditions, with riprap
	<i>Drawn By</i> BP	<i>Company</i> Landau Associates
	<i>Date</i> 10/8/2021, 3:59:47 PM	<i>File Name</i> West Bay Dr
	SLIDEINTERPRET 9.009

Based on the results of its shoreline slope stability analysis, LAI does not recommend removing riprap, as doing so could undermine the stability of the slope.

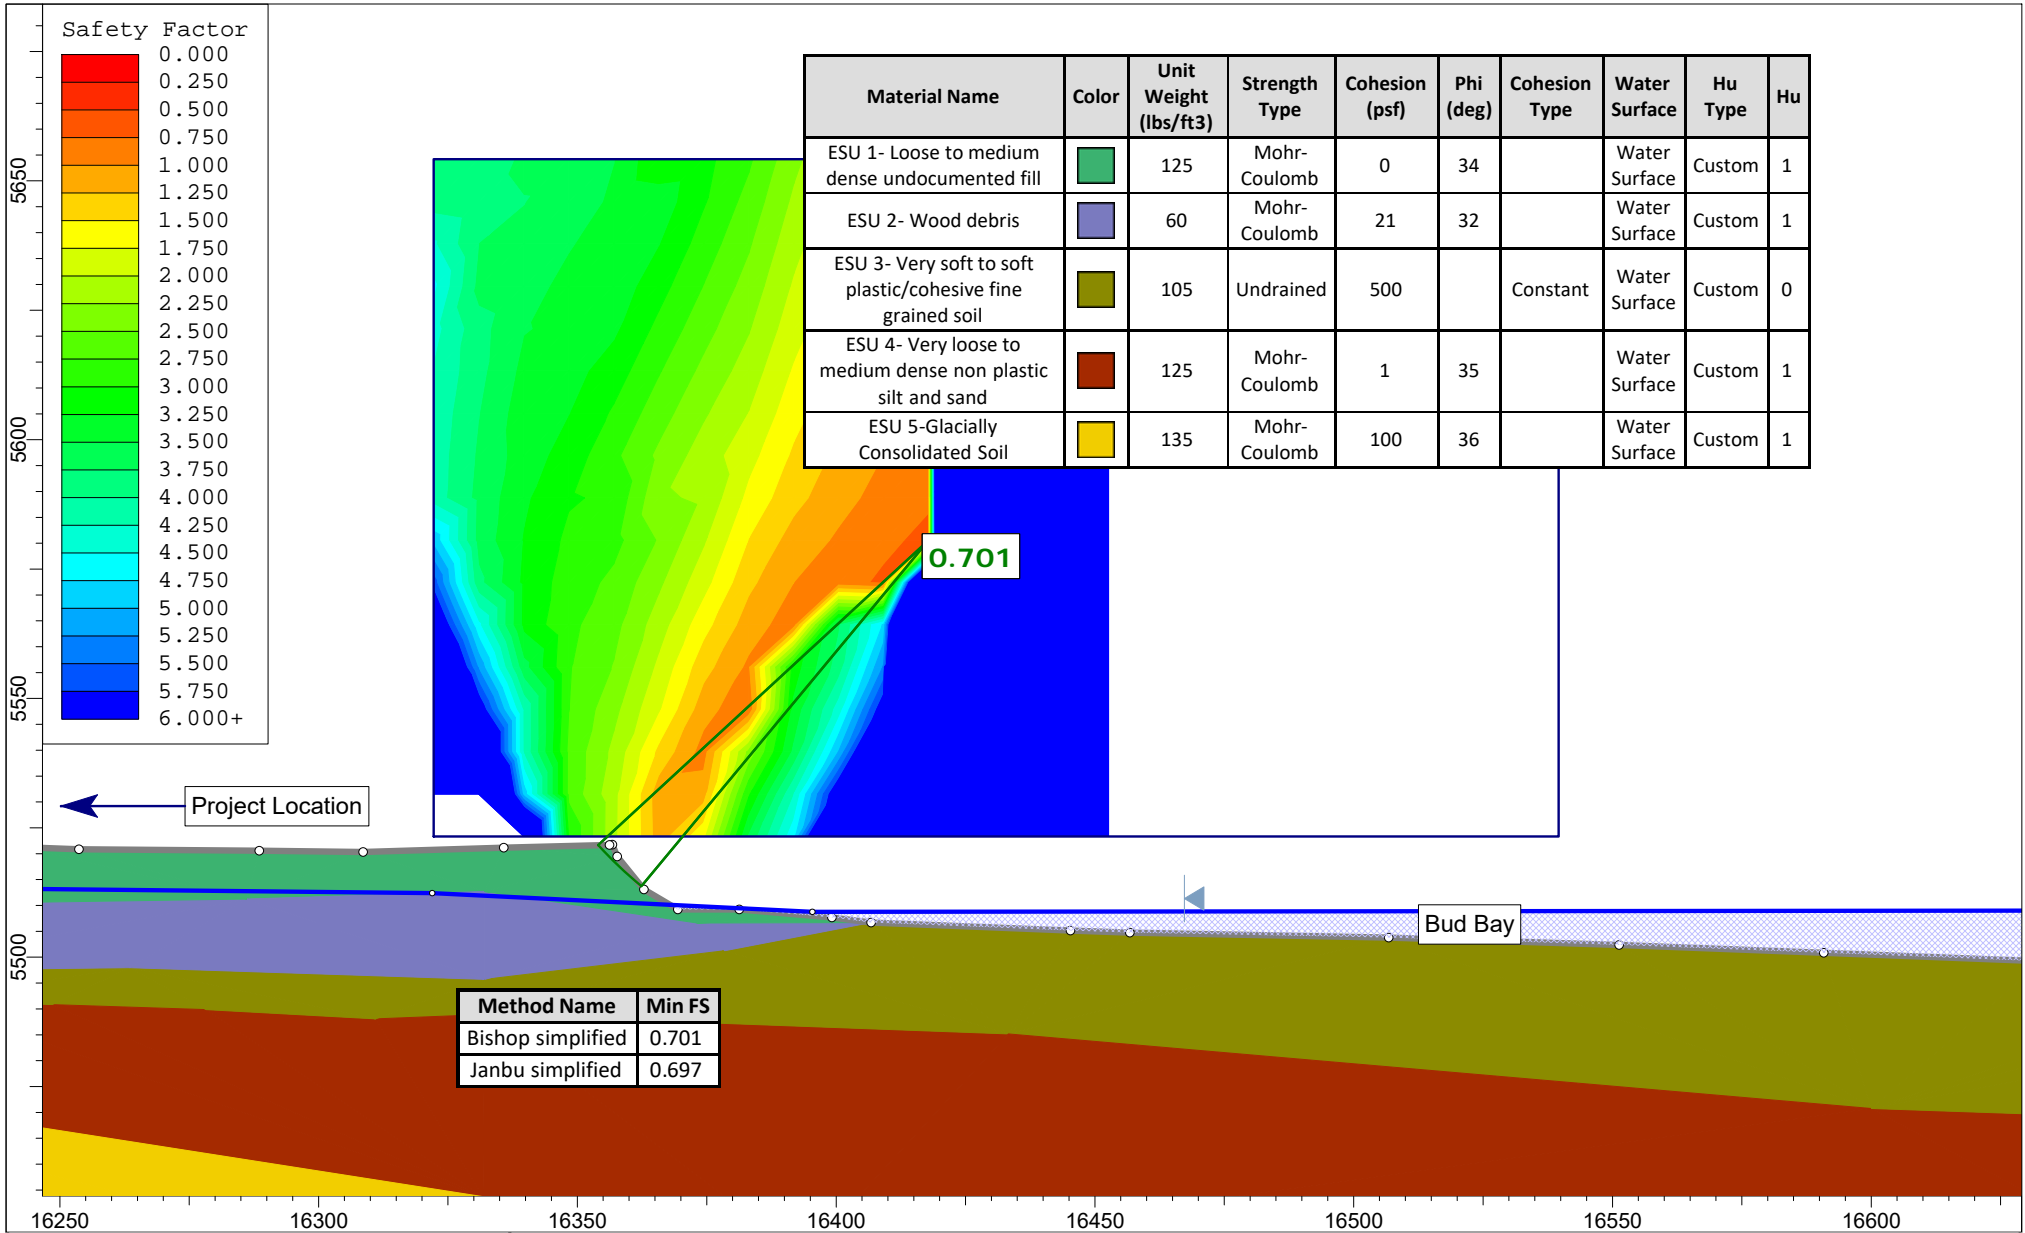
Project West Bay Mixed-Use Development Critical Areas Review	
	Group Group 1	Scenario Existing slope, static conditions, without riprap
	Drawn By BP	Company Landau Associates
	Date 10/8/2021, 3:59:47 PM	File Name West Bay Dr

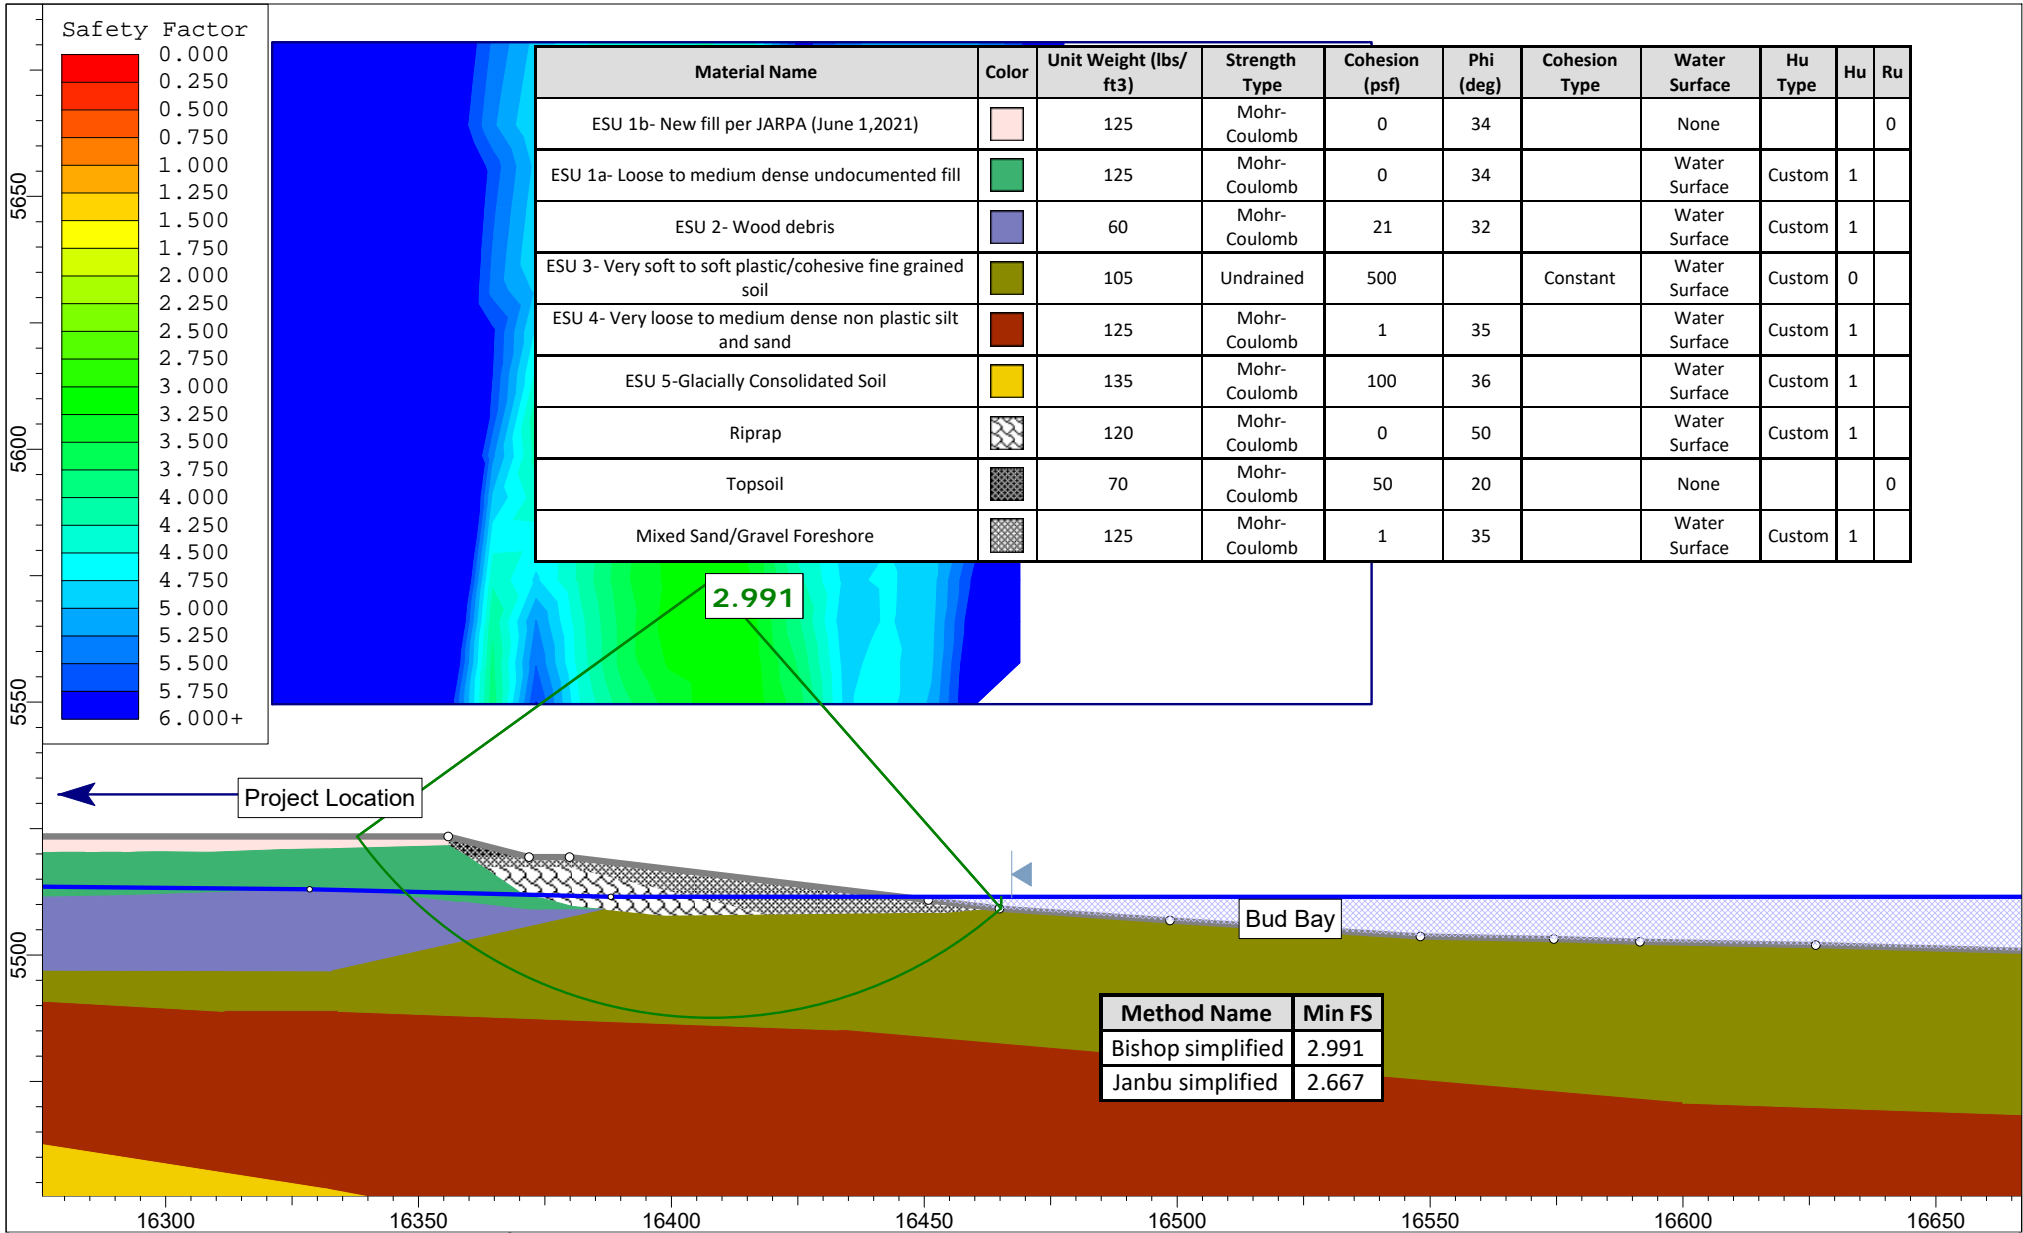
The results of LAI's 2020 engineering analyses indicate that the proposed slope configuration will not meet seismic stability requirements. This concern is addressed in the "Seismic Hazard Critical Area" section below.

Method Name	Min FS
Bishop simplified	2.991
Janbu simplified	2.667

Project West Bay Mixed-Use Development Critical Areas Review	
	Group Group 1	Scenario Proposed slope configuration, static conditions
	Drawn By BP	Company Landau Associates
	Date 10/8/2021, 3:59:47 PM	File Name West Bay Dr
