Kaiser Woods Bike Park Trail System Project  
4300 Park Drive SW  
Olympia, WA 98502

### Level V Soil & Vegetation Report

Prepared for: City of Olympia, Diane Utter, Parks Project Engineer, Parks, Arts & Recreation

Date: 3/29/2023, Amended 11/5/2023, 3/21/2025 & 3/28/2025, 4/4/2025

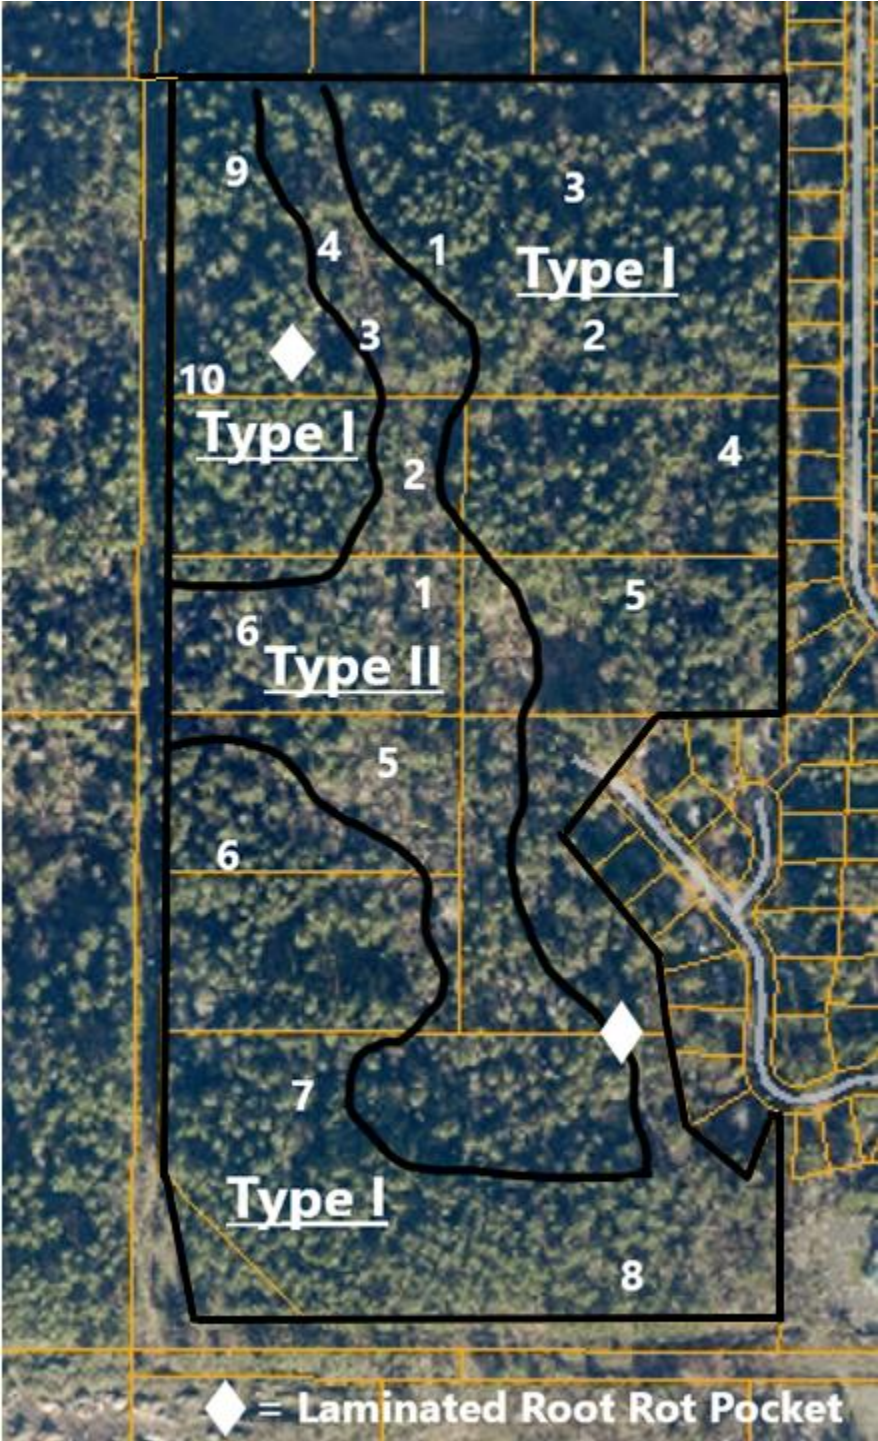
Locations of Forest Cover Types and Sample Plots

**Forest Cover Type I:** Total area is approximately 54.76-acres, taking into account the cleared areas. Dominant Douglas fir with scattered big leaf maple and a few western red cedar. The cedars are regenerating with saplings found throughout. Understory vegetation includes salal, low mahonia, deciduous and evergreen huckleberry, sword fern, hazelnut, bracken fern, English ivy and English holly. Two pockets of Laminated Root Rot (LRR) were identified, as noted with a white triangle on the aerial. A total of ten sample plots were collected.

Forest Cover Type II: Total area is approximately 13.43-acres. This forest cover is more indicative of soils with higher hydraulic properties and includes a mixture of red alder, big leaf maple and western red cedar. A few Douglas fir and western hemlock are also found. Understory vegetation includes salal, salmon berry, sword fern, hazelnut, oceanspray, willow, Nootka rose and English holly. A total of six sample plots were collected.

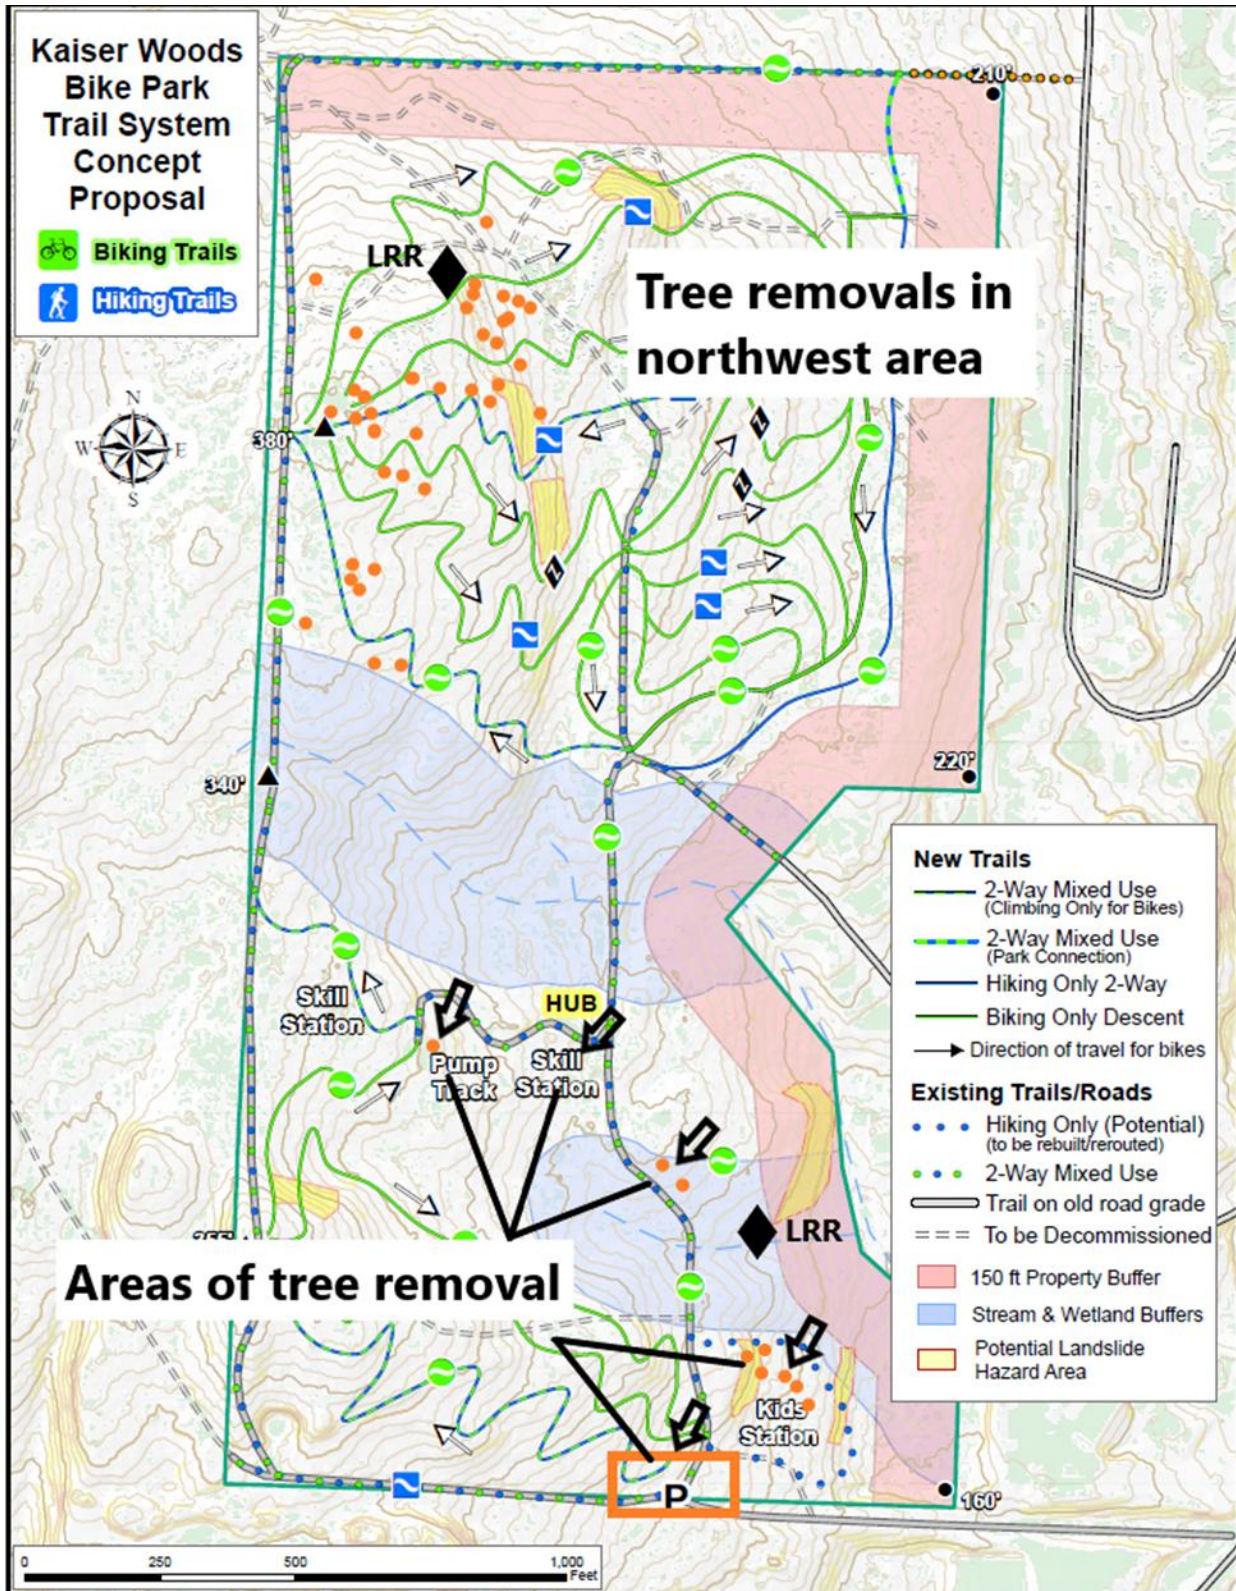
**Appendix 1. Locations of Tree Removals**

- Skill Station 'A': Six Scouler's willows, measuring 6-12" DBH in poor to fair condition. These trees are in conflict with the improvements.
- Pump Track: One dead 19" Douglas fir.

- Parking Area: A total of six trees will require removal. They include: three 1-3" big leaf maple, one 8" Scouler's willow, two Douglas firs measuring 10" & 14" DBH.

- Kids Station: Six dead western red cedars measuring 12", 15", 17", 20", 20", 34" DBH.
- Storm Pond: A total of fifteen trees: 4 big leaf maples (4", 2x10" & 25"), 4 cottonwoods (13-16" & 38"), 3 multi-stem Scouler's willows (14-20") and 4 Douglas firs (5-16").

- Along Trail in SE Corner: There are two 18" DBH Douglas firs along the existing trail that runs north-south that are within the LRR pocket, infected and will require removal.

- Along New Trails in NW Corner: It has been determined that a total of 37 Douglas firs measuring 14"+ DBH and 16 red alders measuring 10"+ DBH will be removed due to being within the LRR pocket and infected or already dead.

Western red cedar trees that have been identified for removal should be cut as close to the ground as possible to facilitate bark collection from the fallen trunks. All other trees should be cut at a height of 10' or less, whichever can be done safely, to provide wildlife habitat.

If the mentioned 37 LRR infected Douglas firs are removed within the NW corner, I would recommend a replanting effort. Only species that are resistant to this disease should be used. I suggest big leaf maple, western red cedar, incense cedar, ponderosa and shore pines. Due the density of forest cover, I do not believe there is the need to replant for any other proposed tree removals.
