Current Photos
1701 4th Ave E
Heritage Review Committee Meeting
October 31, 2016

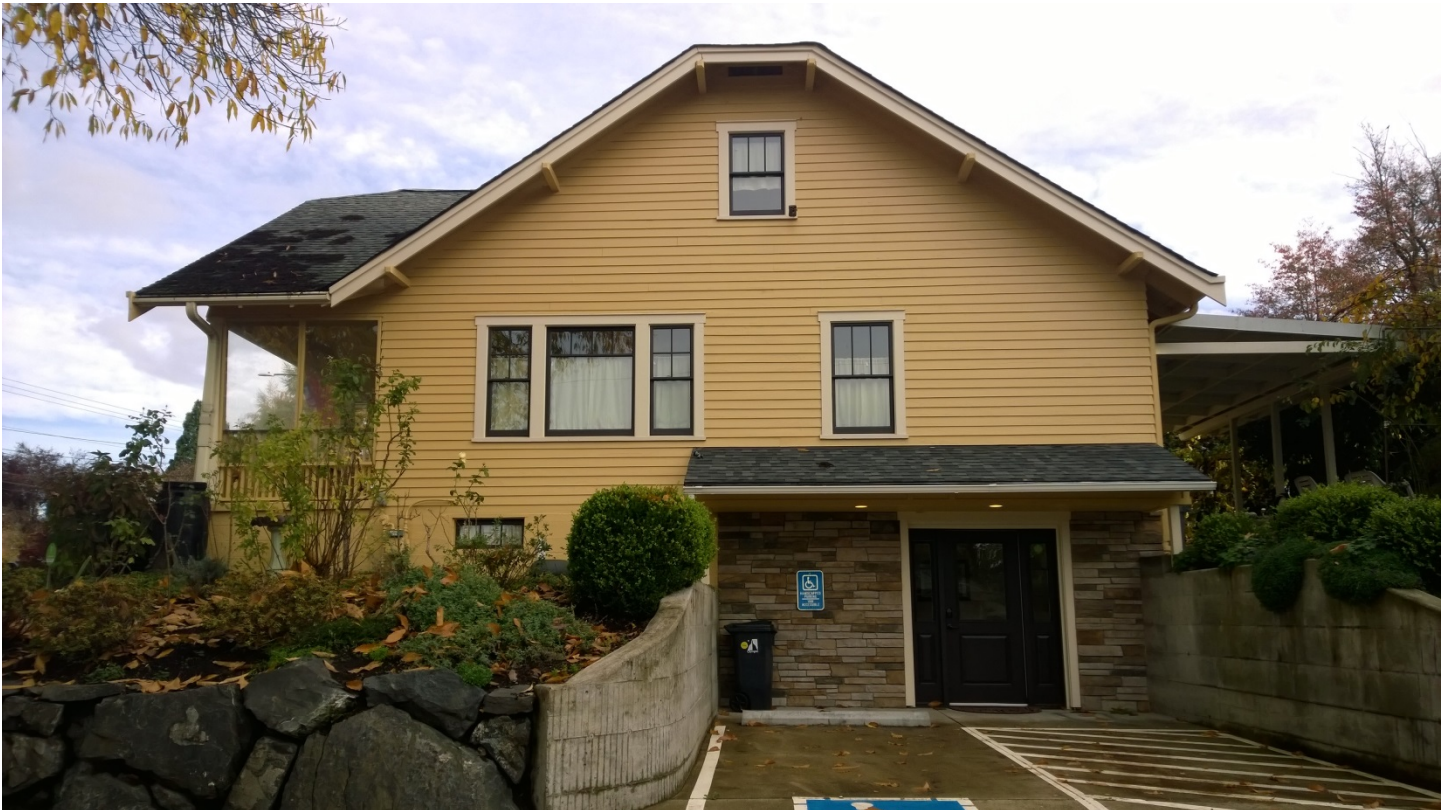
Figure 3: Side (West) Elevation). Note pedestrian entrance alterations to accommodate an accessible entrance and meeting/treatment rooms, replacing a (non-historic) garage door.

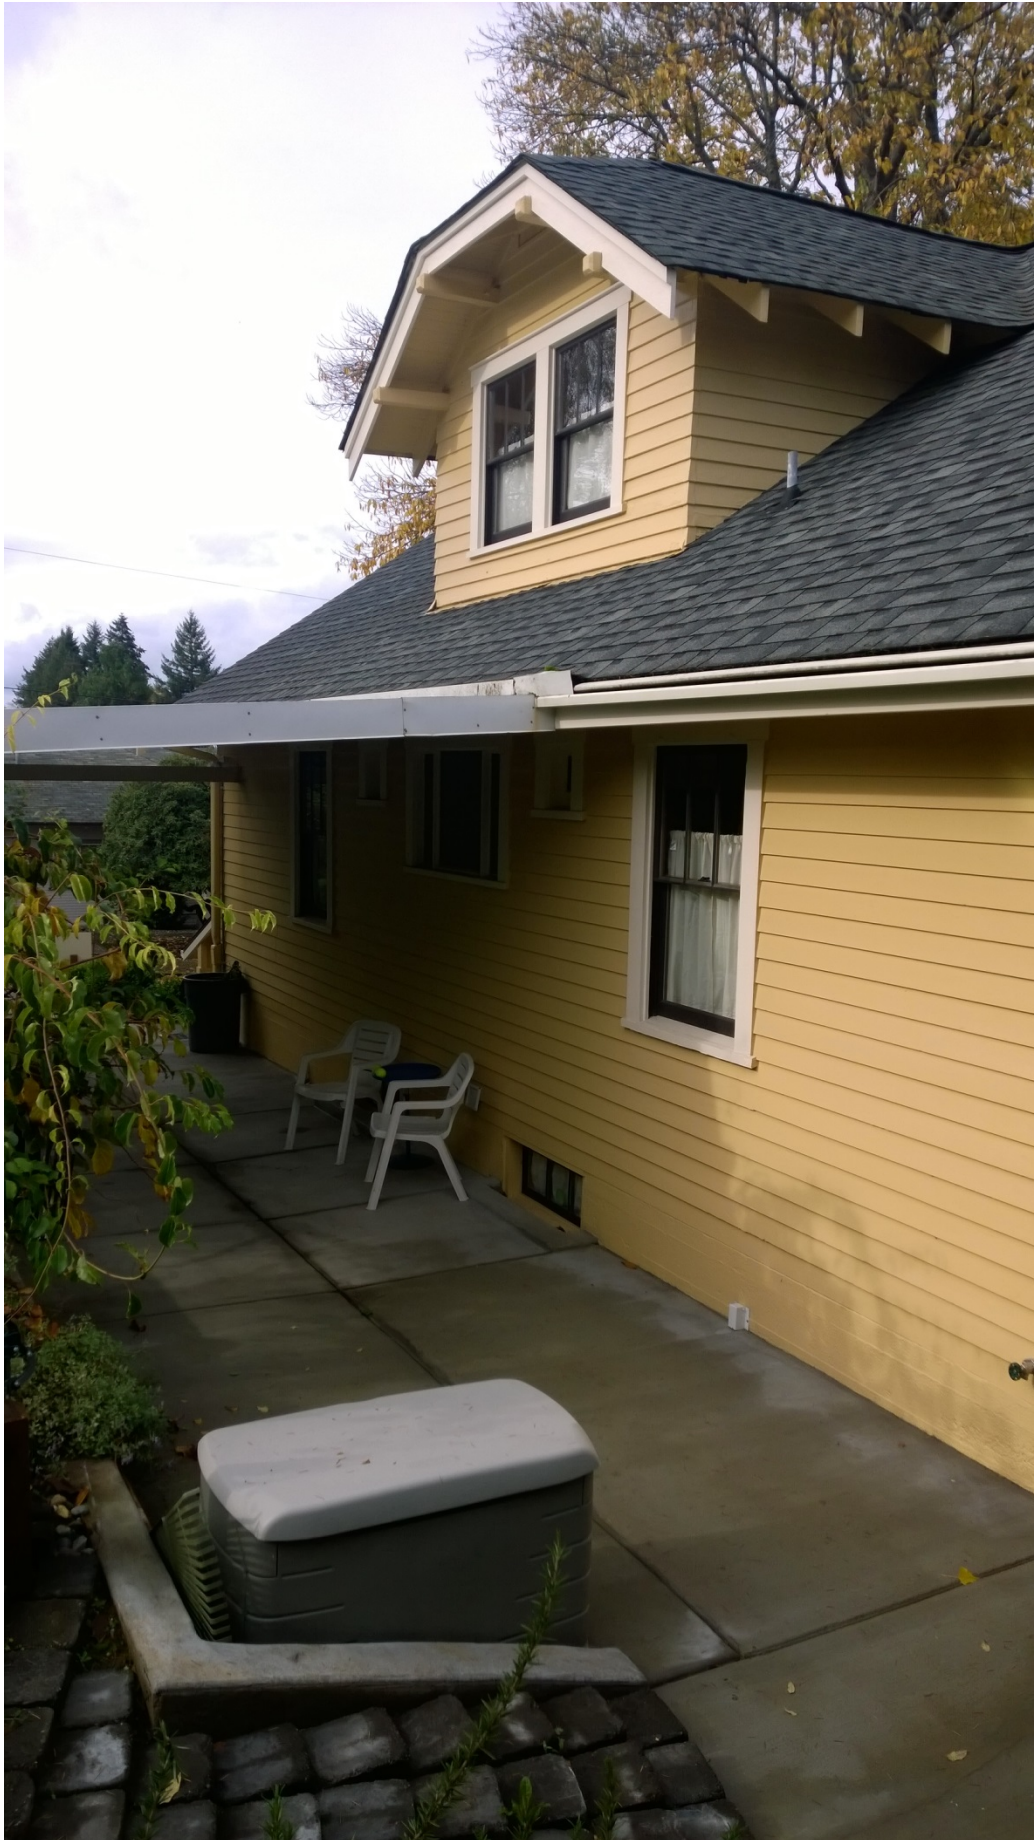
Figure 5: Rear (South) Elevation. Significant drainage works and bicycle parking are accommodated in this space.

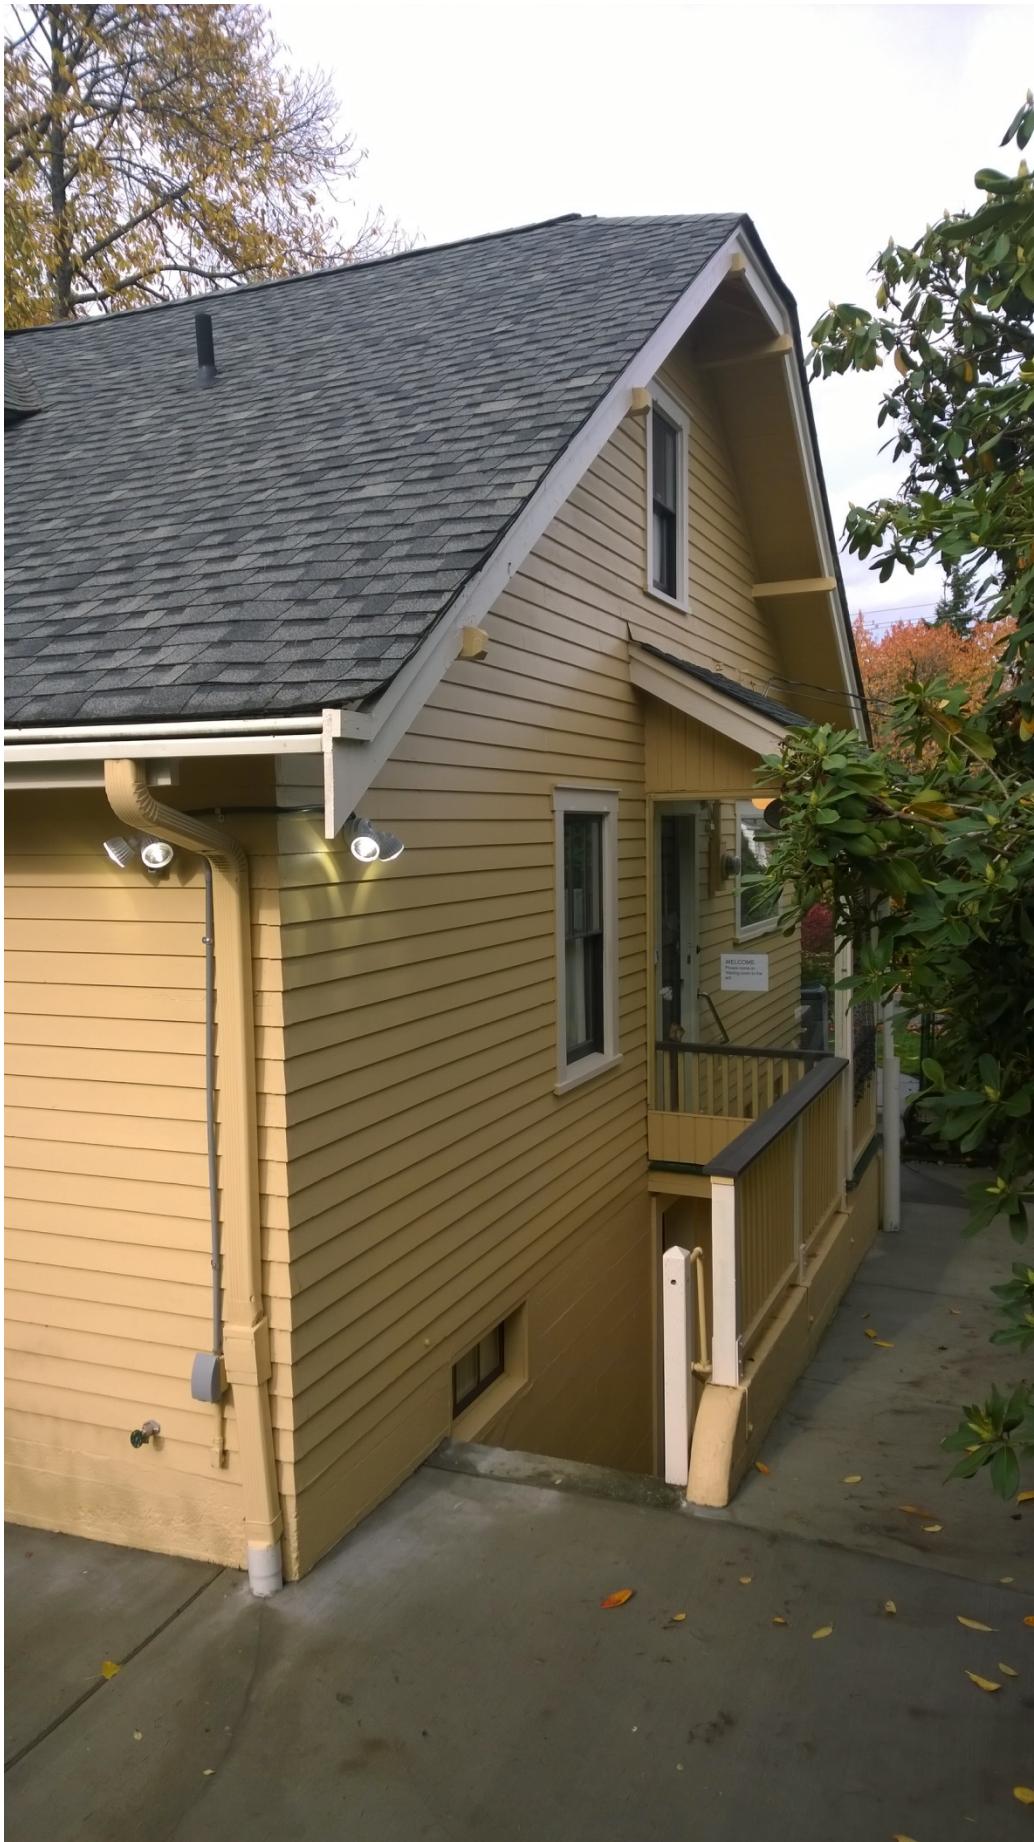
Figure 6: Side (East) Elevation. Significant drainage work involved new paving and safety railings were installed.

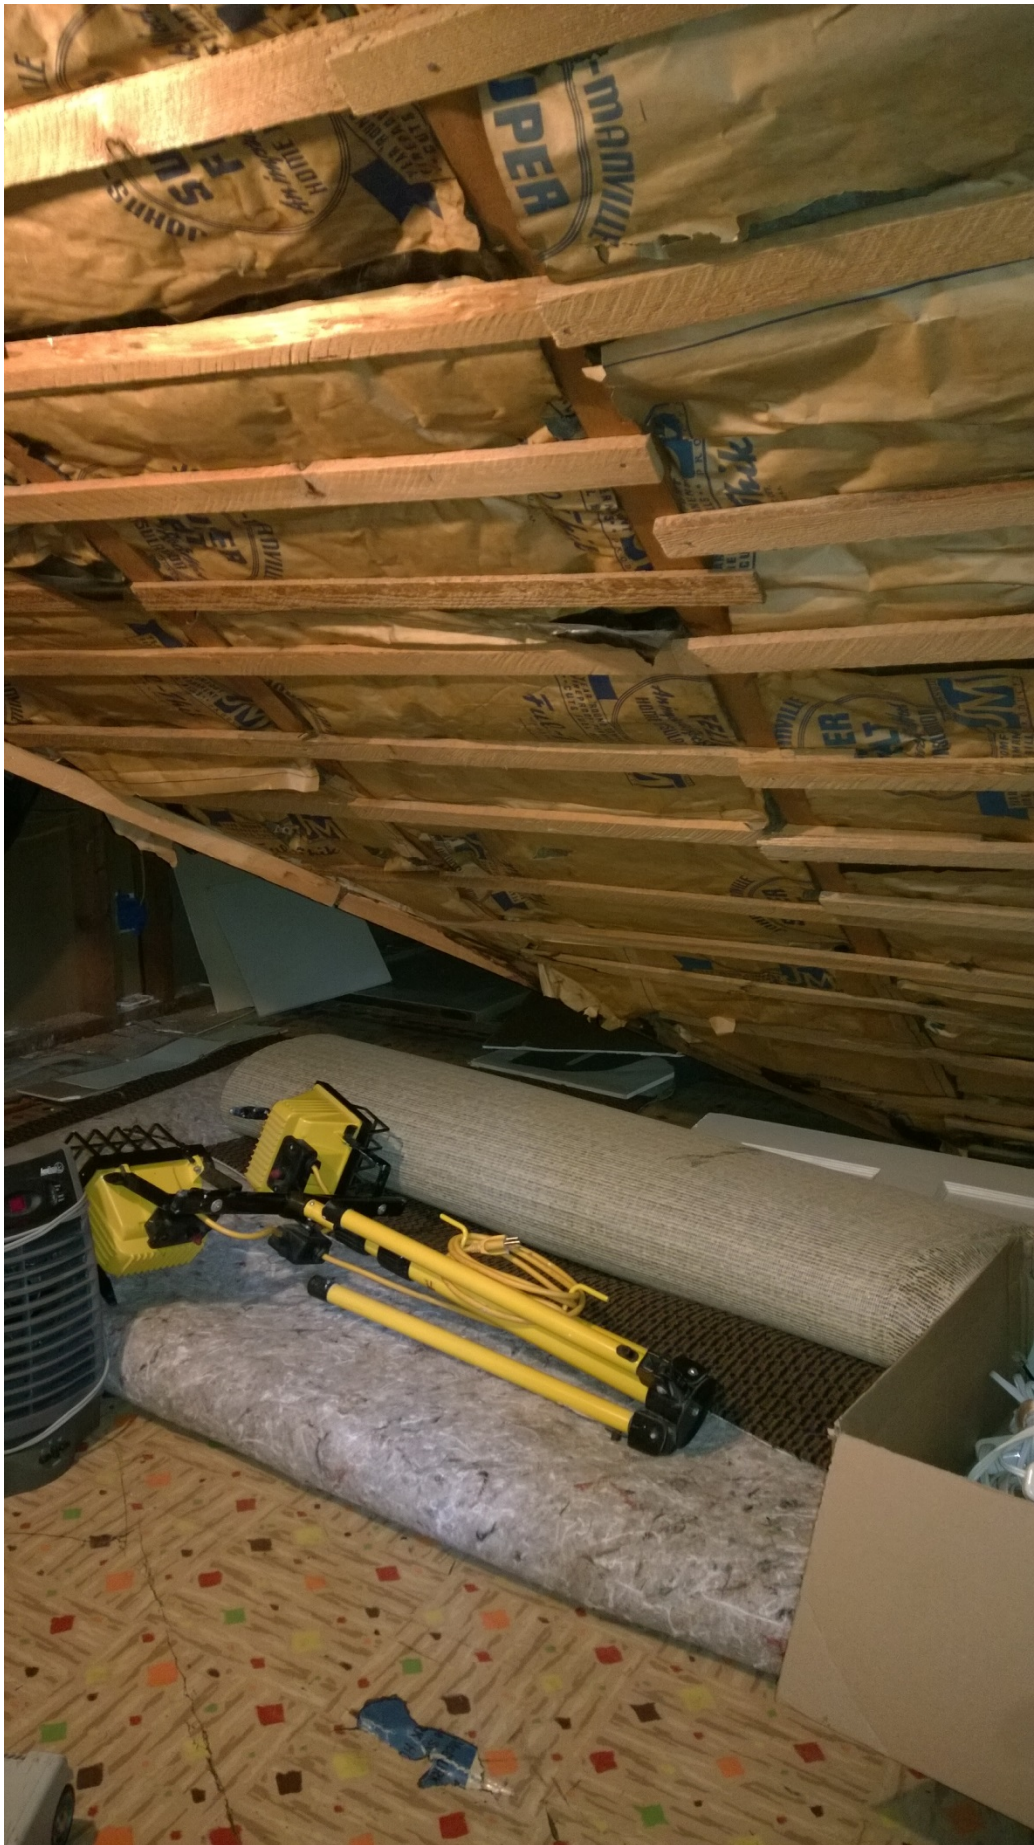
Figure 7: Roof and insulation improvements. Note retention of original or early linoleum.

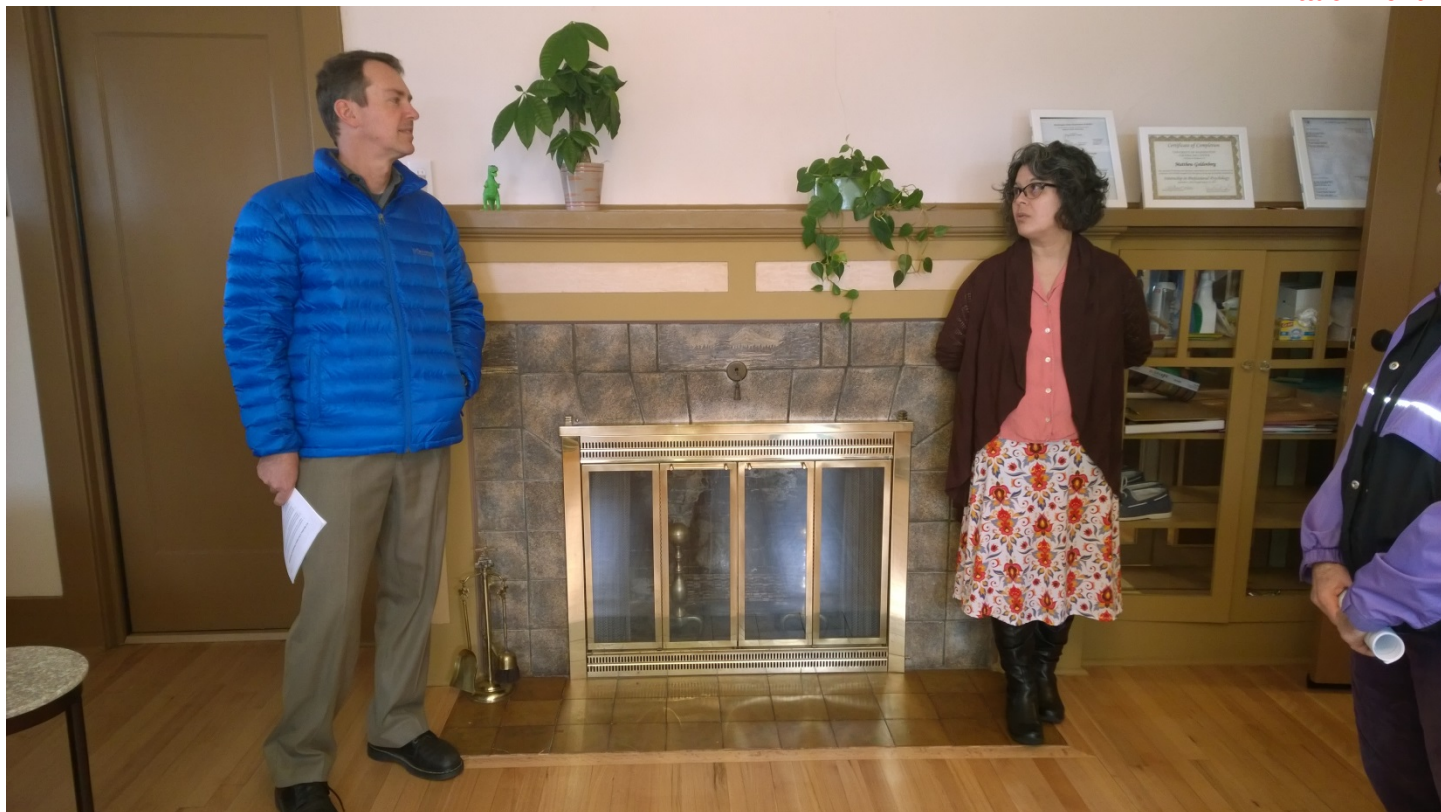
Figure 8: The former living room now serves as an office/treatment room. Floors were refinished and wall/trim surfaces repainted throughout the building.

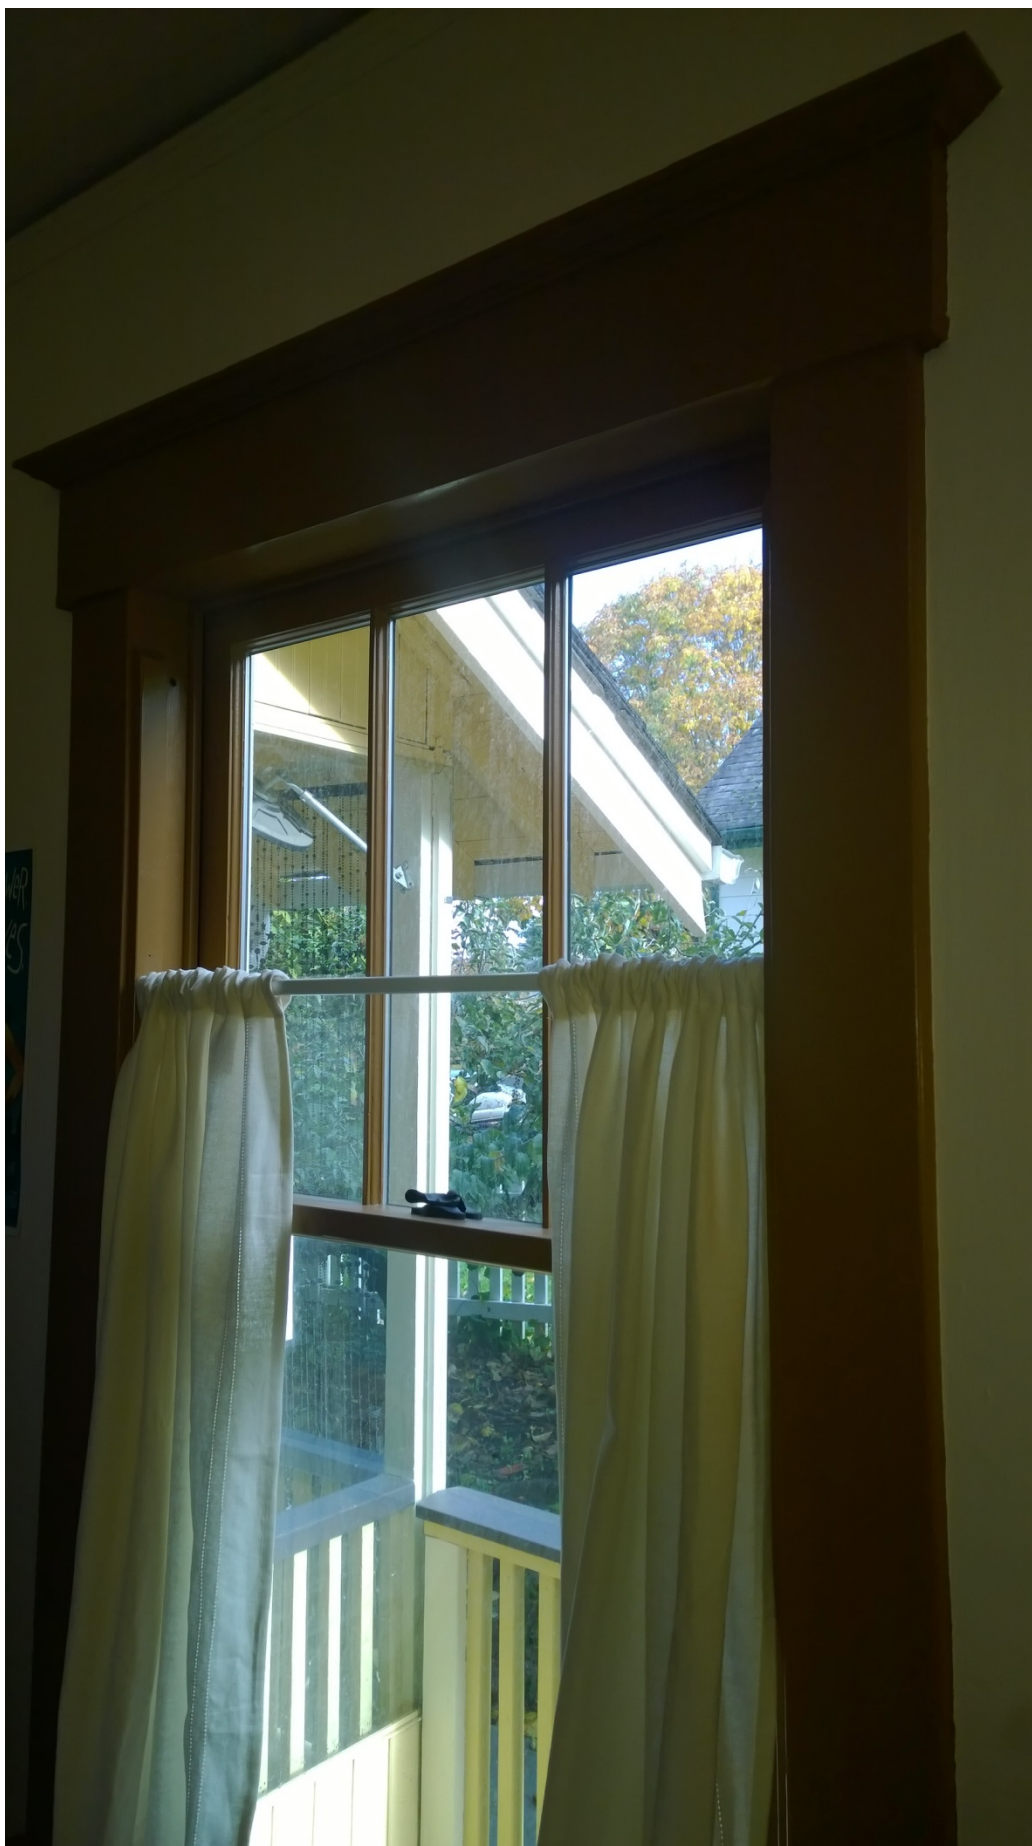
Figure 10: All original windows were refurbished and refitted with double-glazed units.

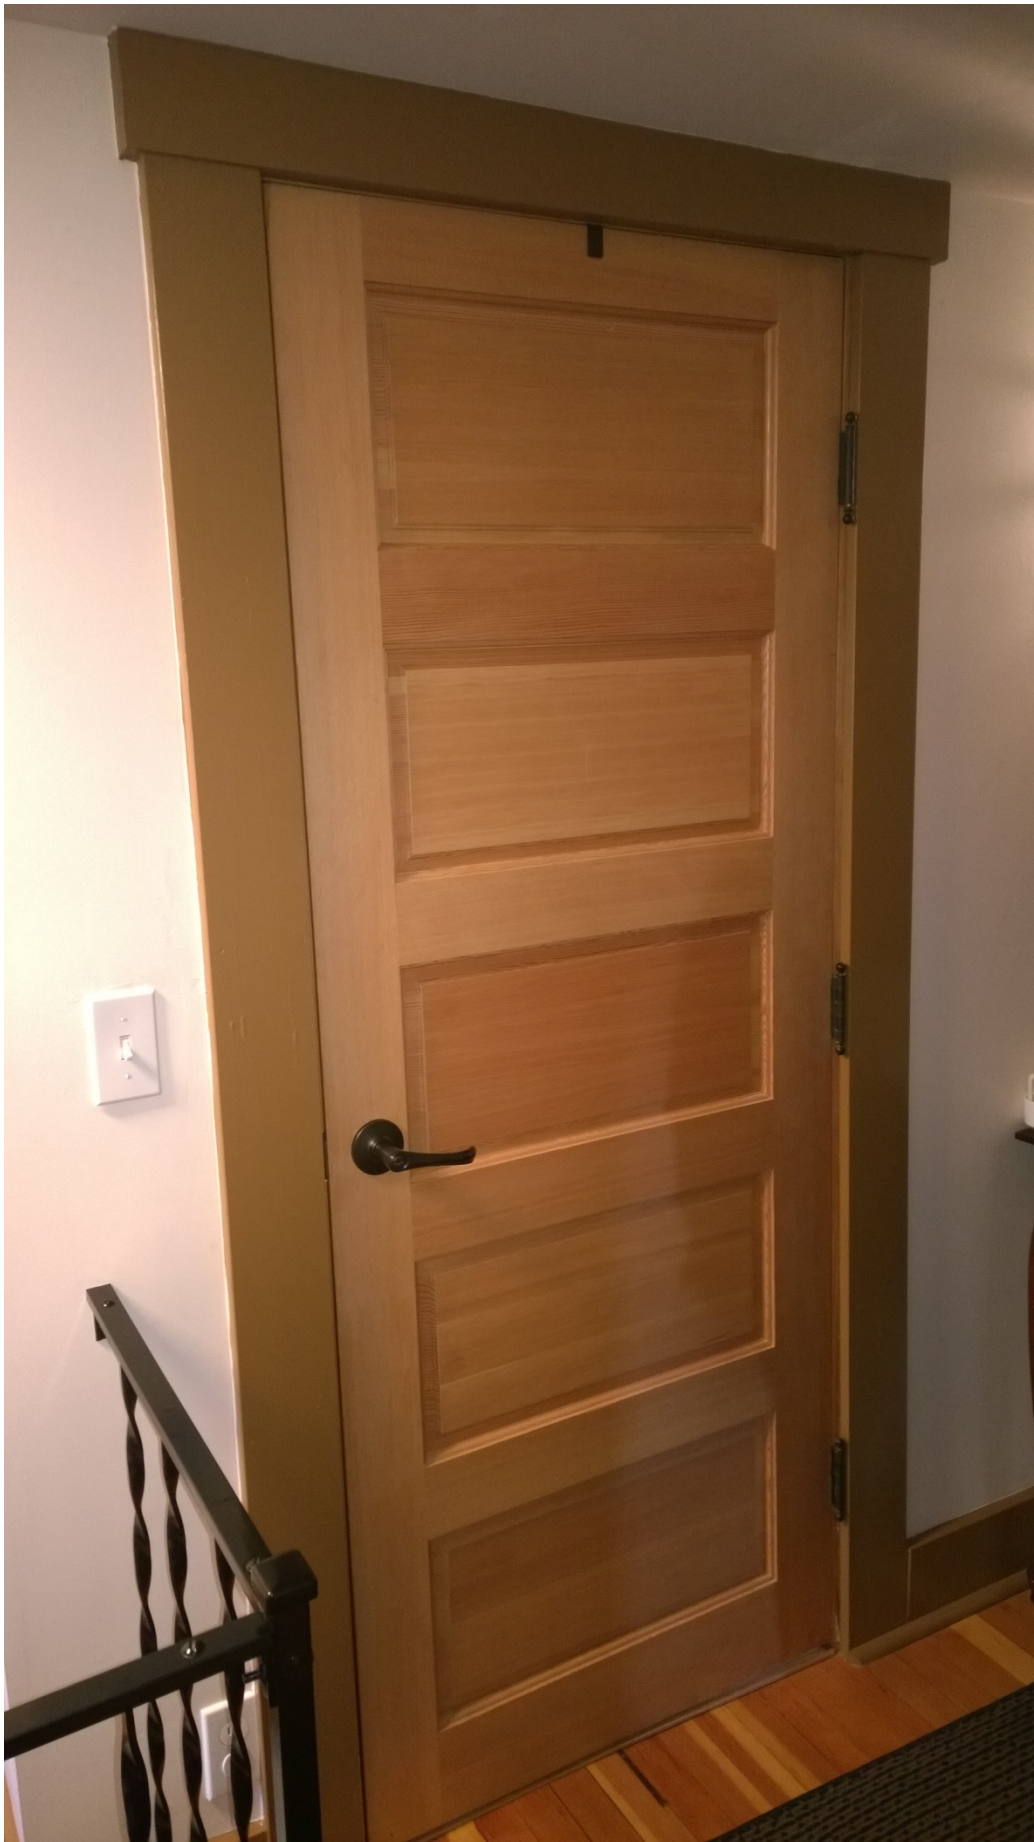
Figure 11: Some new doors were built to replace non-historic ones.

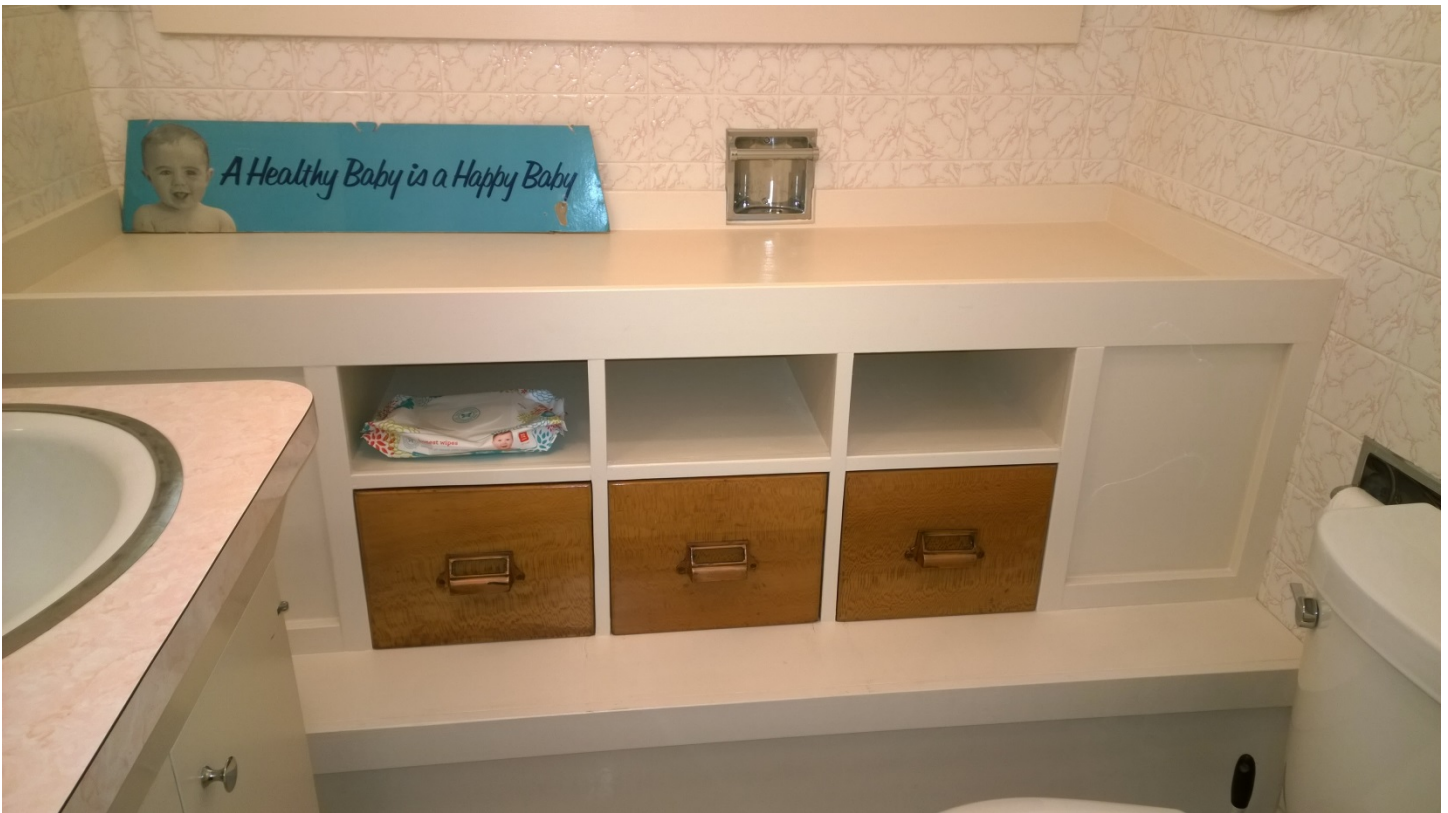
Figure 12: Bathrooms were upgraded while retaining and reusing historic fittings. Here the bath is covered with a baby-changing table that reuses some of the drawers from the pharmacy run by former owners.

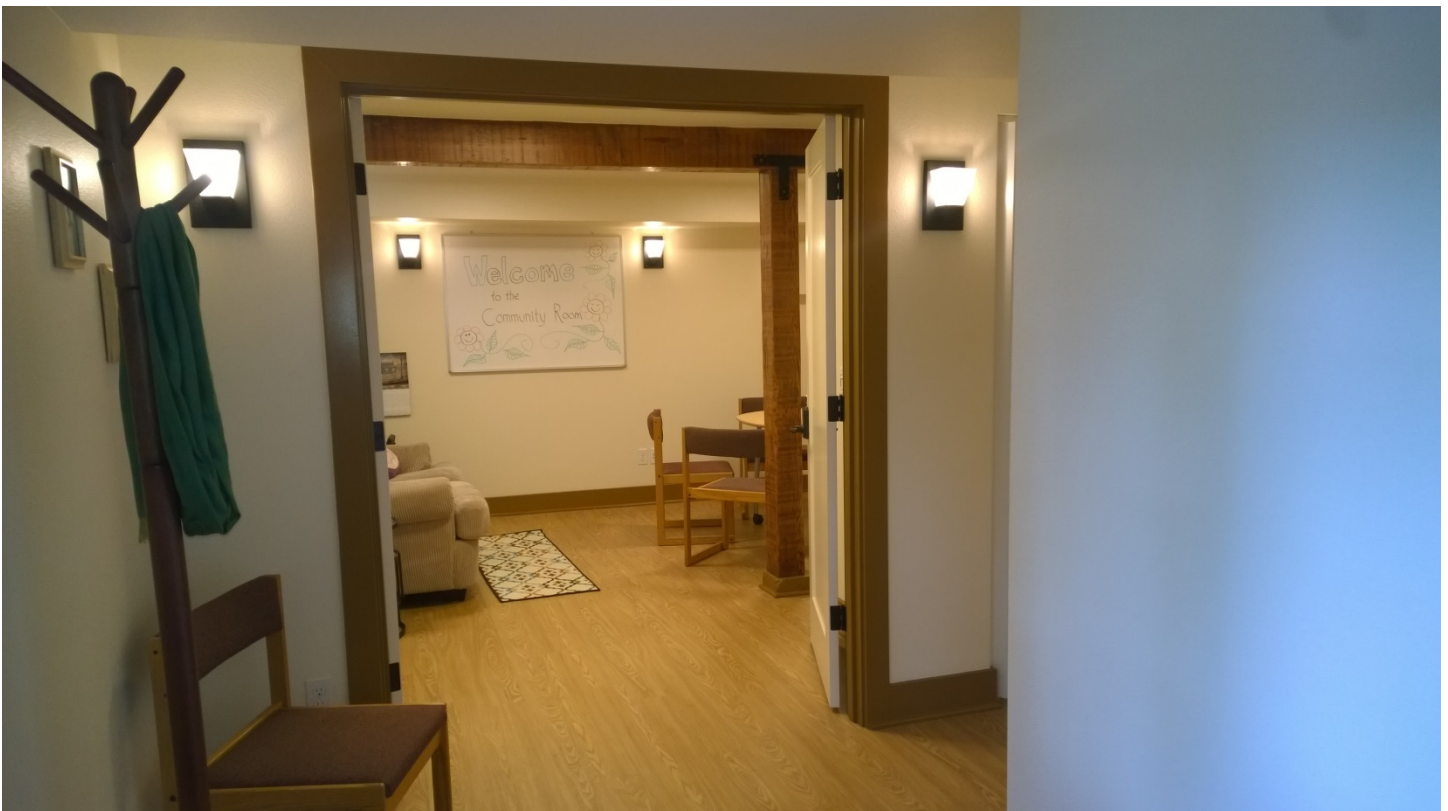
Figure 13: The previously unfinished basement was entirely framed out to create accessible meeting and treatment spaces. This is the view from the entrance into the main meeting and treatment room.

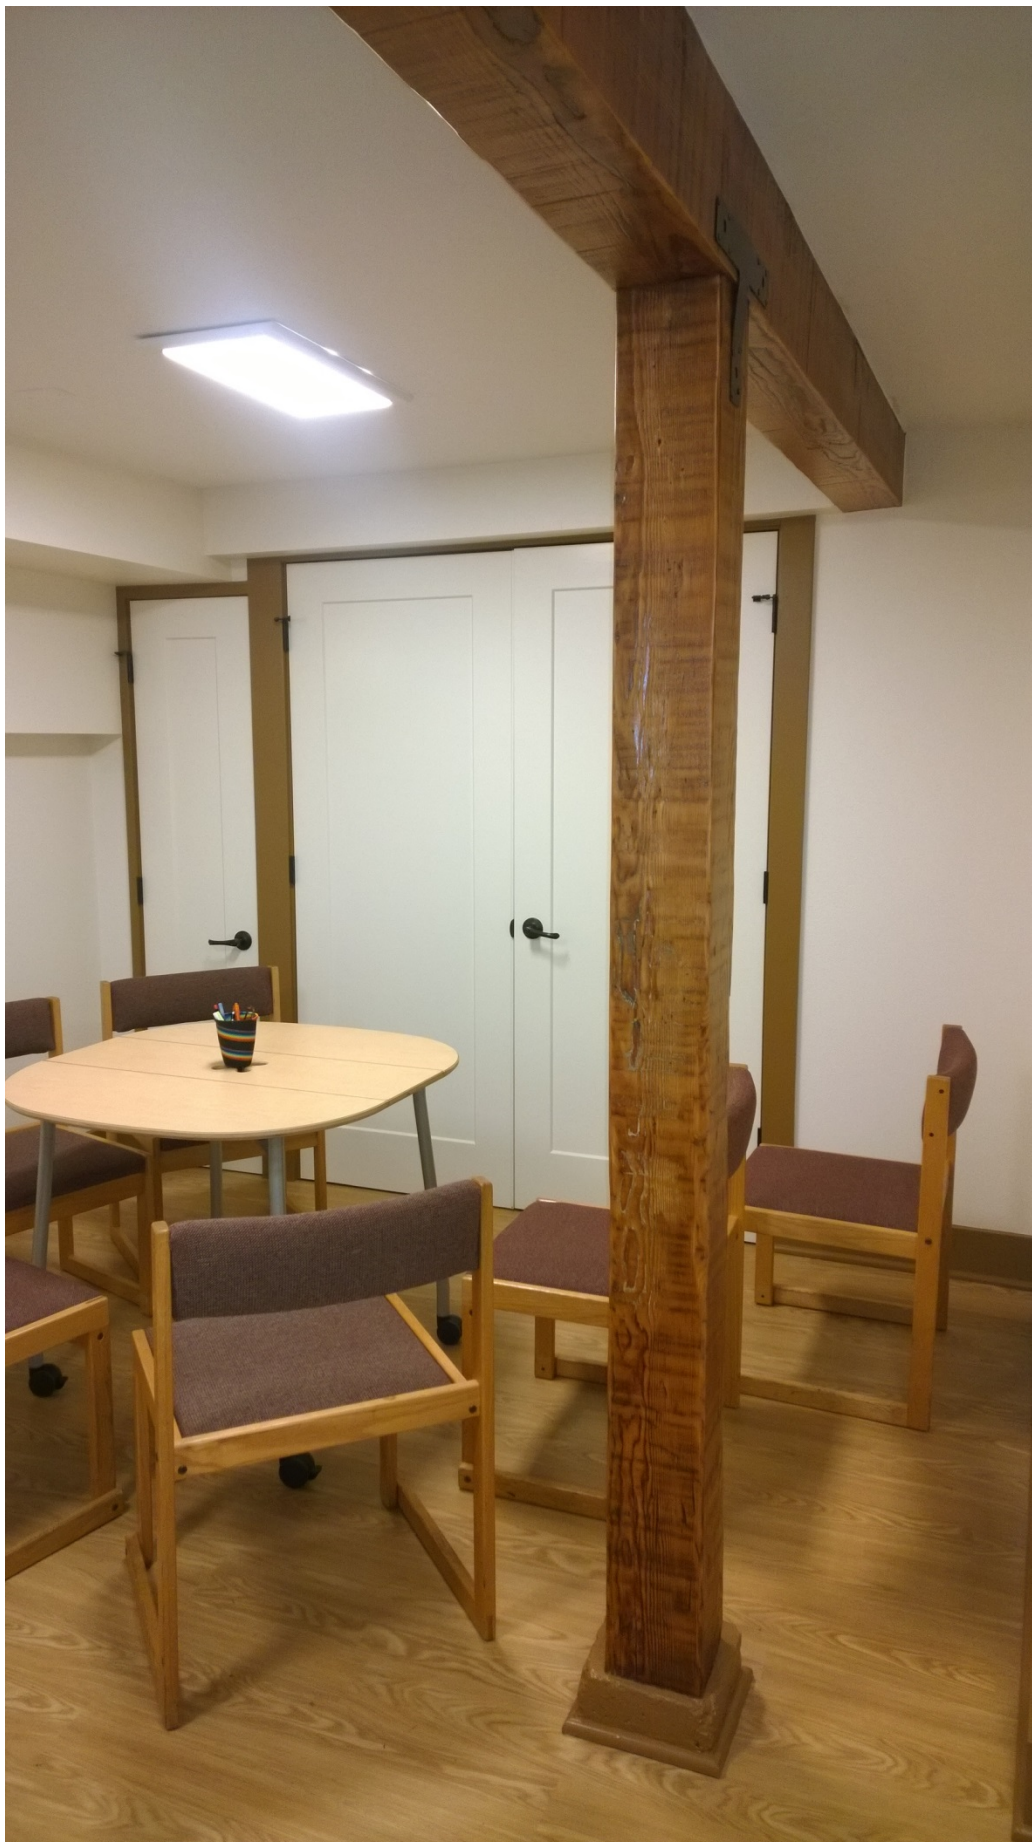
Figure 14: The main accessible meeting and treatment room in the basement. Original framing was retained and is now highlighted as a feature throughout the basement spaces.

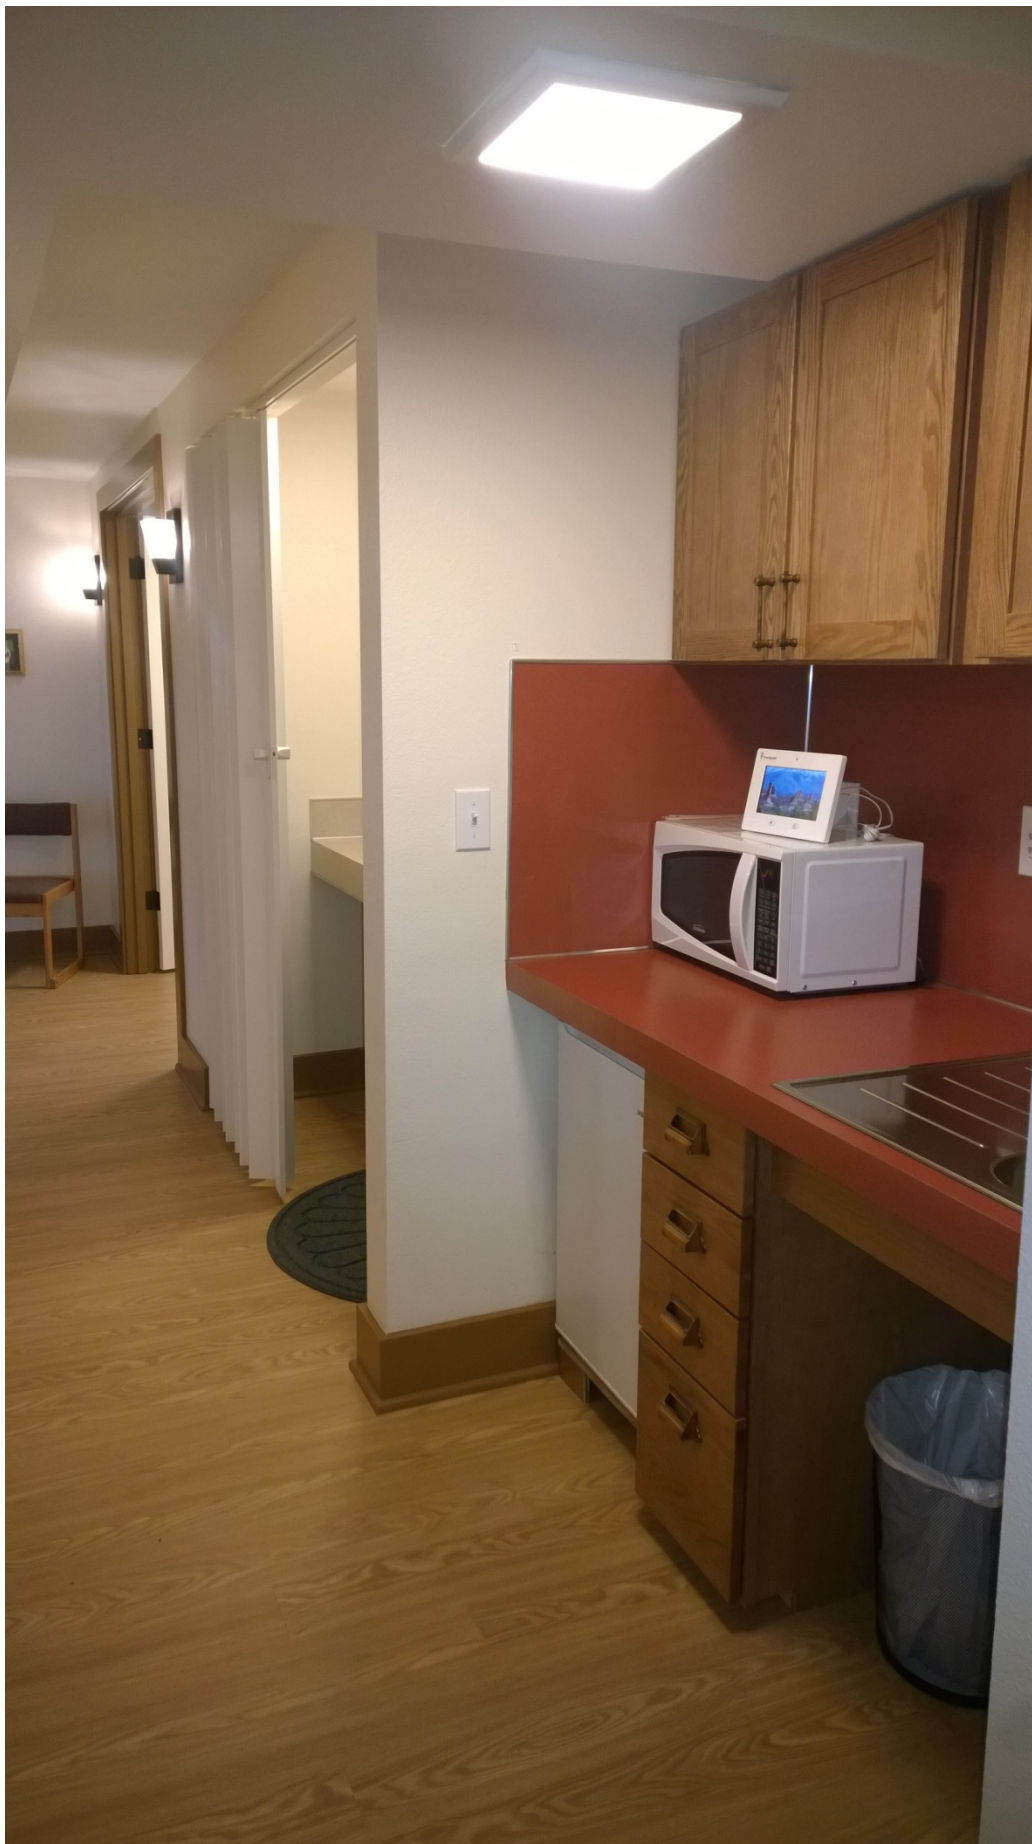
Figure 16: Basement kitchen area. Cabinet and drawer handles are reused fittings from the pharmacy run by previous owners of the house.
