# Appendix B. Detailed Blight Findings

## 1 Blighted Properties

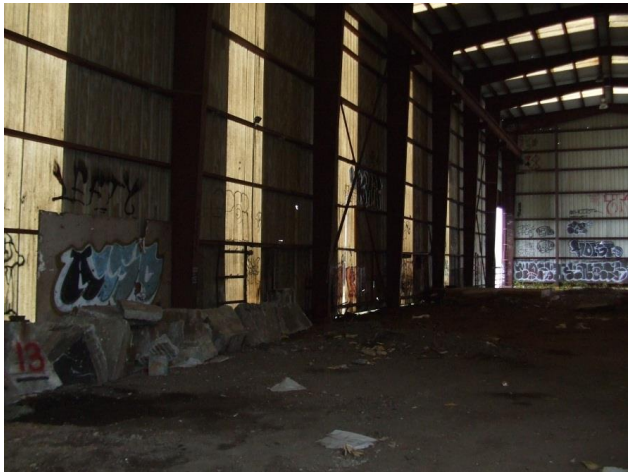
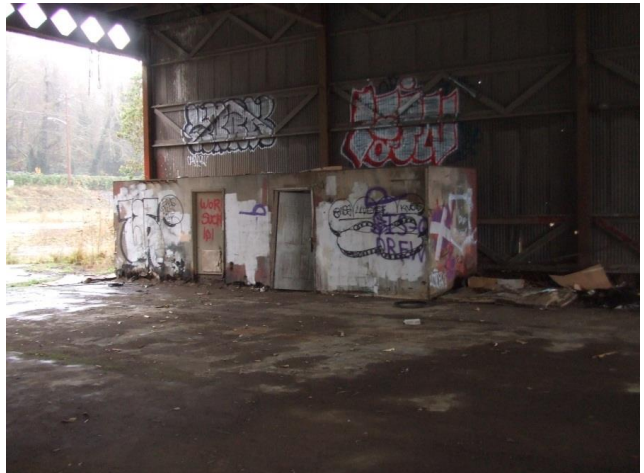
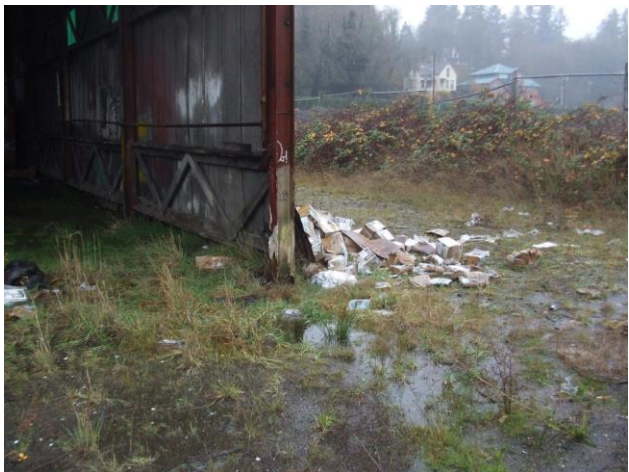
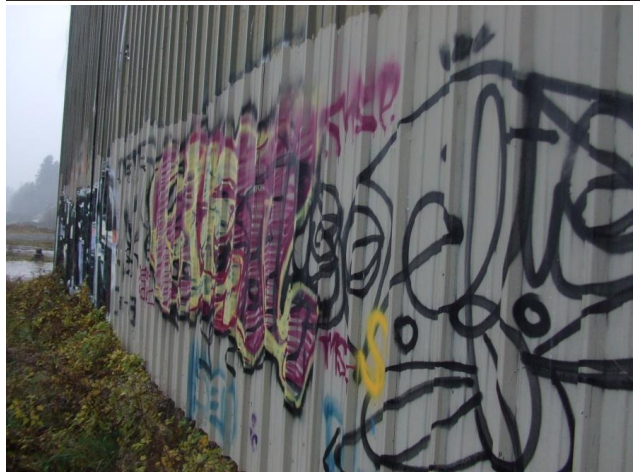
## 1.1 Reliable Steel

Trash & Debris on Building Exterior (16.06.030.307.1)  
Holes on Exterior Walls (16.06.030.304.6)  
No Exterior Doors (16.06.030.304.15)  
Rodent Infestation (16.06.030.308.1)  
Graffiti on Several Walls (16.06.030.302.9)  
Leaking Roof (16.06.030.304.7)

The entire property sits on fill. Sea level rise projections show that the majority of the parcel would be submerged at 19-foot tide levels. Contaminated soil has been located in four locations within 200 feet to the west and southwest of the parcels.

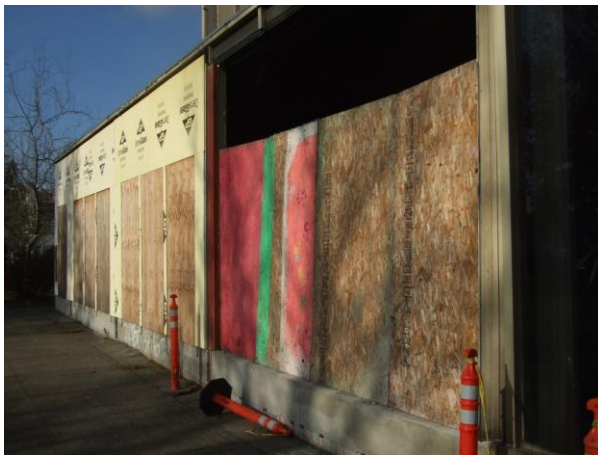
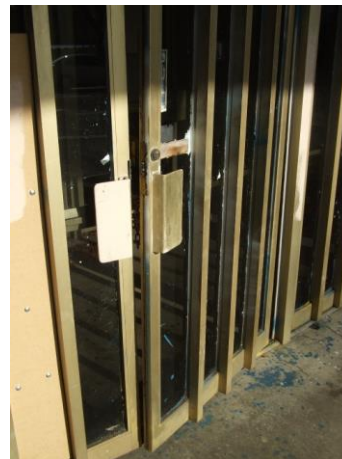
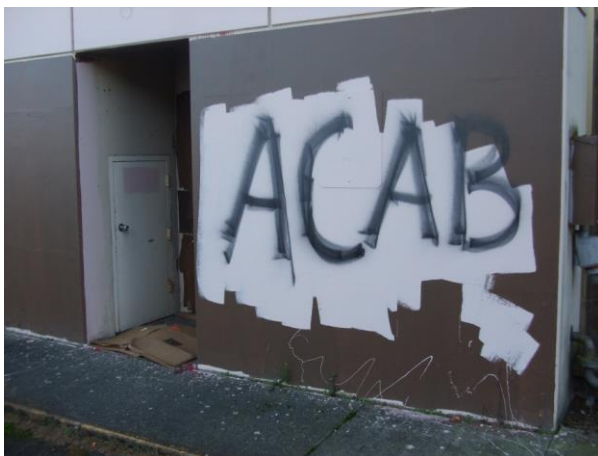
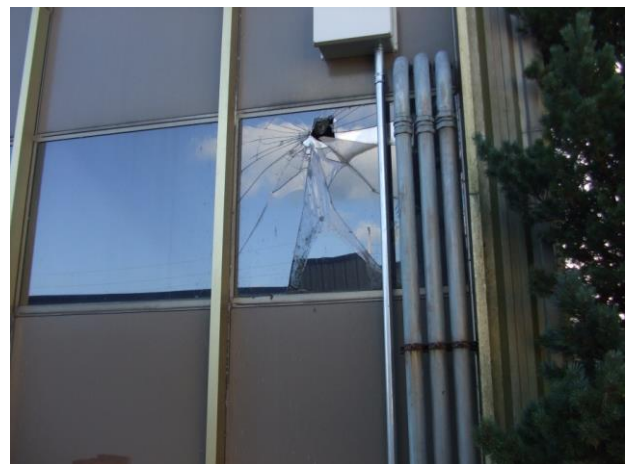
## 1.2 Capitol Center Properties

Trash & Debris on Building Exterior (16.06.030.307.1)

Holes on Exterior Walls (16.06.030.304.6)

Unsecure Exterior (16.06.030.304.15)

Broken/Boarded Windows (16.06.030.304.13)

Graffiti on Several Walls (16.06.030.302.9)

The entire property sits on fill. Sea level rise projections show that a small portion of the parcels on the north of 4th Avenue (parking lot) would be submerged at 18.5-foot tide level, about half at 19-foot tide levels, and the approximately 90% at the 19.5-foot level. The parcels on the south side of 4th Avenue would be 75% submerged at the 19-foot tide level. Contaminated soil has been located within 100 feet to the north of the parking lot on the north side of 4th Avenue, and in the northeast corner of the parcels south of 4th Avenue.

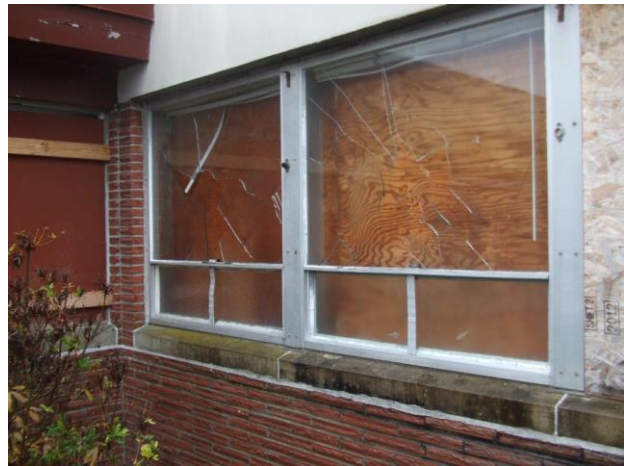
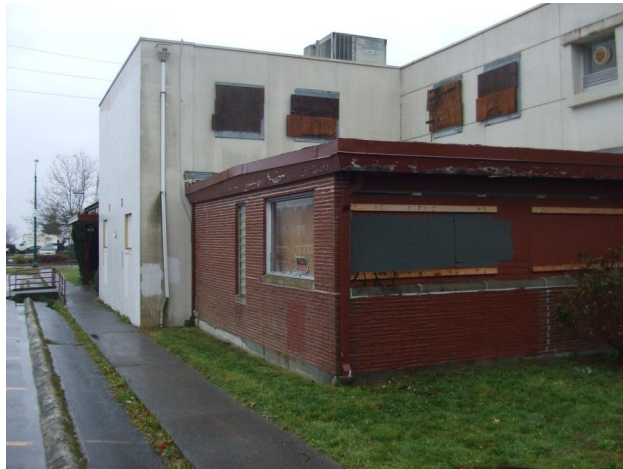
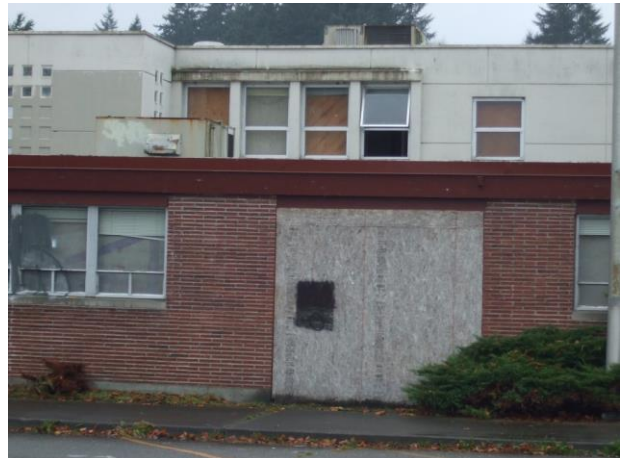
### 1.3 City-Owned Isthmus Property

- Flaking Exterior Surface (16.06.030.304.2)
- No Roof (16.06.030.304.7)
- Holes, Breaks, Loose, and Deteriorating Exterior Wall (16.06.030.304.6)
- Missing/Boarded Windows (16.06.030.304.13)
- Graffiti on Several Walls (16.06.030.302.9)

The entire property sits on fill. Sea level rise projections show that nearly 90% of the east parcel would be submerged at the 19-foot tide level. The west parcel (old health department building) would be 75% submerged at the 20-foot tide level. Contaminated soil has been located within 25 feet to the north of the old health department building. City of Olympia staff is currently working on plans and specifications for demolition. The estimated cost of demolition is \$1,000,000. Staff are hopeful to start demolition in Spring, 2015.

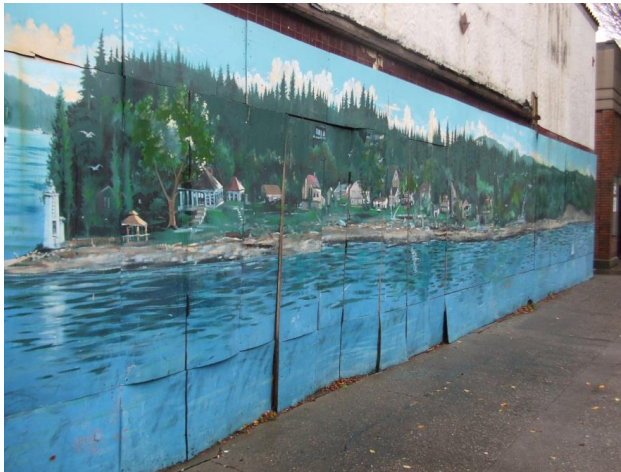
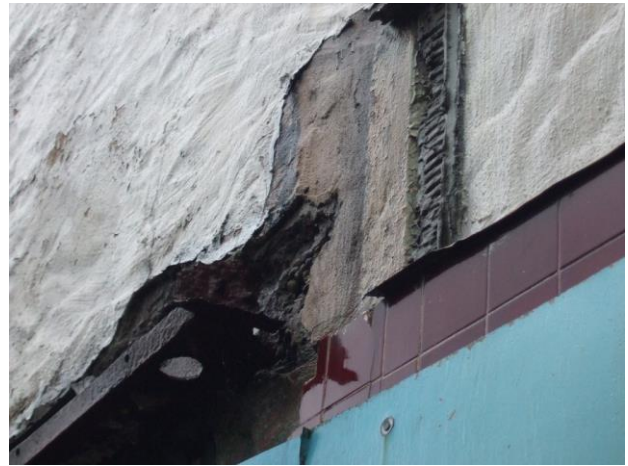
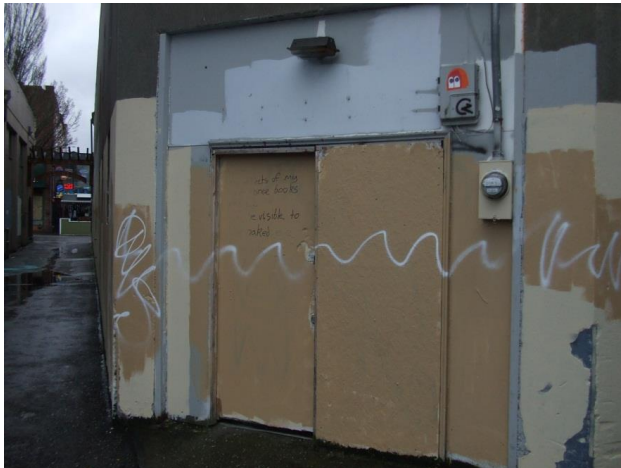
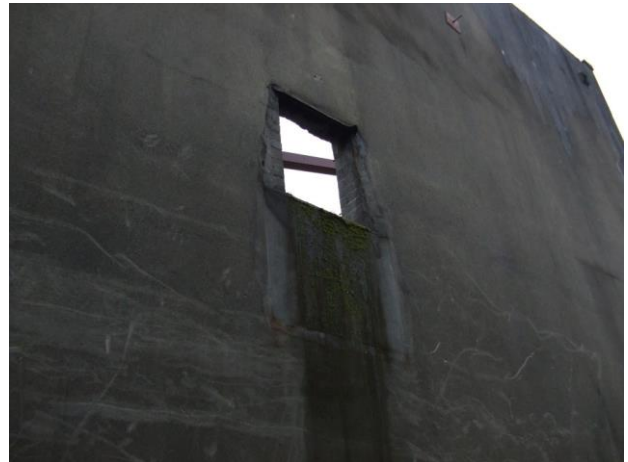
## 1.4 Griswold's Building

Flaking Exterior Surface (16.06.030.304.2)

No Roof (16.06.030.304.7)

Holes, Breaks, Loose, and Deteriorating Exterior Wall (16.06.030.304.6)

Missing/Boarded Windows (16.06.030.304.13)

Graffiti on Several Walls (16.06.030.302.9)

The parcel does not sit on fill. Sea level rise projections show that approximately 10% of the parcel would be submerged at the 20.5 feet tide level, and 90% at 22 feet. Contaminated soil has been located approximately 100 feet to the northwest of the parcel and 250 feet to the southeast.

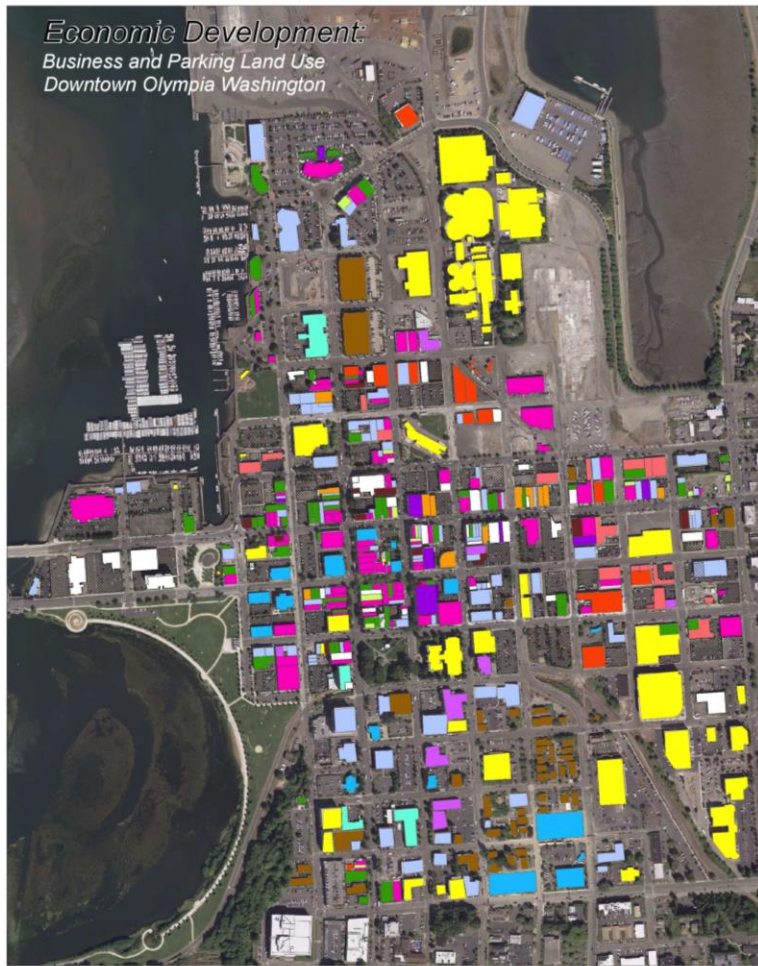
**Figure 13. Surface Parking and Uses in Downtown Olympia**

There are 21 acres of surface parking in downtown, and surface parking is the single largest land use within the downtown core. Figure 13 shows that almost 90% of surface parking in downtown is private lots. Many of the surface parking lots are also confirmed or suspected contaminated sites.

Parking Type	Area (sq ft)	Percentage
<b>Total Parking Lot Area:</b>	<b>929,659</b>	<b>100.0%</b>
City Managed (Monthly Fee)	39,480	4.2%
City Managed (Daily Fee)	33,102	3.6%
City Managed (Free)	22,765	2.4%
Private (Pay Lot)	248,654	26.7%
Private (Patron Only)	585,658	63.0%
