From: Michelle Sadlier
Sent: Friday, July 10, 2015 3:12 PM
To: Todd Stamm
Cc: Michelle Sadlier; Nancy Lenzi
Subject: Medela Rezone - Review of Historical-Period Resources
Attachments: 1 - Aerial of Cemetery Labeled w Concentration of Historical-Period Markers.jpg; 2 - Historical-Period Buildings Labeled.jpg; 3 - Table of Properties Surveyed.docx

Informal Reconnaissance-Level Survey for Medela Rezone
Buildings Aged 45 Years Old & Older

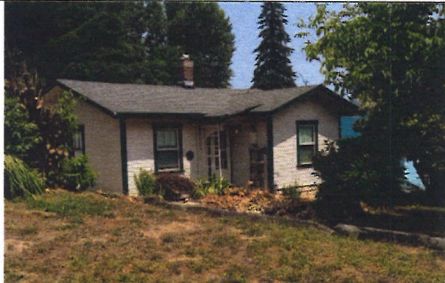
Address	Date of Construction (Assessor)	Notes	Identification Photo
2318 7 th Ave SE	1925	Poor integrity – significantly altered	N/A
2324 7 th Ave SE	1924	On Register

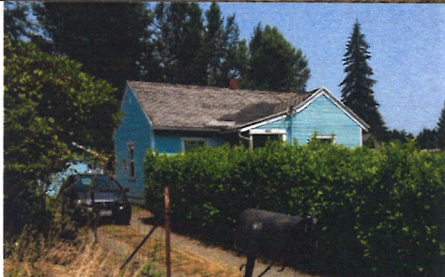
2326 7 th Ave SE	1924	Reasonable integrity; condition issues

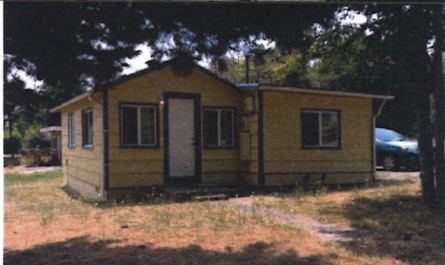
2327 7 th Ave SE	1946	Reasonable integrity; windows altered

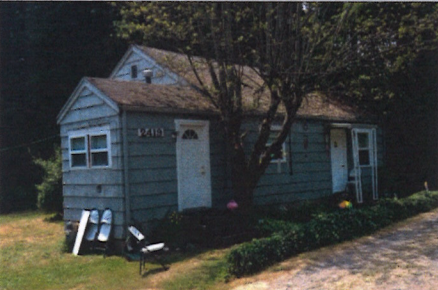
Address	Date of Construction (Assessor)	Notes	Identification Photo
2419 8 th Ave SE	1938	Reasonable integrity; windows and doors altered

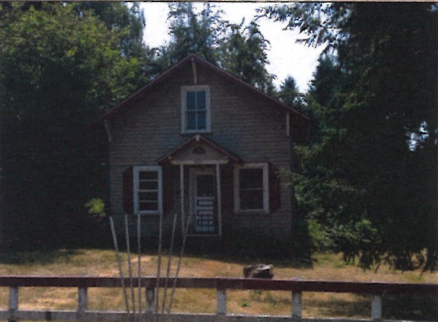
2421 8 th Ave SE	1920	Reasonable integrity; some windows altered; porch alterations likely

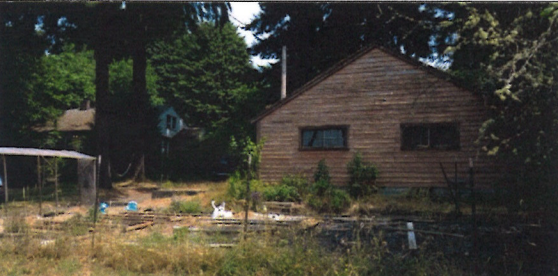
2504 8 th Ave SE	1940	Poor integrity – siding & windows replaced	N/A
2502 8 th Ave SE	1937	Integrity unknown – limited access with distant views

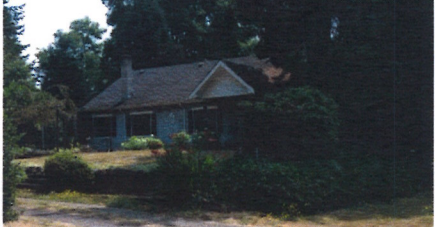
Address	Date of Construction (Assessor)	Notes	Identification Photo
2525 9 th Ave SE	1935	Building style appears to be out of period – sign of significant alteration?

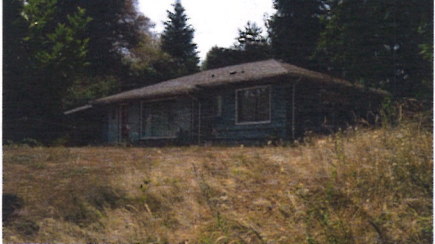
715 Chambers St SE	1956	Poor quality construction; poor integrity	N/A
729 Chambers St SE	1951	Reasonable integrity; door replaced, windows possibly altered

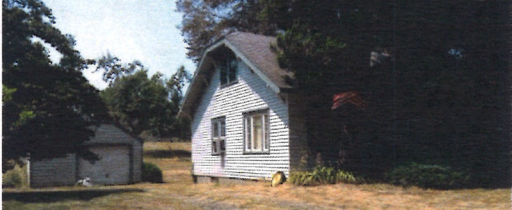
815 Chambers St SE	1929	High integrity – one window replacement visible; very good example of its type

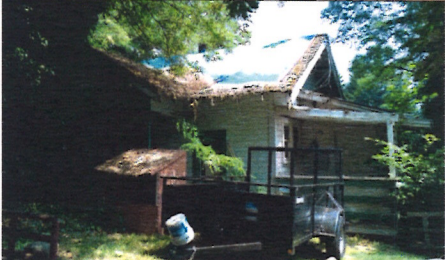
908 Chambers St SE	1930	Integrity impacted by poor condition; some unsympathetic alterations

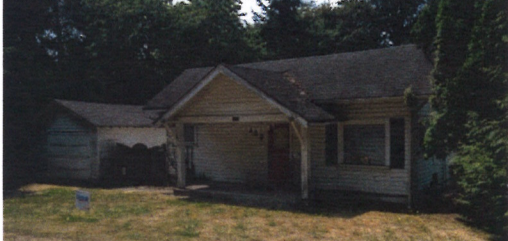
Address	Date of Construction (Assessor)	Notes	Identification Photo
915 Chambers St SE	1959	Poor integrity	N/A
923 Chambers St SE	1939	Not accessible (safety)	N/A
927 Chambers St SE	1941	Not accessible (safety)	N/A
823 Steele St SE	1910	Good condition but style does not reflect its date of construction – significantly altered?

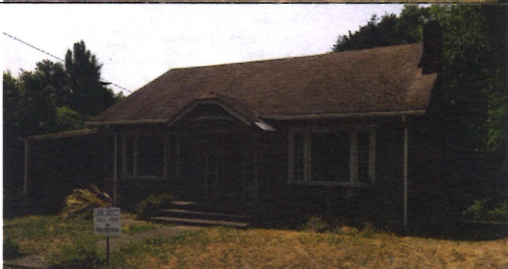
825 Steele St SE	1924	Very high integrity – no alterations to house visible; very good example of its type

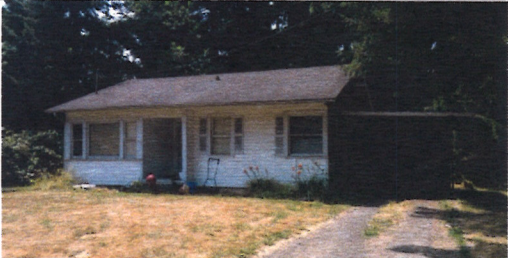
Address	Date of Construction (Assessor)	Notes	Identification Photo
919 Steele St SE	1901	Building style appears to be out of period – sign of significant alteration?
