August 25, 2017

Updated Geotechnical Engineering Report  
Briggs Village  
Proposed Residential Development  
xxx – Eagle Bend Drive SE  
Olympia, Washington  
PN: 37030000015  
Doc ID: SCJAlliance.BriggsWestKettle.RG

## INTRODUCTION

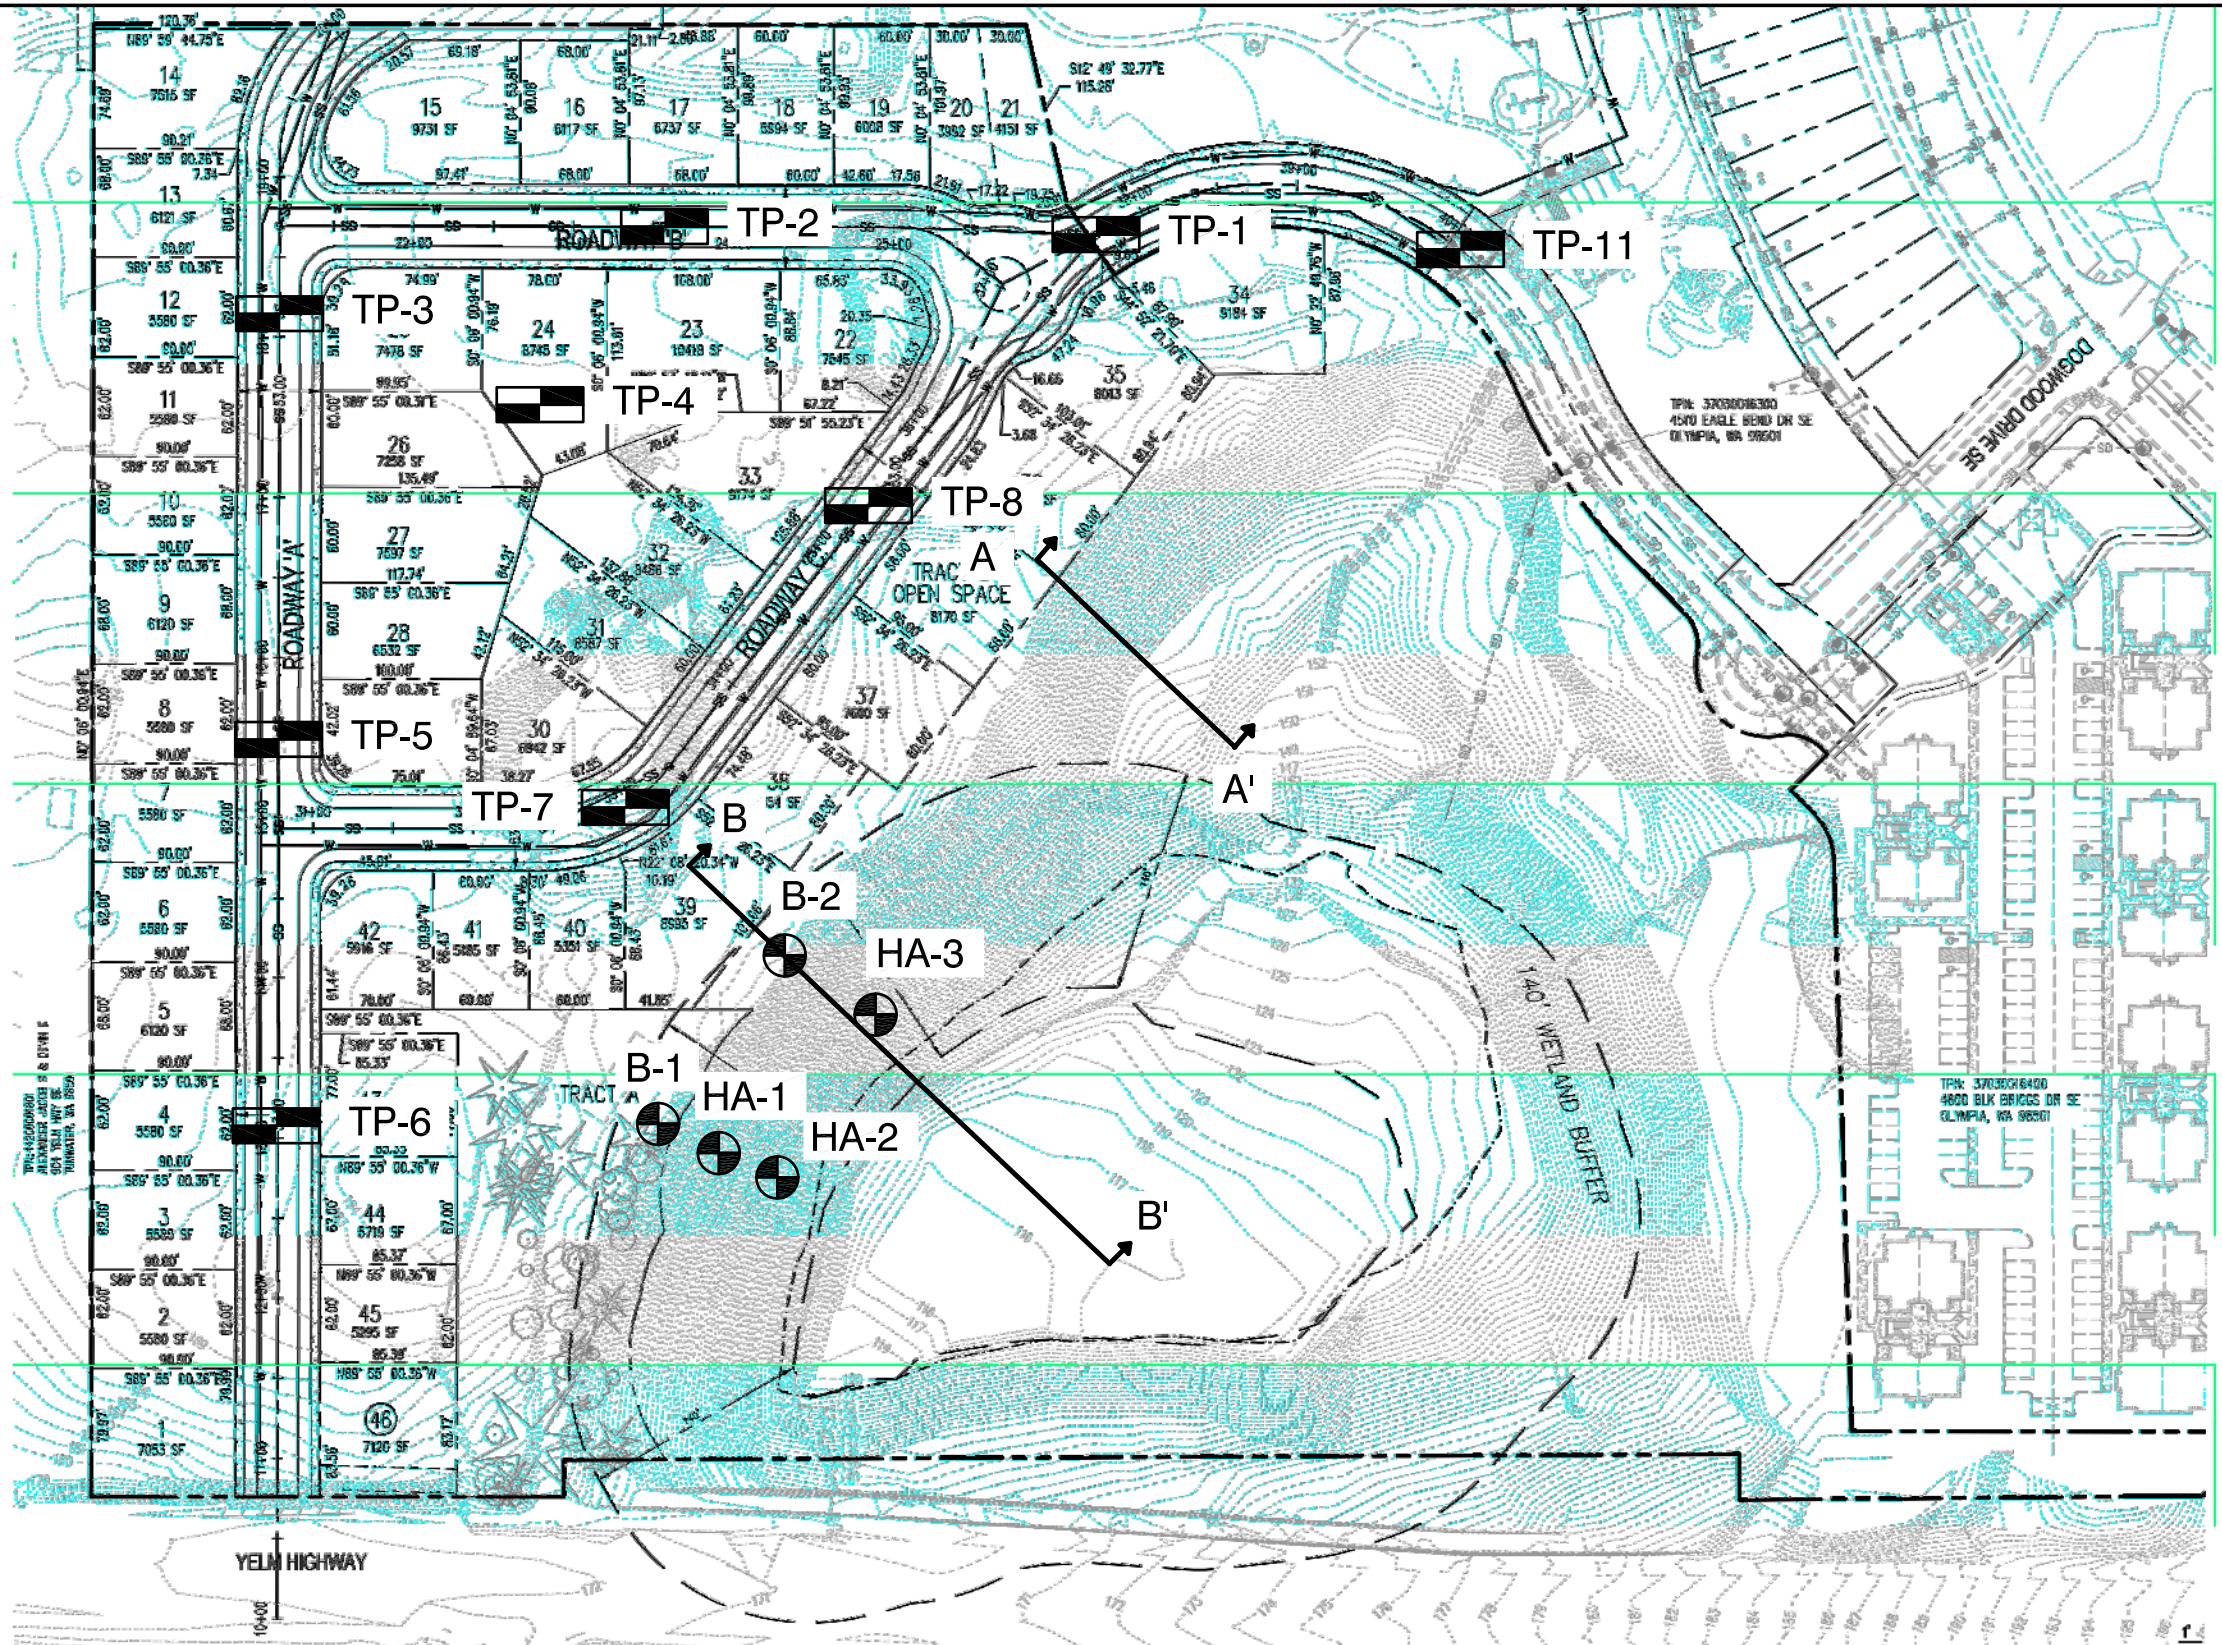
#### Site and Exploration Plan

#### Approximate Location of Subsurface Explorations

TP-01 (Test Pit By GeoResources, 2005)

Our understanding of the project is based on our discussions with you, a review of the preliminary plans provided by you, our subsurface explorations, our original May 23, 2005 site visit and recent July 5, 2017 site visit, our understanding of the City of Olympia development codes, and our experience in the project area since 2005. We understand that the proposed development will include the construction of 46 residential lots on the site with paved roadways, and associated utilities. We anticipate the new residences will consist of conventional wood-framed structures supported on conventional spread footings, with associated utilities and driveways. The existing site configuration is illustrated on the attached Site & Exploration Plan, Figure 2b.

On July 5, 2017, a field engineer from GeoResources visited the site and explored the subsurface conditions onsite by monitoring the drilling of two hollow stem auger borings to depths of 51.5 feet below the existing ground surface, and by monitoring the excavation of three hand auger explorations to depths of 8.5 to 10 feet below the existing ground surface. The borings were drilled by a licensed driller operating a small track-mounted drill rig under contract to GeoResources, LLC. In the spring of 2005, GeoResources excavated a total of 47 test pits on the Briggs Village site as part of the original *Geotechnical Engineering Report* for the development. Nine of the test pits (TP-1 through TP-8, TP-11) were excavated on the area west of the central and southern kettle.

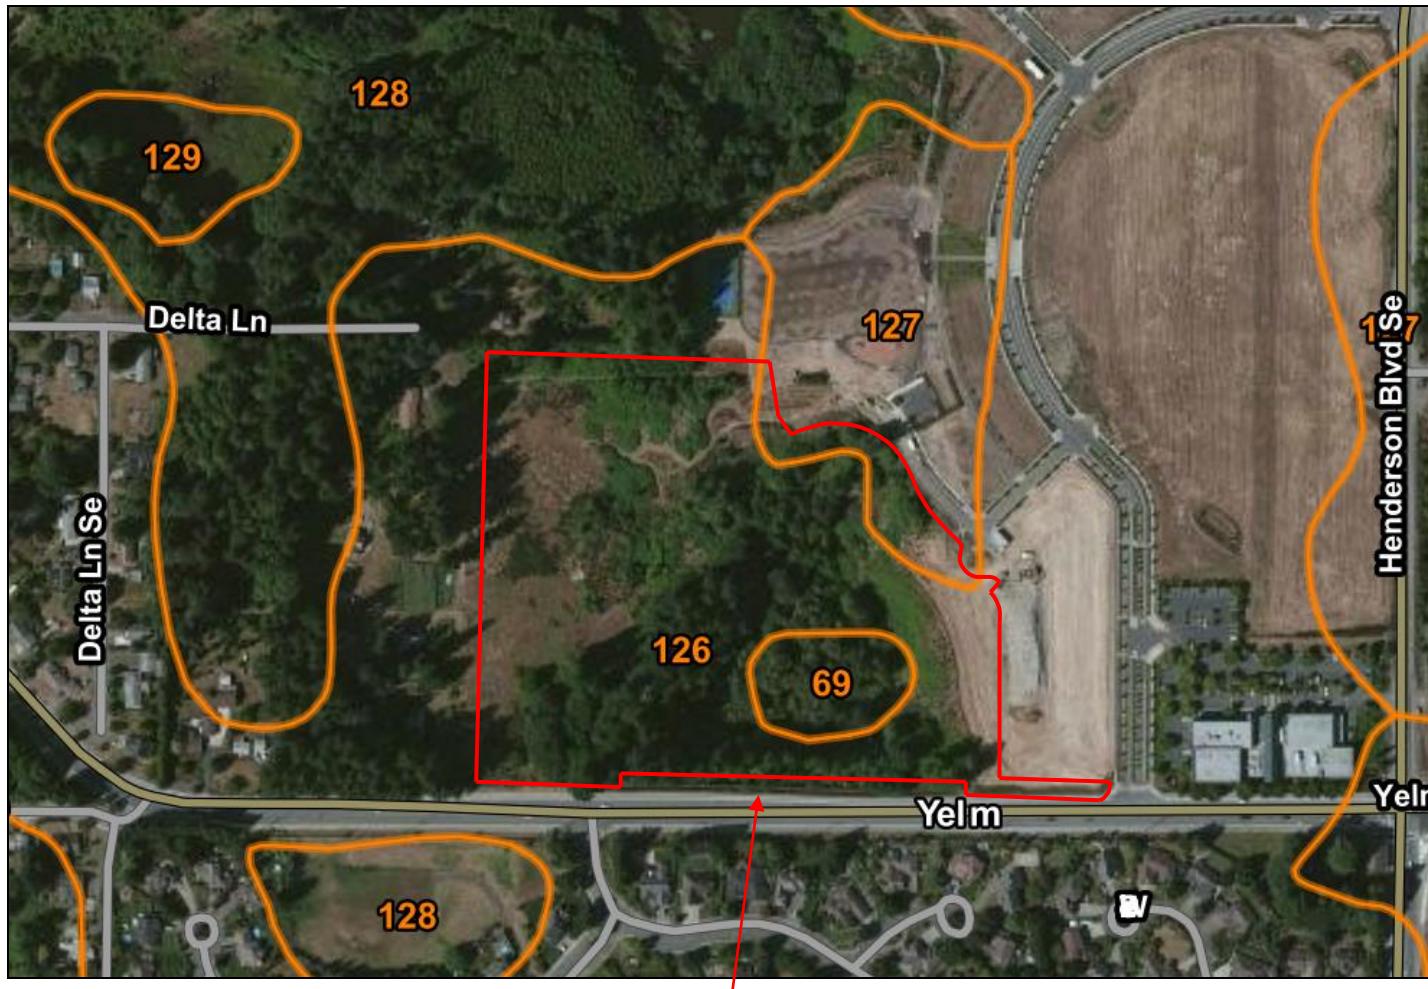
### NRCS Soils Map

Map created from Web Soil Survey (<http://websoilsurvey.sc.egov.usda.gov/App/WebSoilSurvey.aspx>)

The USDA Natural Resource Conservation Service (NRCS) Web Soil Survey maps the lower, bottom at the kettle as being underlain by Mukiteo muck (69), while the flatten uplands and kettle slopes are mapped as being underlain by Yelm fine sandy loam (126 & 127) soils. The Mukiteo soils are typically derived from herbaceous organic material, form on slopes of 0 to 2 percent, have "none" erosion hazard, and are included in hydrologic soils group B/D. The Yelm soils are typically derived from glacial outwash, have a "slight" erosion hazard when exposed, and are included in hydrologic soils group B. The Yelm (126) and Yelm (127) soils form on slopes of 0 to 3 percent and slopes of 3 to 15 percent, respectively. A copy of the SCS soils map for the site area is included as Figure 3.

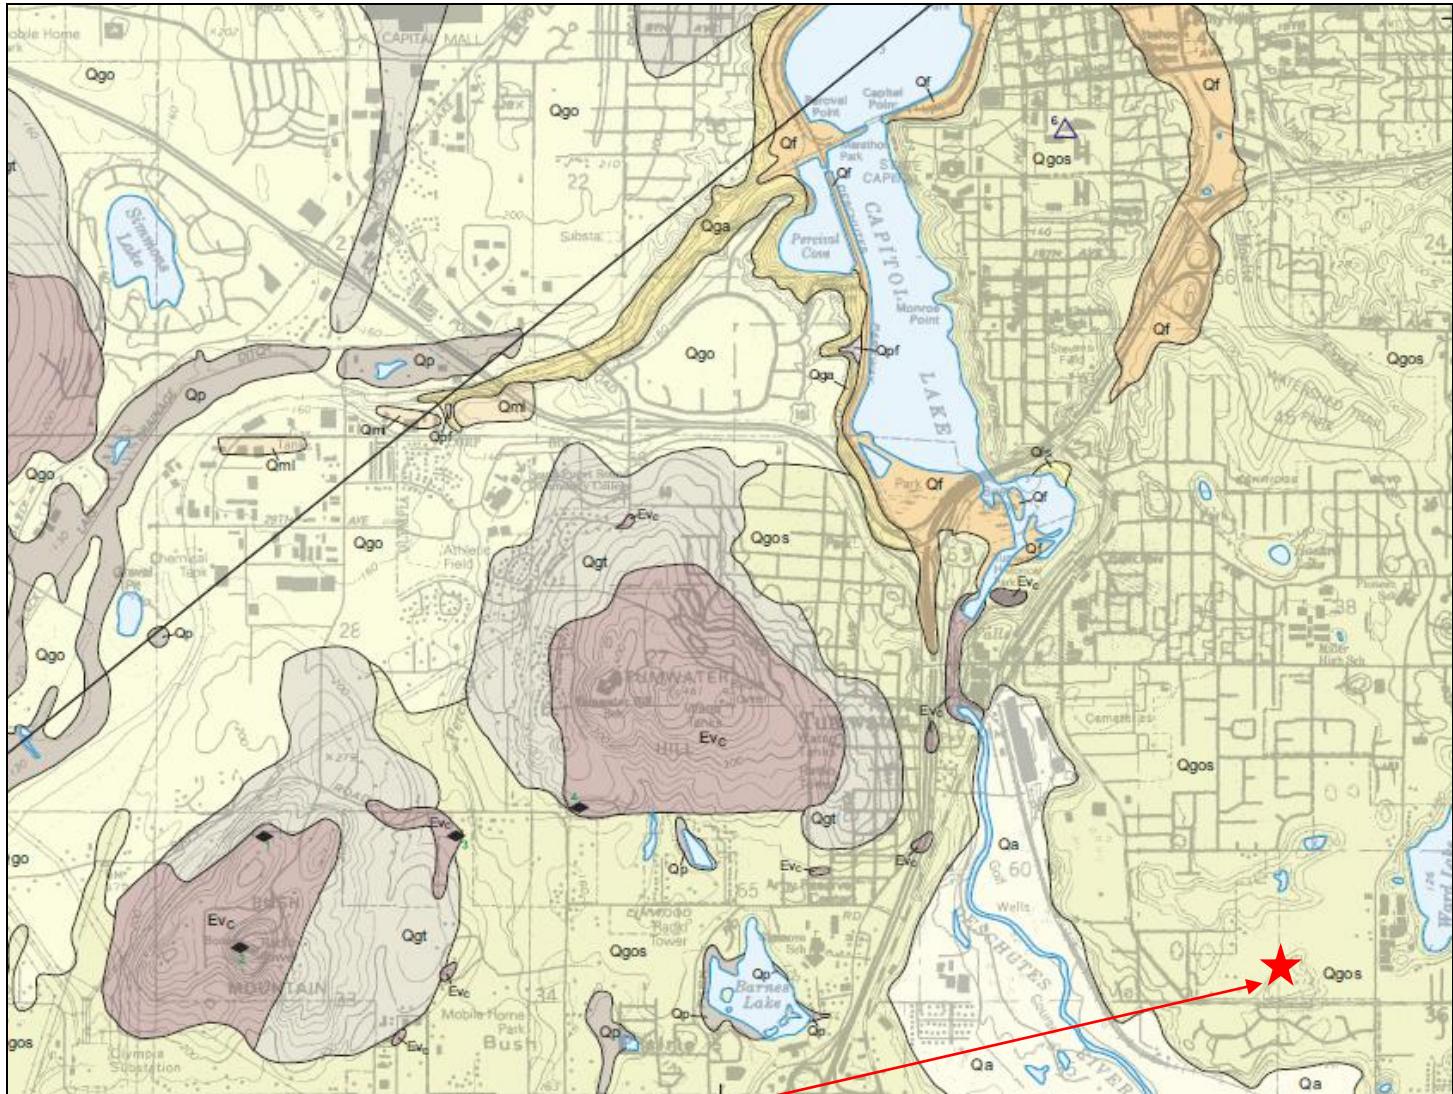
(An excerpt from the *Geologic Map of the Tumwater 7.5-minute Quadrangle, Thurston County, Washington* by Walsh, Logan, Schasse, and Polenz, 2009)

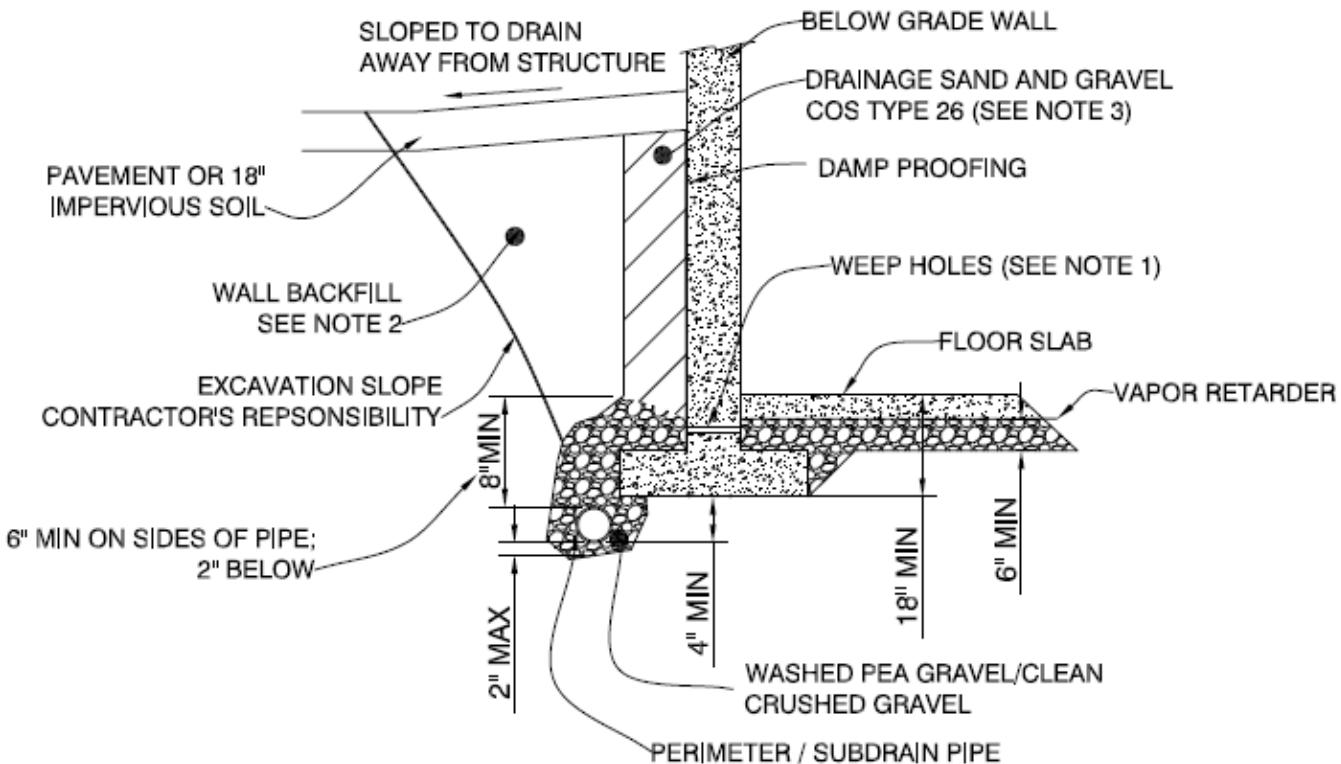
1. Washed pea gravel/crushed rock beneath floor slab could be hydraulically connected to perimeter/subdrain pipe. Use of 1" diameter weep holes as shown is one applicable method. Crushed gravel should consist of 3/4" minus. Washed pea gravel should consist of 3/8" to No. 8 standard sieve.

2. Wall backfill should meet WSDOT Gravel Backfill for walls Specification 9-03-12(2).

Adequate drainage behind retaining structures is imperative. Positive drainage which controls the development of hydrostatic pressure can be accomplished by placing a zone of drainage behind the walls. Granular drainage material should contain less than 2 percent fines and at least 30% greater than the #4 sieve. A geocomposite drain mat may also be used instead of free draining soils, provided it is installed in accordance with the manufacturer's instructions. A soil drainage zone should extend horizontally at least 18 inches from the back of the wall. The drainage zone should also extend from the base of the wall to within 1 foot of the top of the wall. The soil drainage zone should be compacted to approximately 90 percent of the MDD. Over-compaction should be avoided as this can lead to excessive lateral pressures. Typical wall drainage and backfilling details are shown in Figure 4. Recommended earth pressures for the native and fill soils are shown in Figure 5

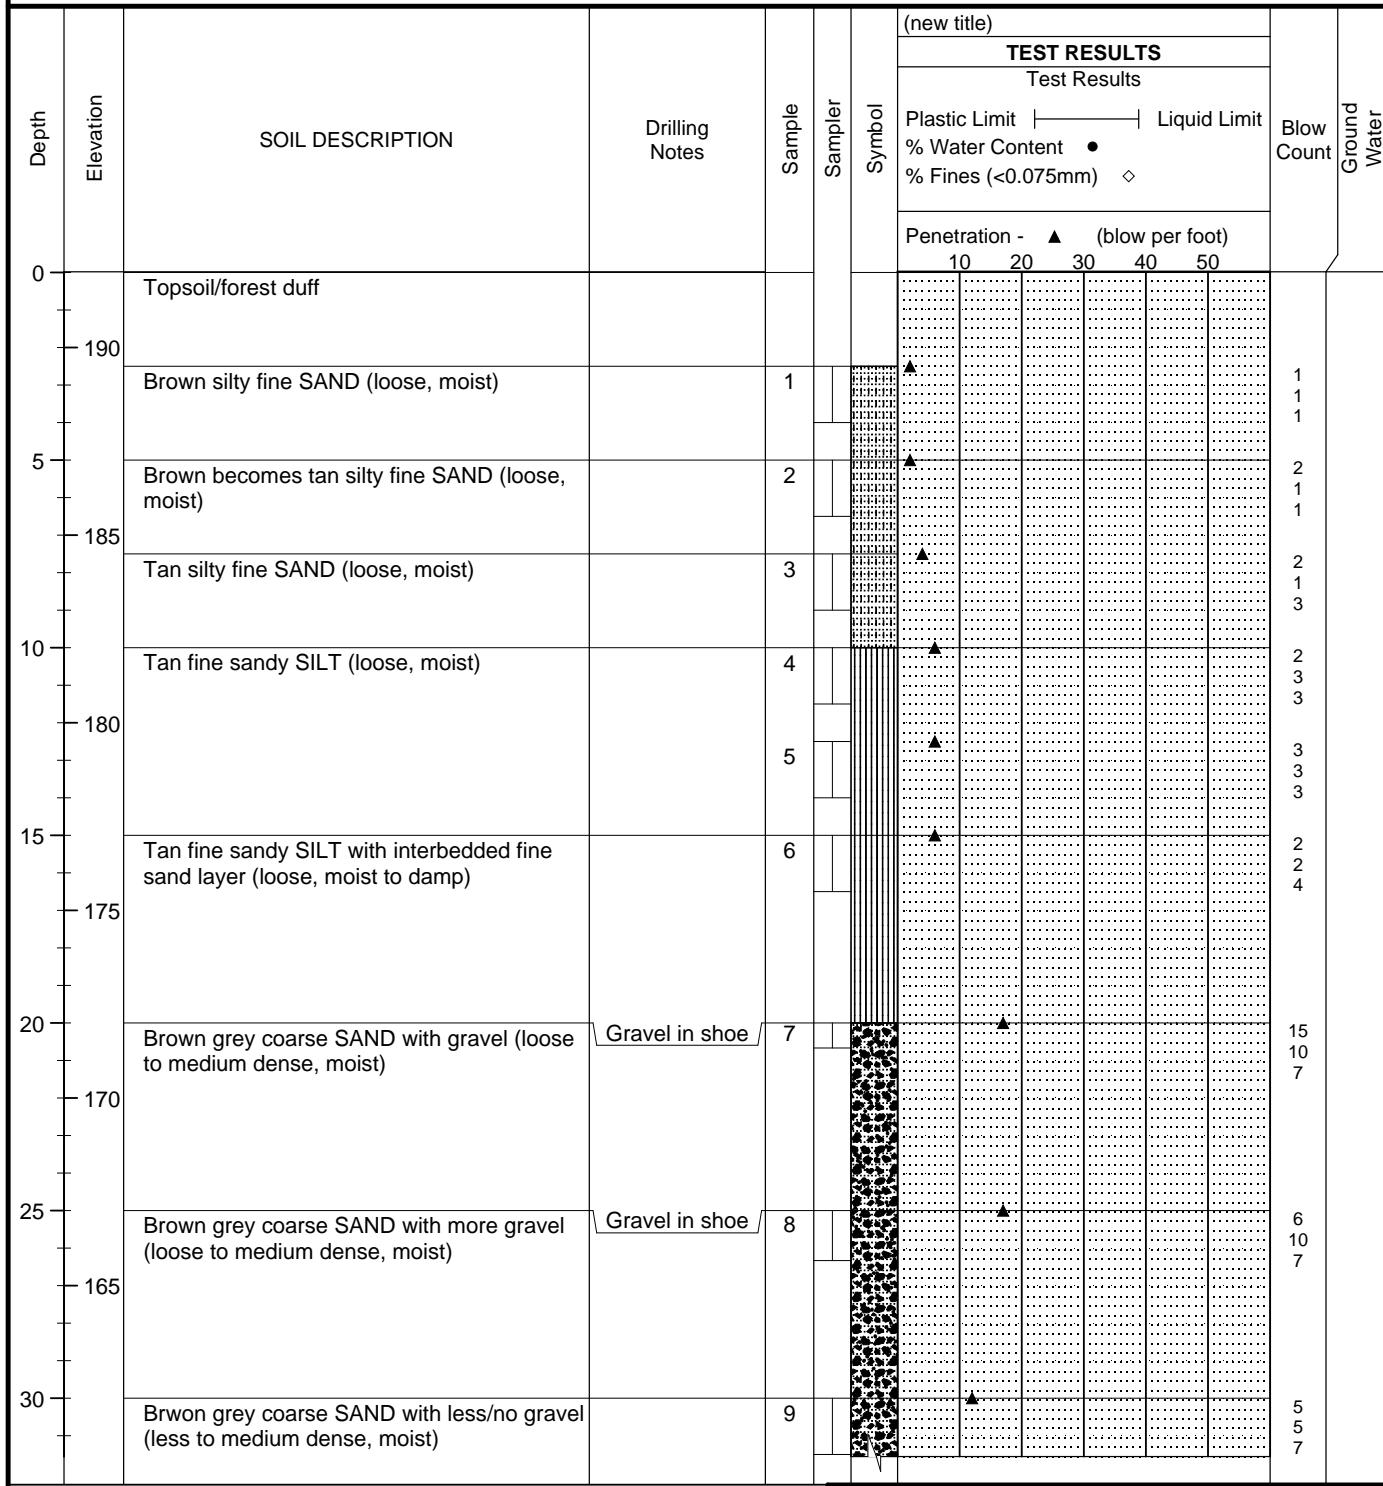
TOTAL DEPTH: 51.5feet	EXCAVATION METHOD: HSA	LOGGED BY: CC
TOP ELEVATION: 192	EXCAVATION COMPANY: Bortec1, Inc.	HAMMER TYPE: Cathead
LATITUDE:	EQUIPMENT:	HAMMER WEIGHT: 140lb
LONGITUDE:	NOTES: Top of slope about 50 feet to the northeast of transformer

1. Refer to log key for definition of symbols, abbreviations and codes
2. USCS designation is based on visual manual classification and selected lab testing
3. Groundwater level, if indicated, is for the date shown and may vary
4. N.E. = Not Encountered

Our recent borings encountered fairly uniform subsurface conditions. In general, our borings encountered about 20 feet of tan fine sandy silt in a loose, moist to saturated condition mantling grey coarse sand with gravel in a loose to medium dense, moist condition to the full depth explored. We interpret both the shallow and deeper soils to be recessional outwash deposits. Hand augers HA-1, HA-2 and HA-3 encountered about 1.0 to 1.5 feet of dark brown forest duff/top soil mantling about 2.0 to 3.5 feet of brown to tan fine sandy silt in a loose, moist condition. These surficial soils were underlain by tan fine sandy silt in a loose, moist condition to the full depth explored. Table 2 summarizes the approximate thicknesses, depths, and elevations of selected soil layers.

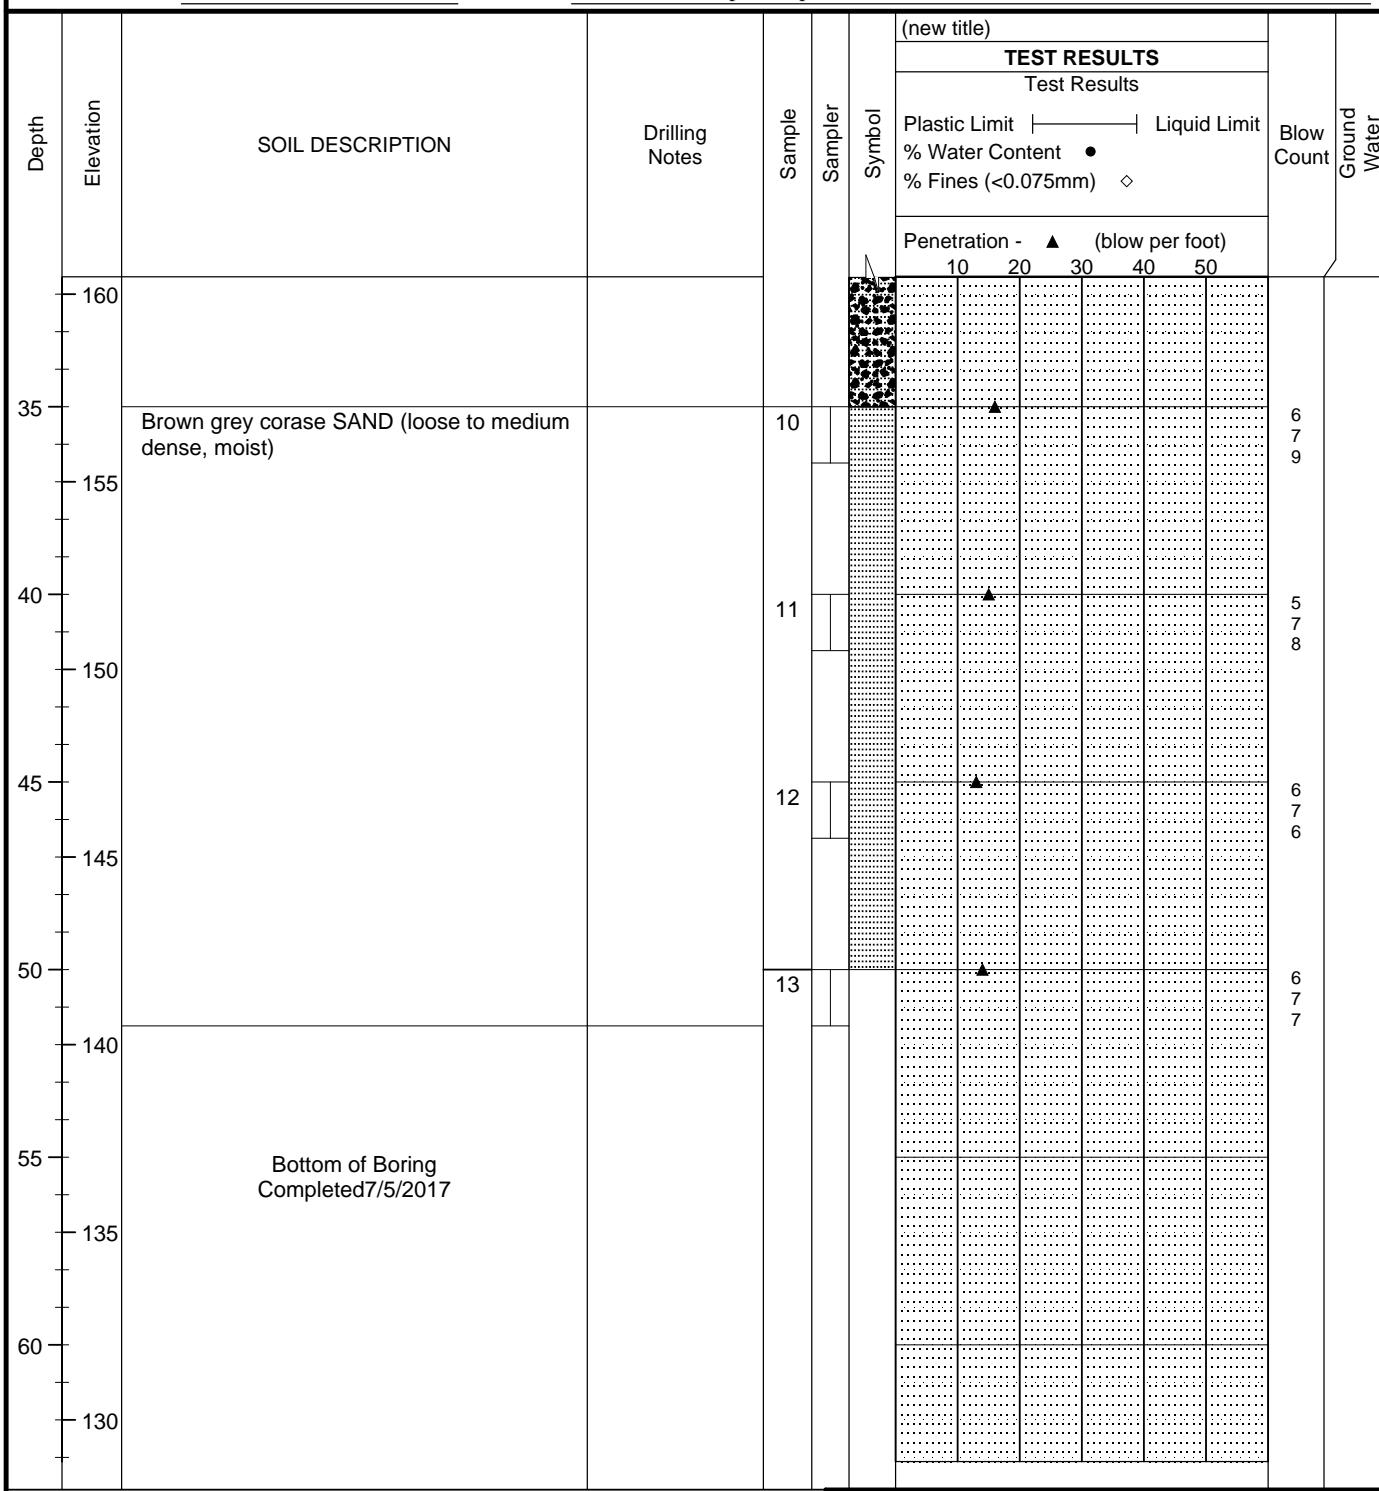
TOTAL DEPTH: 51.5feet	EXCAVATION METHOD: HSA	LOGGED BY: CC
TOP ELEVATION: 192	EXCAVATION COMPANY: Bortec1, Inc.	HAMMER TYPE: Cathead
LATITUDE:	EQUIPMENT:	HAMMER WEIGHT: 140lb
LONGITUDE:	NOTES: Top of slope about 50 feet to the northeast of transformer

1. Refer to log key for definition of symbols, abbreviations and codes
2. USCS designation is based on visual manual classification and selected lab testing
3. Groundwater level, if indicated, is for the date shown and may vary
4. N.E. = Not Encountered

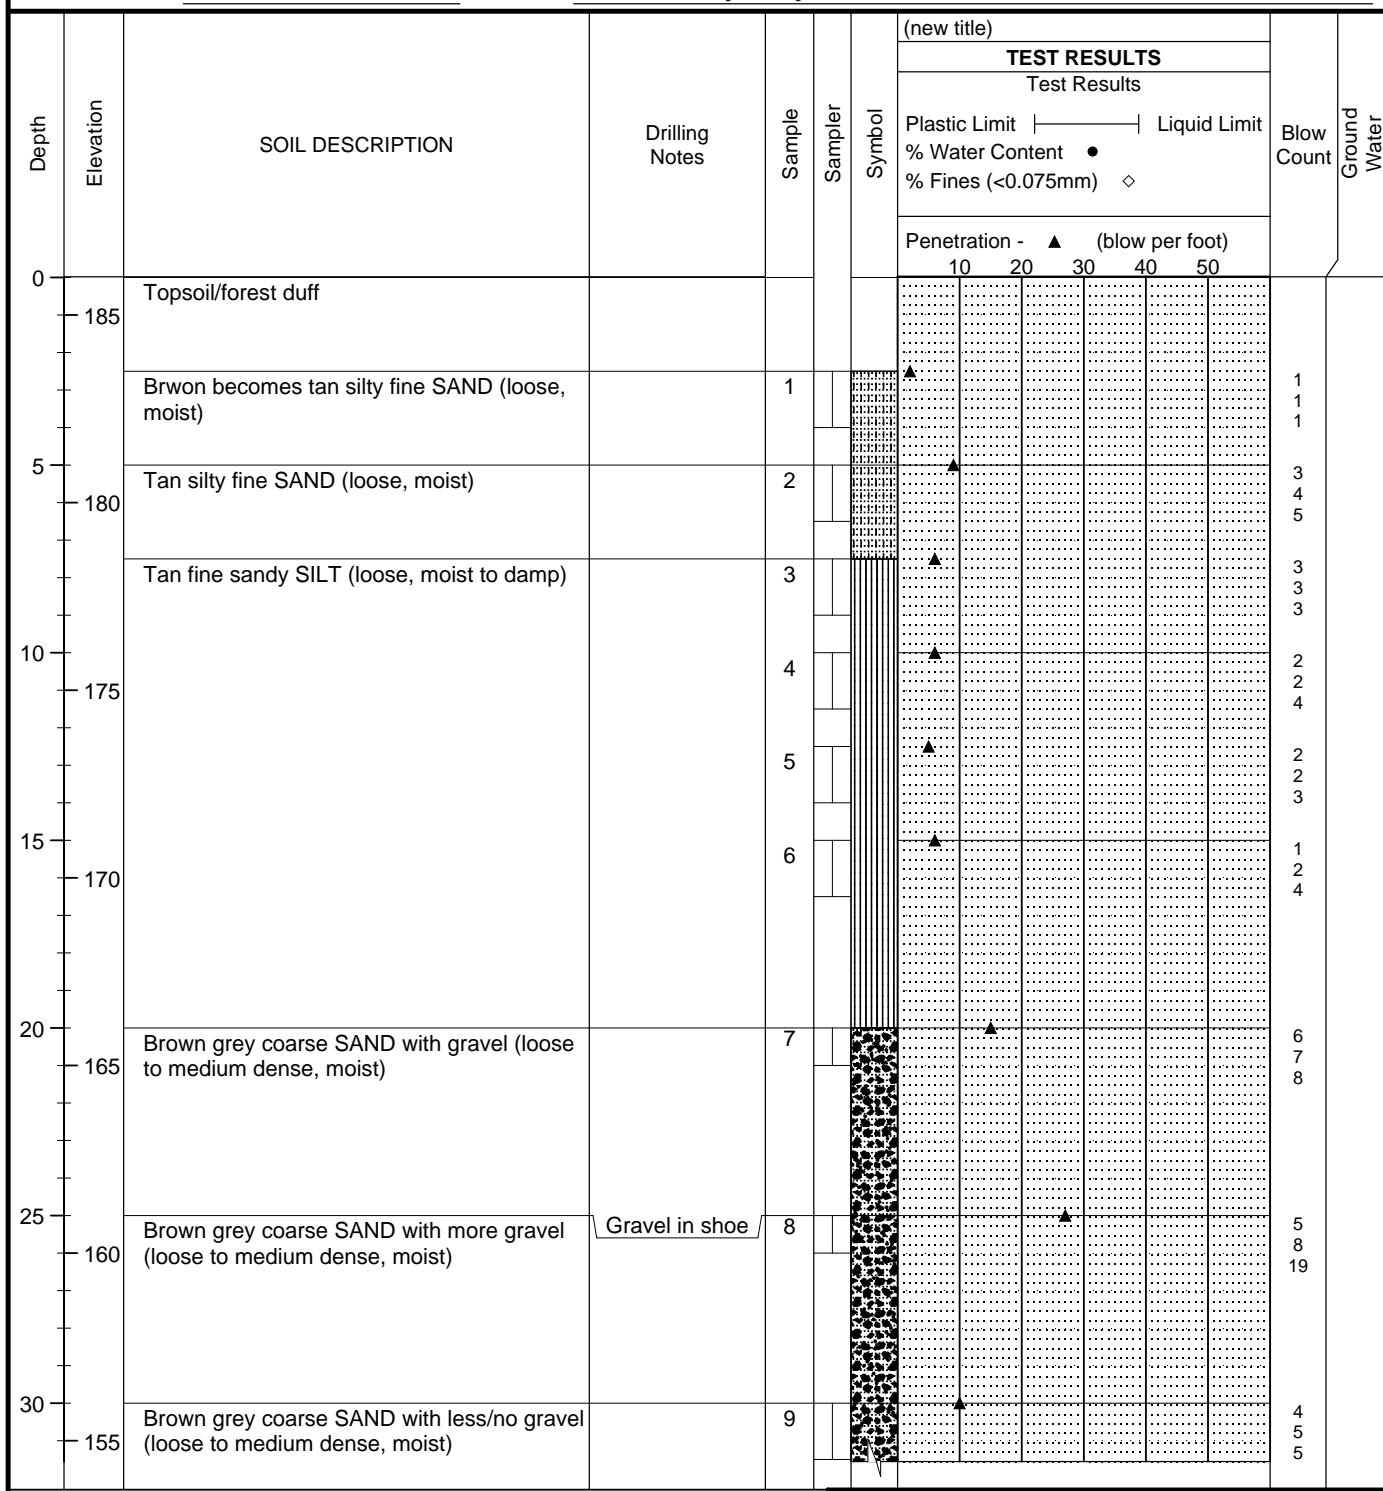
TOTAL DEPTH: 51.5feet	EXCAVATION METHOD: HSA	LOGGED BY: CC
TOP ELEVATION: 186	EXCAVATION COMPANY: Bortec1, Inc.	HAMMER TYPE: Cathead
LATITUDE:	EQUIPMENT:	HAMMER WEIGHT: 140lb
LONGITUDE:	NOTES: Top of slope about 150 feet to the northeast of transformer

1. Refer to log key for definition of symbols, abbreviations and codes
2. USCS designation is based on visual manual classification and selected lab testing
3. Groundwater level, if indicated, is for the date shown and may vary
4. N.E. = Not Encountered

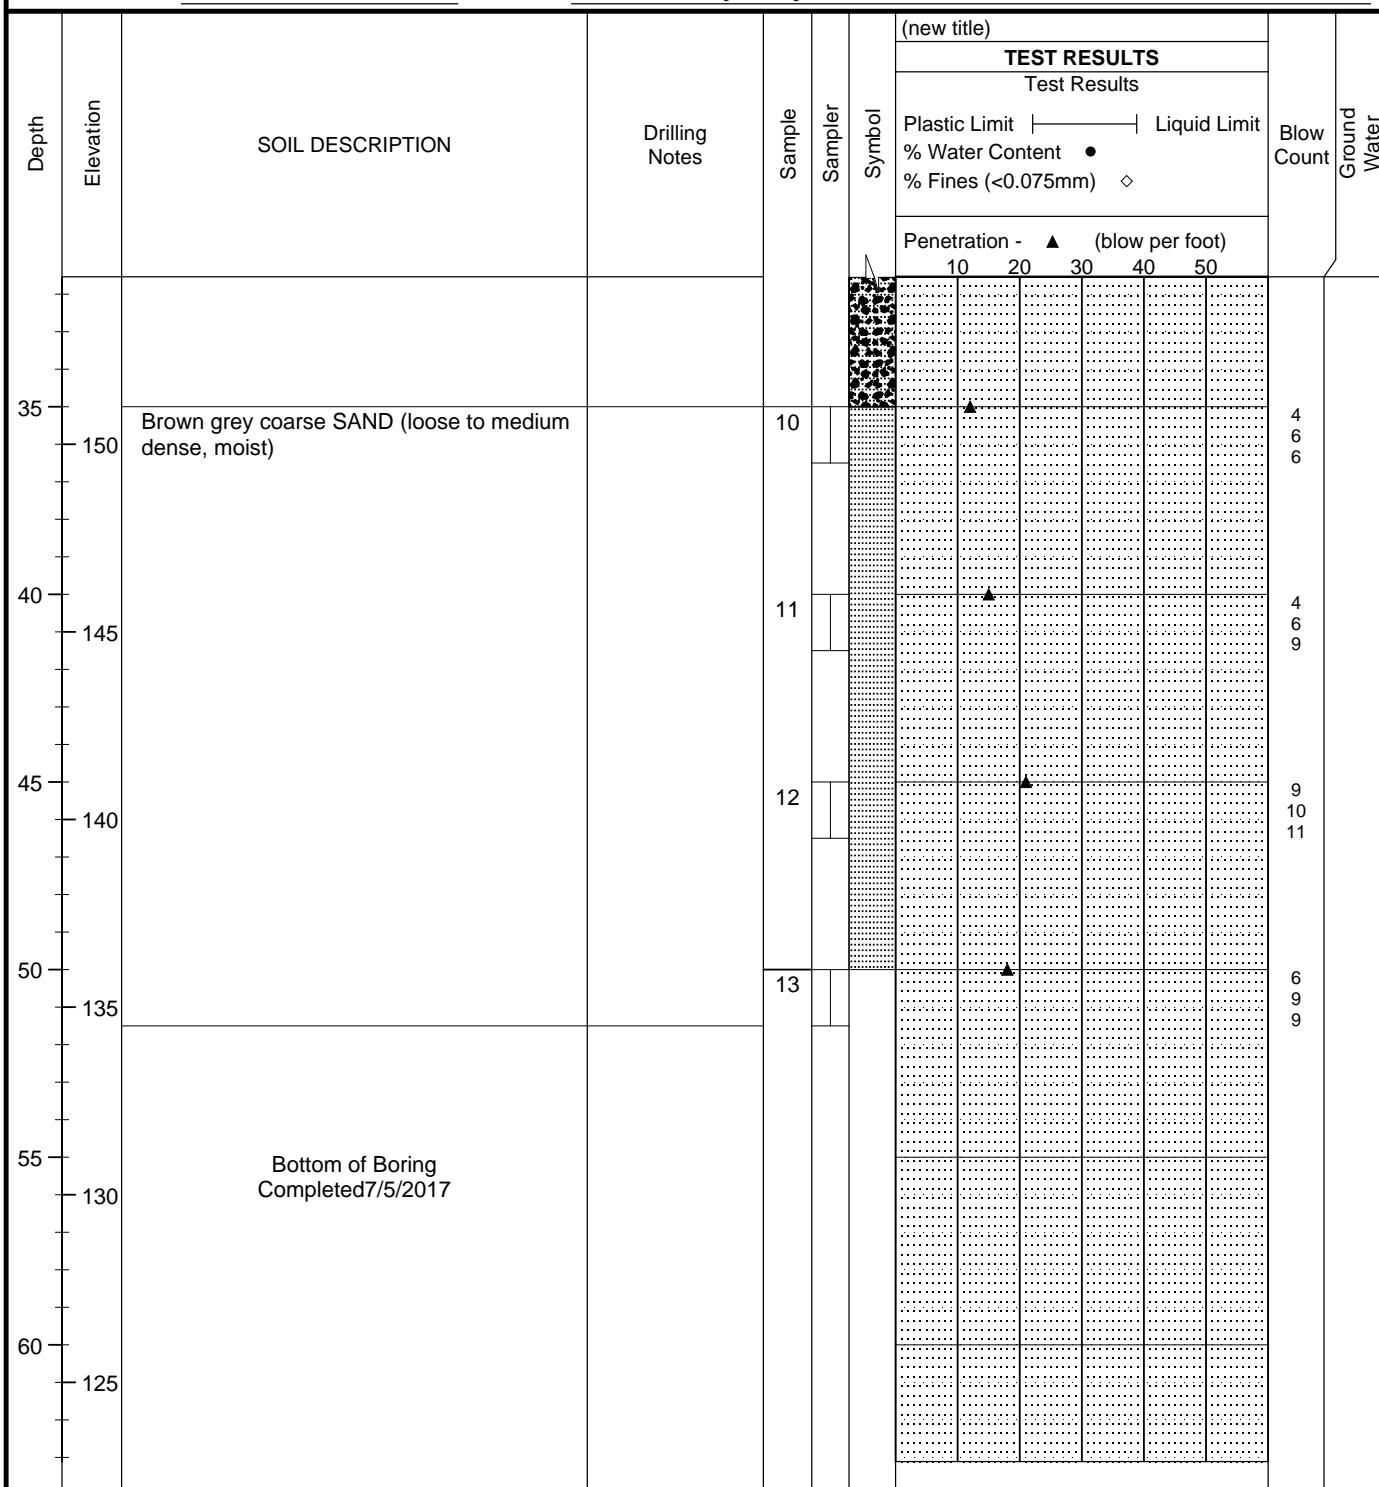
TOTAL DEPTH:	51.5feet	EXCAVATION METHOD:	HSA	LOGGED BY:	CC
TOP ELEVATION:	186	EXCAVATION COMPANY:	Bortec1, Inc.	HAMMER TYPE:	Cathead
LATITUDE:		EQUIPMENT:		HAMMER WEIGHT:	140lb
LONGITUDE:		NOTES:	Top of slope about 150 feet to the northeast of transformer

1. Refer to log key for definition of symbols, abbreviations and codes
2. USCS designation is based on visual manual classification and selected lab testing
3. Groundwater level, if indicated, is for the date shown and may vary
4. N.E. = Not Encountered

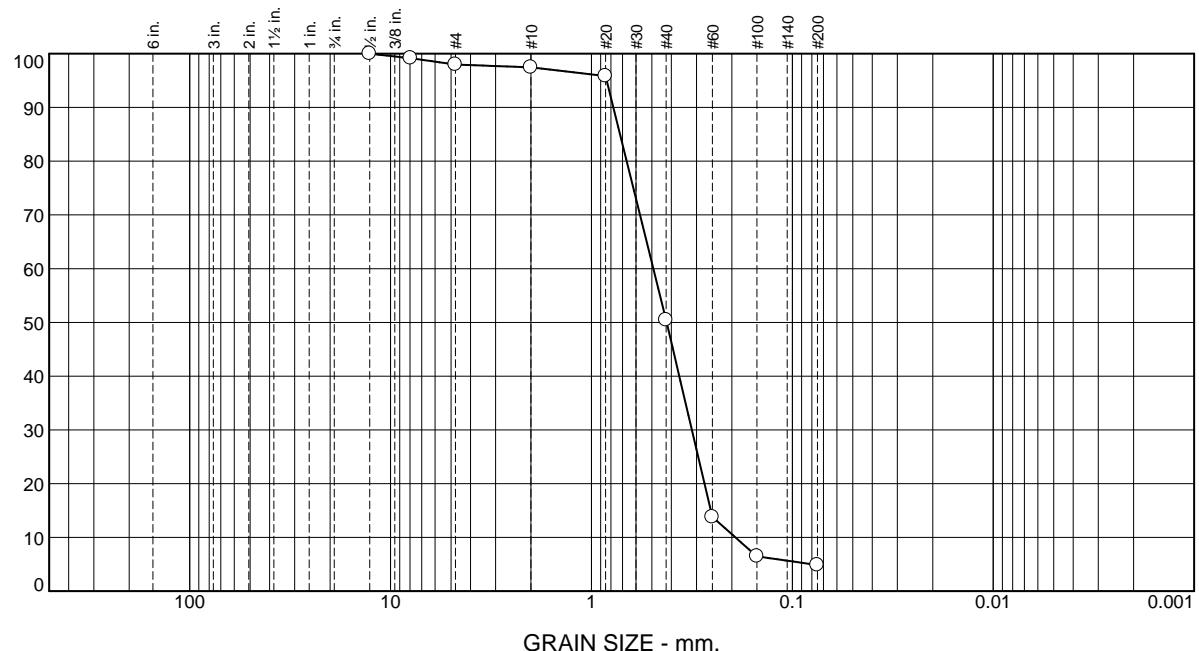
# Particle Size Distribution Report

Test Results (ASTM D 422 & ASTM C 117)			
Opening Size	Percent Finer	Spec.* (Percent)	Pass? (X=Fail)
.5	100.0		
.3125	99.1		
#4	98.0		
#10	97.4		
#20	95.8		
#40	50.4		
#60	13.8		
#100	6.5		
#200	4.9

soil classification per ASTM D: 2488, moisture content determinations per ASTM D: 2216, and grain size analyses per ASTM D: 422 standard procedures. The results of the laboratory tests are included in Appendix B, and summarized below in Table 3.

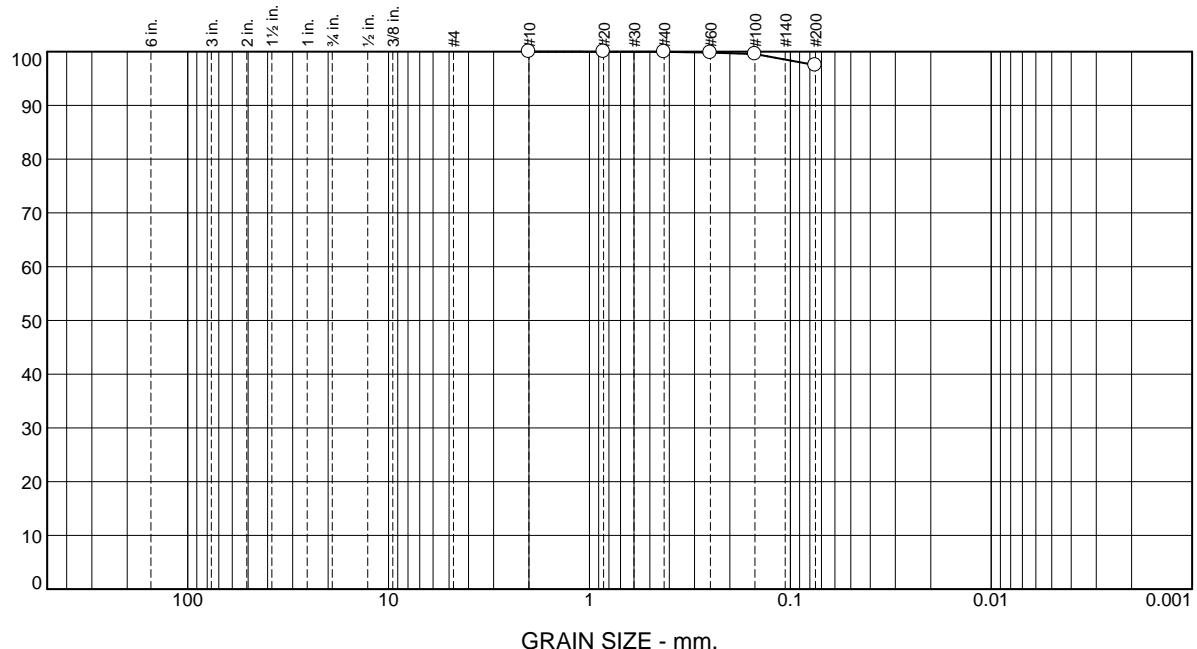
# Particle Size Distribution Report

% +3"		% Gravel		% Sand			% Fines	
		Coarse	Fine	Coarse	Medium	Fine	Silt	Clay
0.0		0.0	0.0	0.0	0.0	2.5		97.5
<b>Test Results (ASTM D 422 &amp; ASTM C 117)</b>								
Opening Size	Percent Finer	Spec.* (Percent)	Pass? (X=Fail)					
#10	100.0							
#20	100.0							
#40	100.0							
#60	99.8							
#100	99.6							
#200	97.5

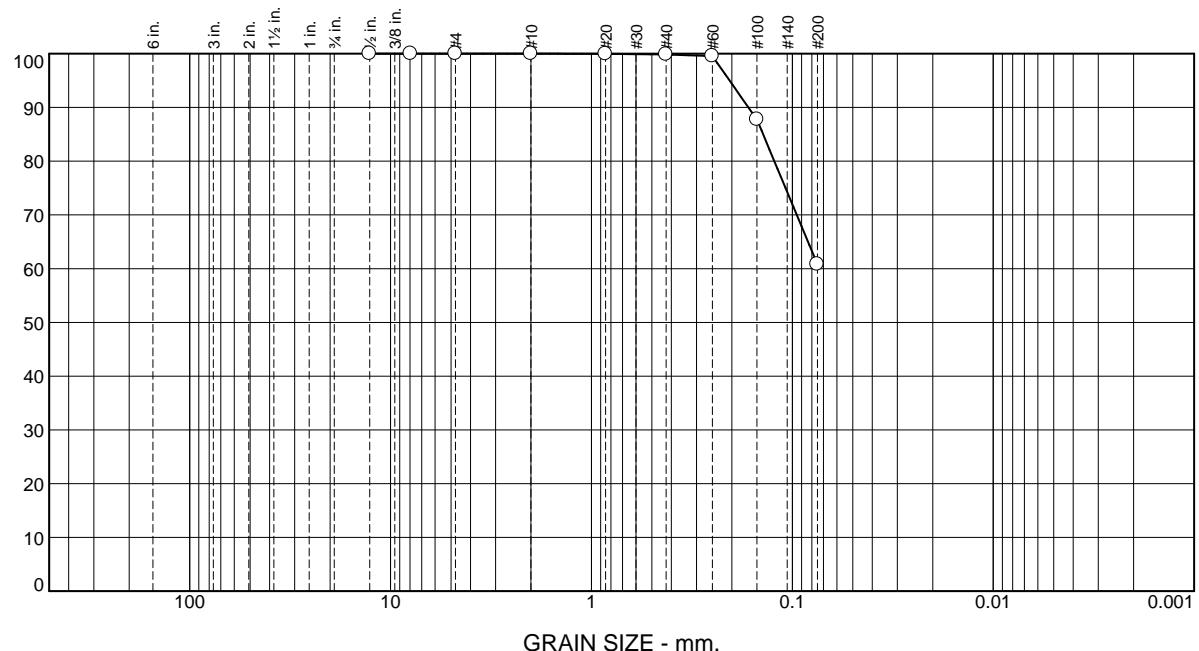
# Particle Size Distribution Report

% +3"		% Gravel		% Sand			% Fines	
		Coarse	Fine	Coarse	Medium	Fine	Silt	Clay
0.0		0.0	0.0	0.0	0.1	39.1		60.8
<b>Test Results (ASTM D 422 &amp; ASTM C 117)</b>								
Opening Size	Percent Finer	Spec.* (Percent)	Pass? (X=Fail)					
.5	100.0							
.3125	100.0							
#4	100.0							
#10	100.0							
#20	100.0							
#40	99.9							
#60	99.5							
#100	87.7							
#200	60.8

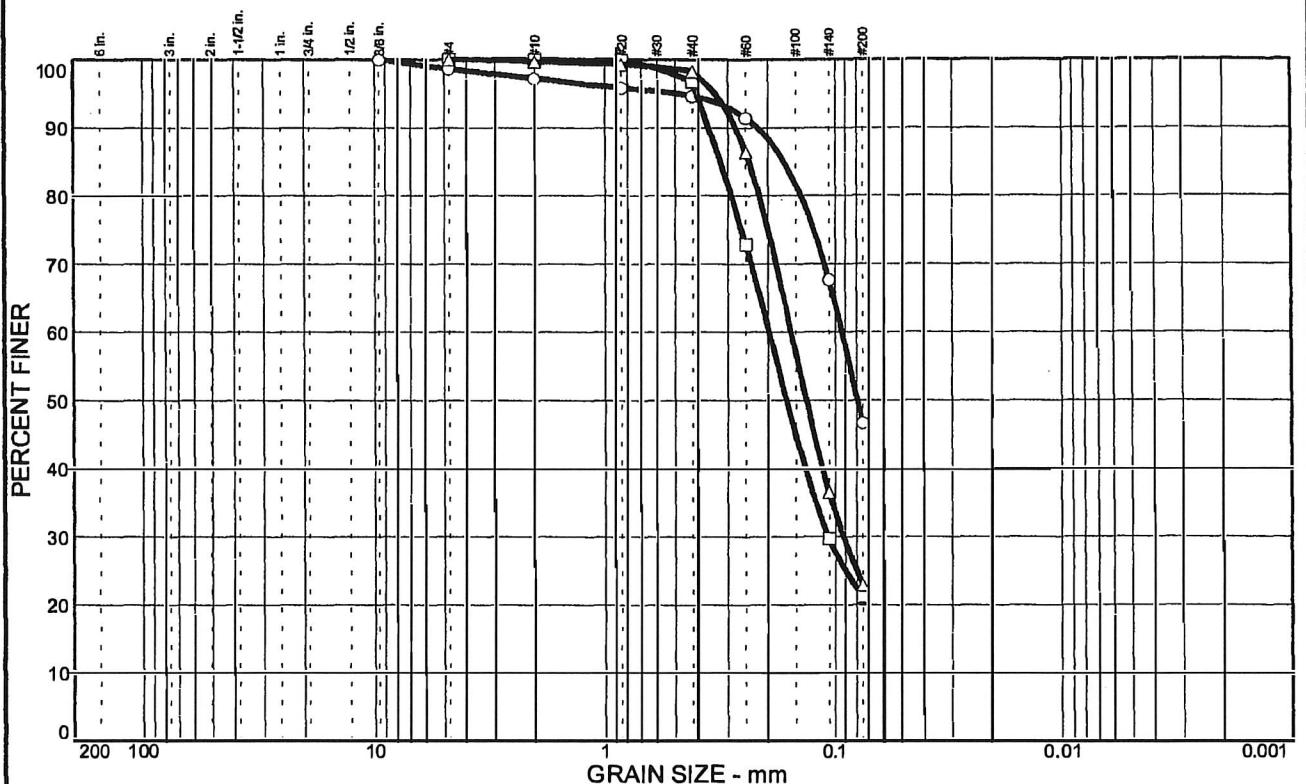
# Particle Size Distribution Report

% COBBLES	% GRAVEL	% SAND	% SILT	% CLAY	USCS	AASHTO	PL	LL
O	1.4	52.0	46.6		SM			
□		78.8	21.2		SM			
△		77.1	22.9		SM

SIEVE Inches size	PERCENT FINER		
	O	□	△
.375	100.0		
<del>GRANULARITY</del>			
D <sub>60</sub>	0.0927	0.197	0.157
D <sub>30</sub>		0.107	0.0913
D <sub>10</sub>			
<del>COEFFICIENTS</del>			
C <sub>c</sub>			
C <sub>u</sub>

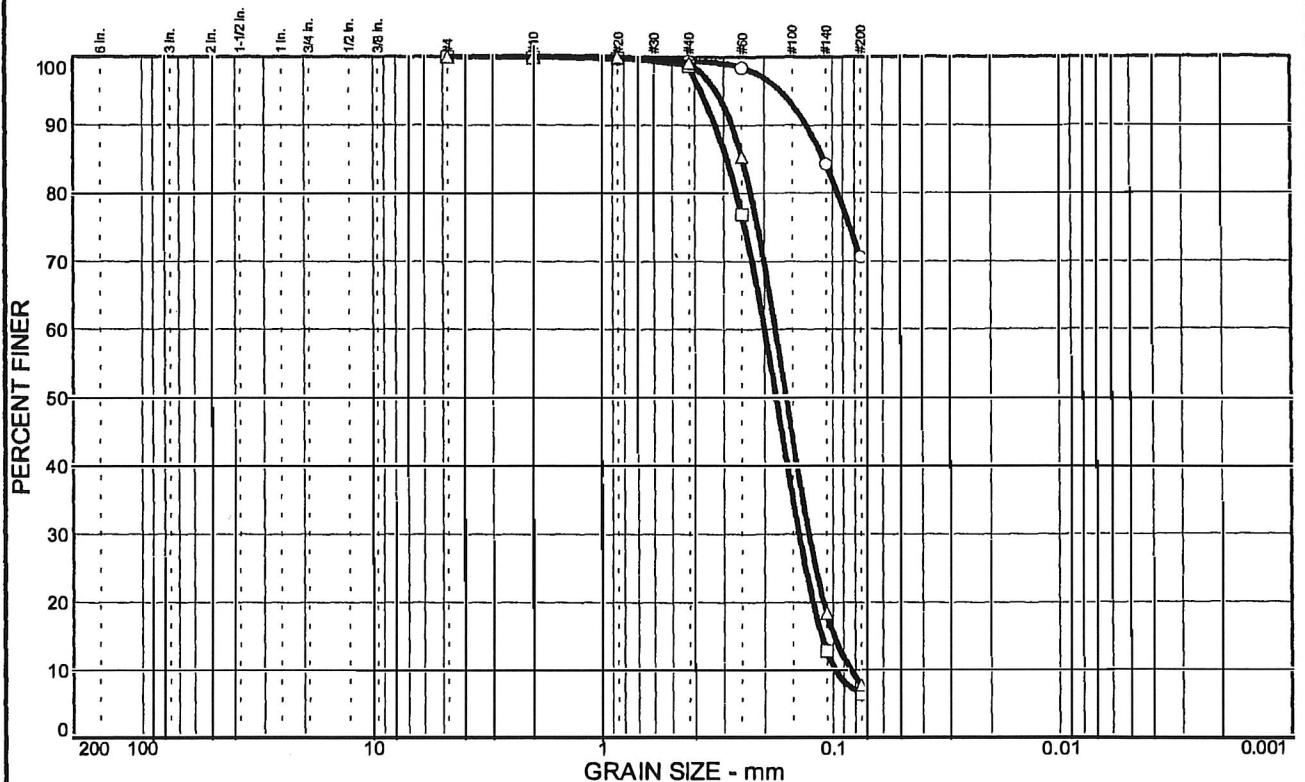
Plate 2

% COBBLES	% GRAVEL	% SAND	% SILT	% CLAY	USCS	AASHTO	PL	LL
O		29.4		70.6	ML			
□		93.5		6.5	SP-SM			
△		92.2		7.8	SP-SM

SIEVE Inches size	PERCENT FINER		
	O	□	△
<del>XX</del>			
D <sub>60</sub>		0.200	0.179
D <sub>30</sub>		0.140	0.127
D <sub>10</sub>		0.0972	0.0832
<del>XX</del>			
COEFFICIENTS			
C <sub>C</sub>		1.01	1.08
C <sub>U</sub>		2.06	2.15
