August 25, 2017

Updated Geotechnical Engineering Report  
Briggs Village  
Proposed Residential Development  
xxx – Eagle Bend Drive SE  
Olympia, Washington  
PN: 37030000015  
Doc ID: SCJAlliance.BriggsWestKettle.RG

## INTRODUCTION

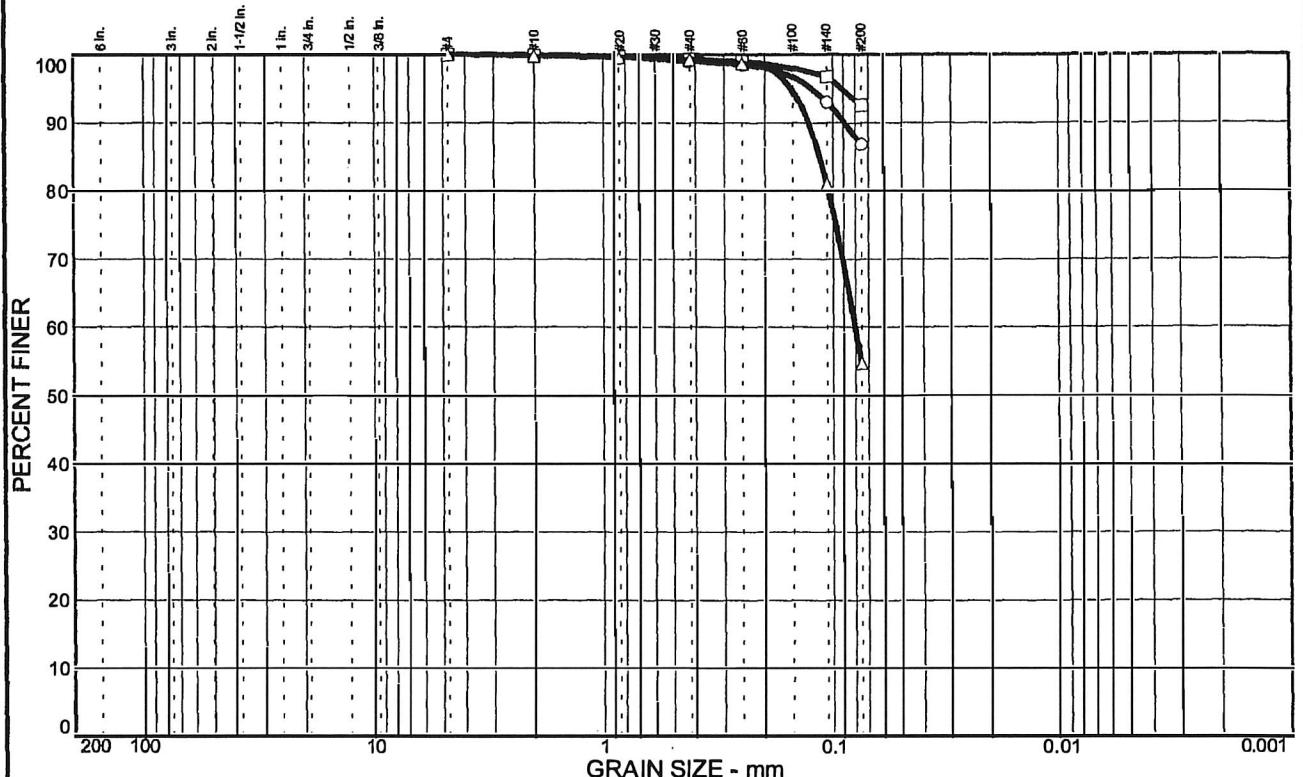
Plate 3

% COBBLES	% GRAVEL	% SAND	% SILT	% CLAY	USCS	AASHTO	PL	LL
○		13.2		86.8	ML			
□		7.4		92.6	ML			
△		45.3		54.7	ML

SIEVE Inches size	PERCENT FINER			SIEVE number size	PERCENT FINER			SOIL DESCRIPTION
	○	□	△		○	□	△	
				#4	100.0	100.0	100.0	○ Silt
				#10	100.0	99.9	99.8	□ Silt
				#20	99.8	99.7	99.6	△ Sandy silt
				#40	99.0	99.4	99.3	
				#60	98.5	99.0	98.7	
				#140	93.0	96.8	81.0	
				#200	86.8	92.6	54.7	
<del>GRANULARITY</del>								
D <sub>60</sub>			0.0799	<del>COHESION</del>			REMARKS:	
D <sub>30</sub>				○ Classification based on grainsize only				
D <sub>10</sub>				□ Classification based on grainsize only				
<del>COEFFICIENTS</del>								
C <sub>c</sub>				△ Classification based on grainsize only				
C <sub>u</sub>

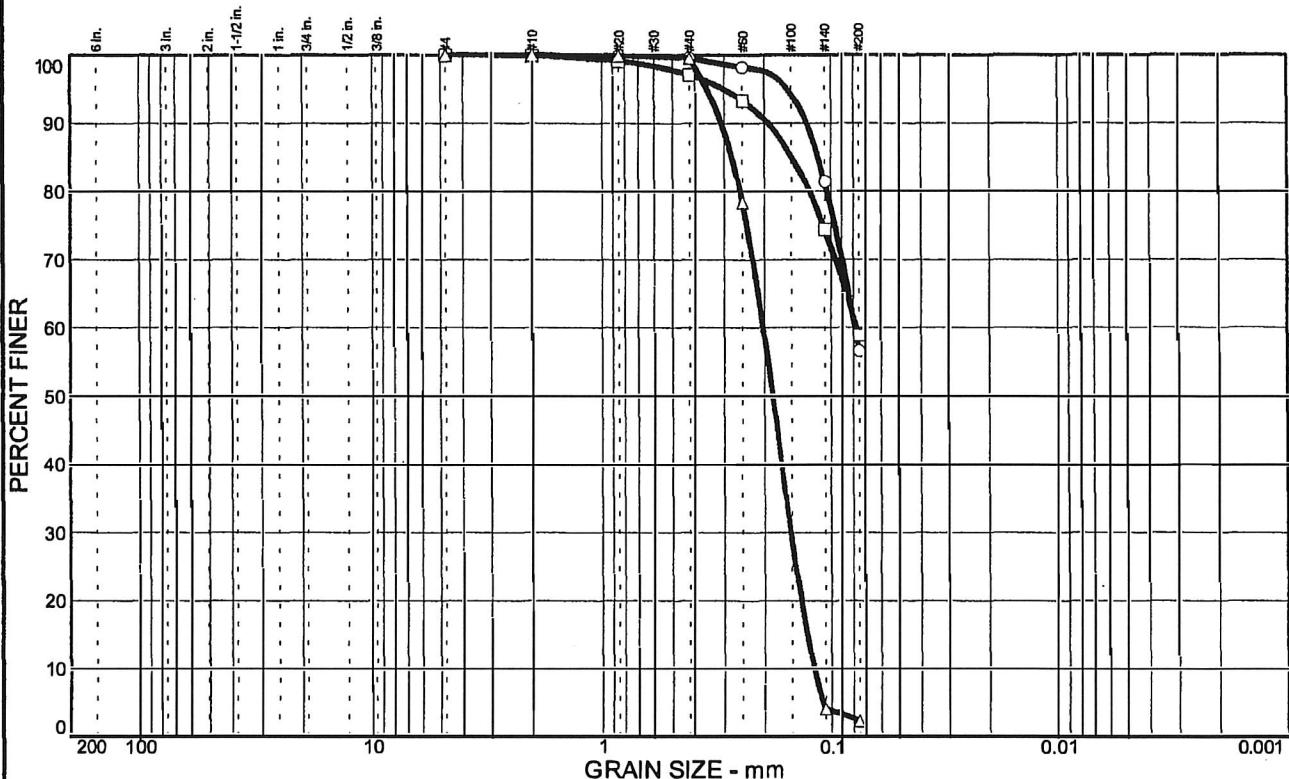
# Particle Size Distribution Report

% COBBLES	% GRAVEL	% SAND	% SILT	% CLAY	USCS	AASHTO	PL	LL
○		43.4		56.6	ML			
□		41.1		58.9	ML			
△		97.7		2.3	SP

SIEVE Inches size	PERCENT FINER			SIEVE number size	PERCENT FINER			SOIL DESCRIPTION
	○	□	△		○	□	△	
				#4	100.0	100.0	100.0	○ Sandy silt
				#10	100.0	99.9	100.0	□ Sandy silt
				#20	99.9	99.1	99.9	△ Poorly graded sand
				#40	99.6	97.1	99.6	
				#60	98.2	93.3	78.4	
				#140	81.4	74.4	4.1	
				#200	56.6	58.9	2.3	
<hr/>								
<hr/>								
GRAIN SIZE								
D <sub>60</sub>	0.0783	0.0767	0.203					
D <sub>30</sub>			0.151					
D <sub>10</sub>			0.119					
<hr/>								
COEFFICIENTS								
C <sub>c</sub>			0.95					
C <sub>u</sub>			1.70

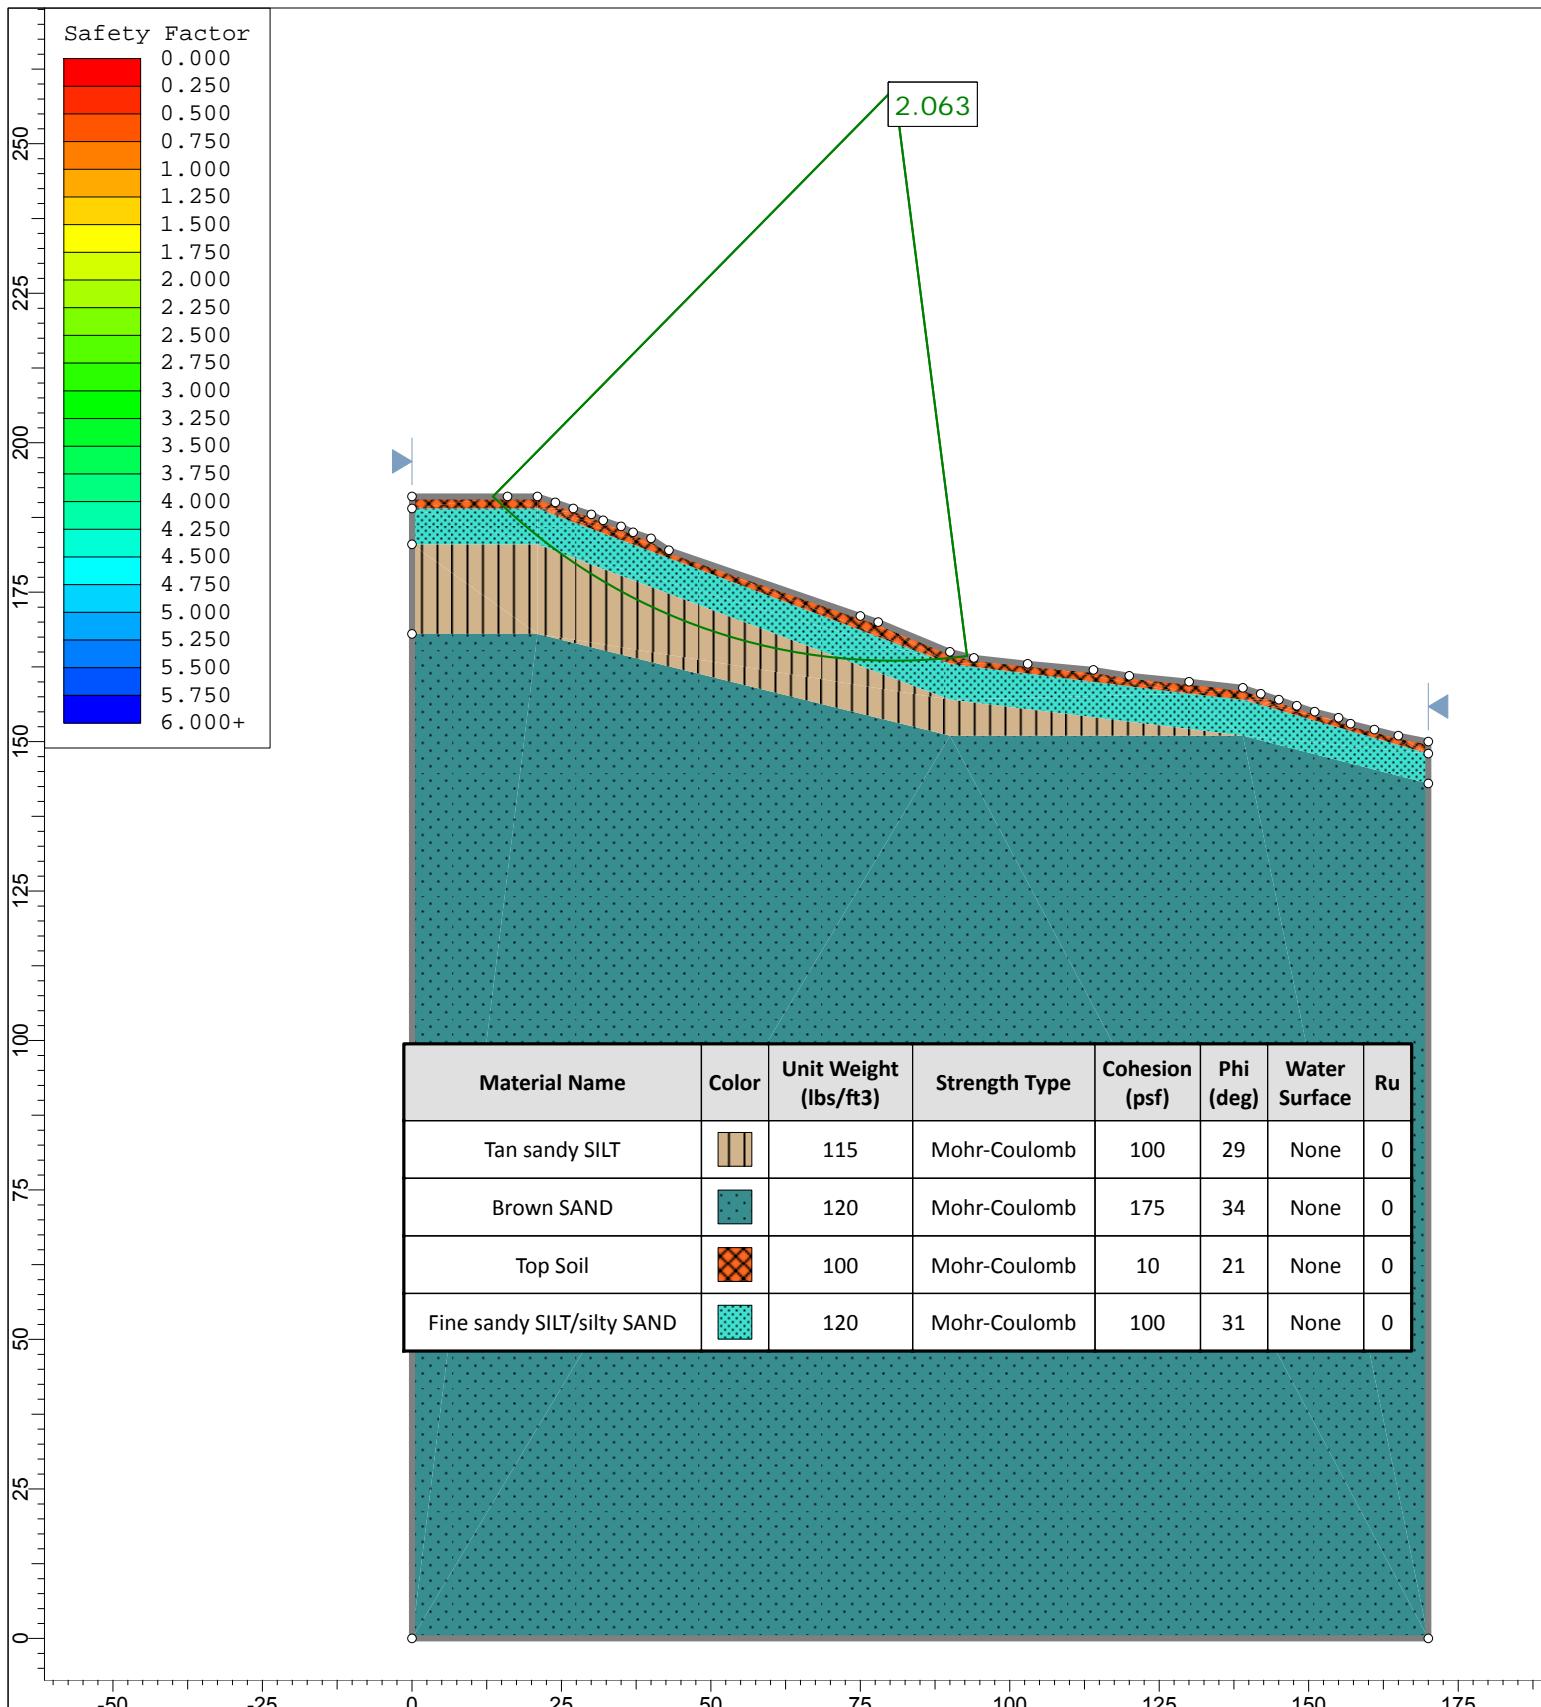
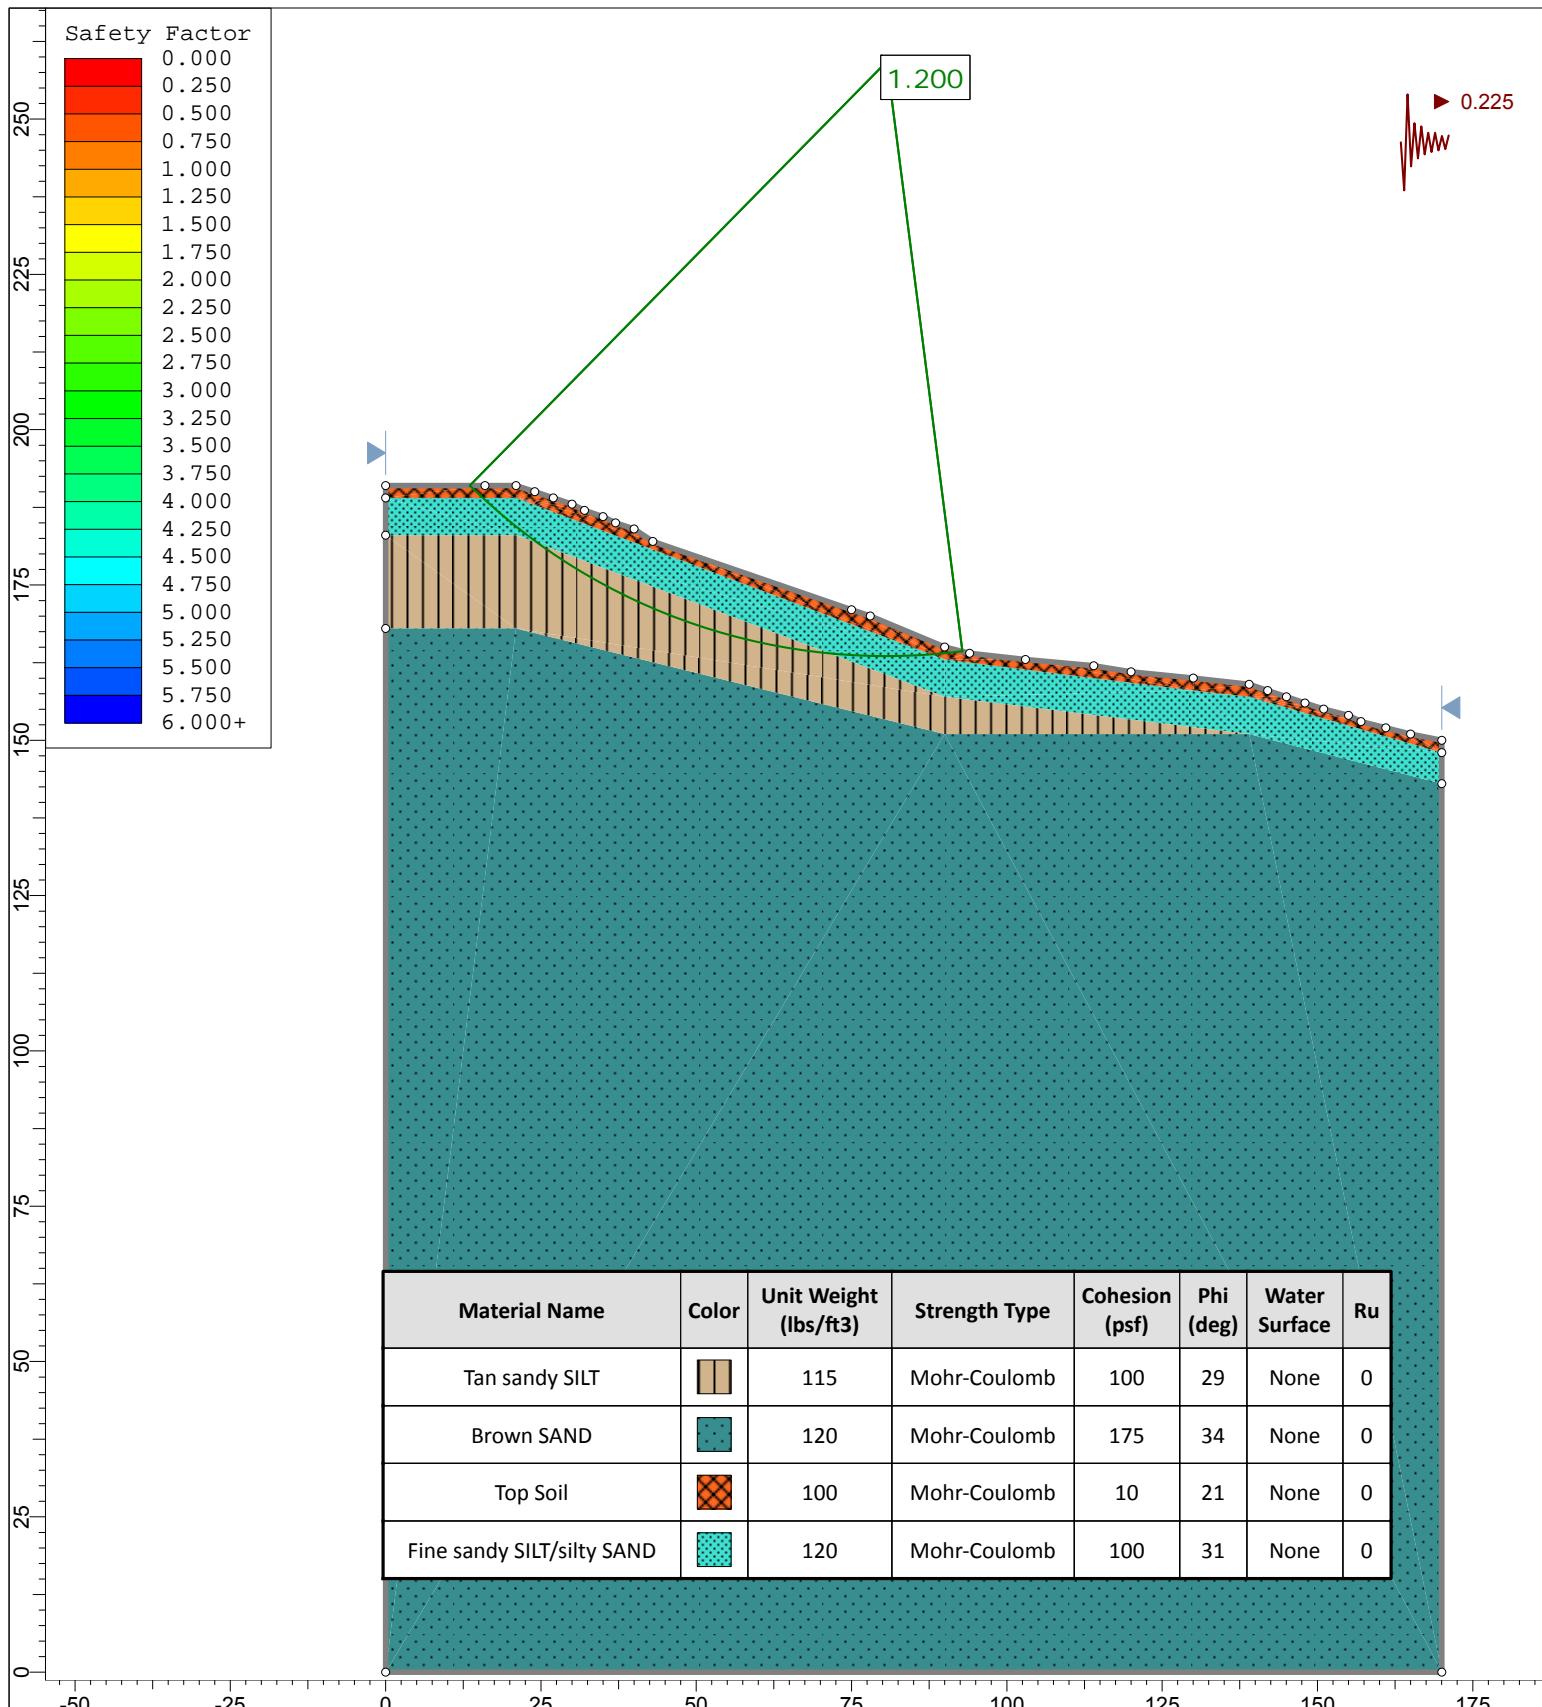
### Slope Stability Analysis

<small>SLIDEINTERPRET 7.022</small>	<i>Project</i> <b>SLIDE - An Interactive Slope Stability Program</b>		
	<i>Analysis Description</i>		
	<i>Drawn By</i>	<i>Scale</i> 1:385	<i>Company</i>
	<i>Date</i> 8/25/2017, 1:29:02 PM	<i>File Name</i>	SCJAlliance.BriggsWestKettle.dcb.slide.slmd

SLIDEINTERPRET 7.022	Project						
	SLIDE - An Interactive Slope Stability Program						
	Analysis Description						
	Drawn By	Scale 1:371		Company			
Date		8/25/2017, 1:29:02 PM		File Name		SCJAlliance.BriggsWestKettle.dcb.slide.slmd

We used the Bishops method, which satisfies both moment and force equilibrium, to search for the location of the most critical failure surfaces and their corresponding FS. Based on the site plan provided by SCJ Alliance, there are two different slope conditions. Cross section AA' is representative of the slope below lots 34 through 37, while cross section BB' is representative of the slope below lots 38 and 39. The most critical surfaces are those with the lowest FS for a given loading condition, and are therefore the most likely to move. To determine the required building setback, a critical surface with a factor of safety 1.1 furthest from the top of the top of slope. On the cross section for AA', the critical factor of safety was about 10 feet back from the top of the slope (which is less than the 15-foot rear yard setback). For cross section BB', the critical surface daylighted about 60 feet back from the top of the slope. Since the top of slope is about 25 feet from the property line, the 60-foot top of slope setback would result in the residence on Lots 38 and 39 being 35 feet back from the rear property line. If this distance does not allow sufficient room for residence on these parcels, the foundations on these two parcels may be deepened (using small diameter pin piles), thereby providing a structural setback as described below. Details of the slope stability analyses are included in Appendix "C".

should be expended to 60 feet. The revised setback distances meet the IBC criteria of having factors of safety greater than 1.5 and 1.1 for the static and seismic condition, respectively.

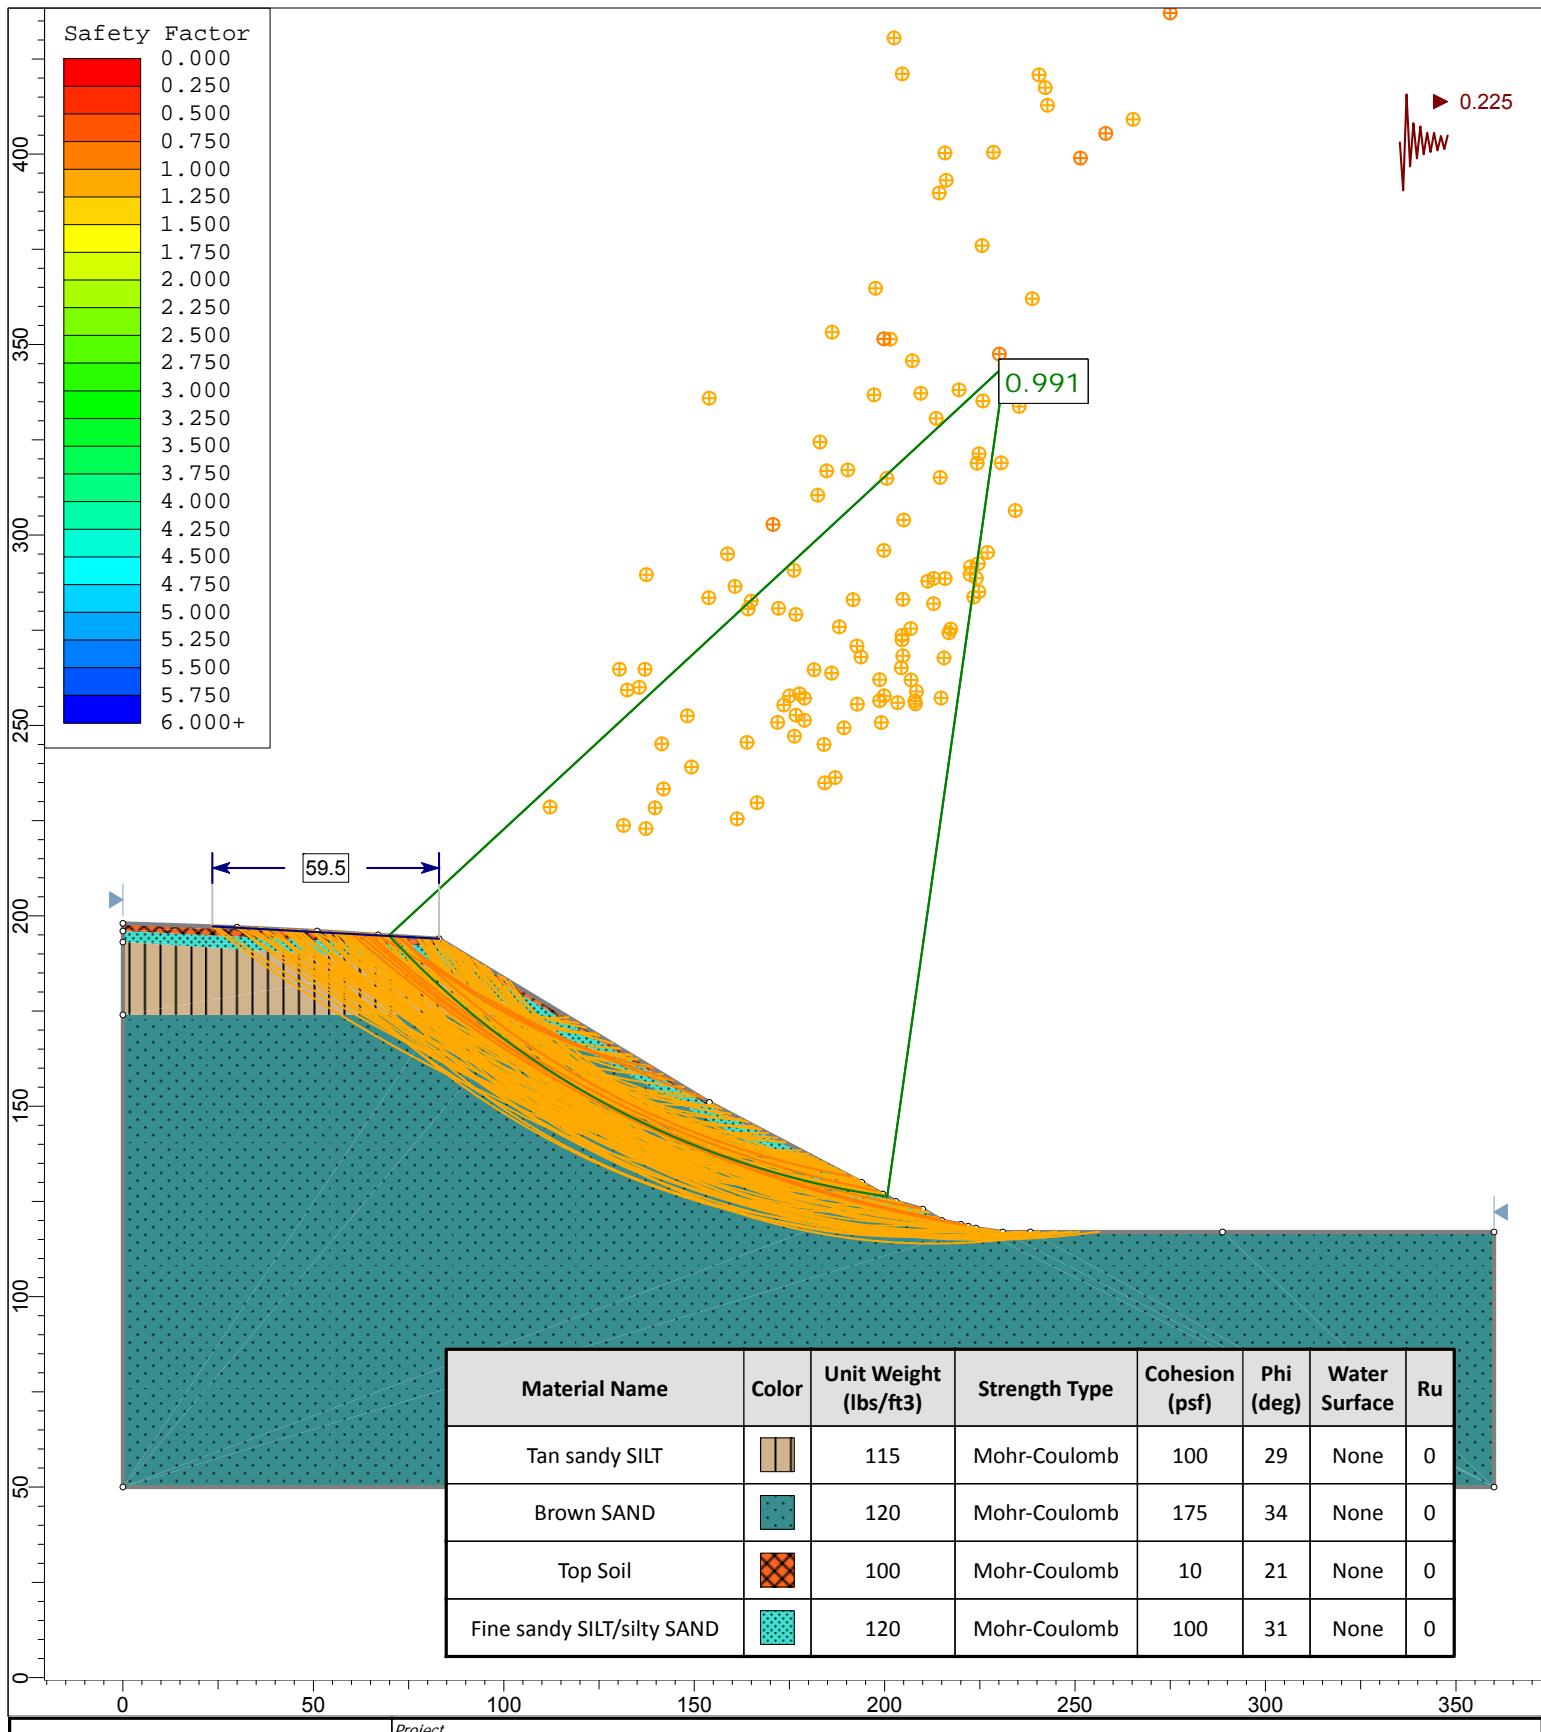
SLIDEINTERPRET 7.022	Project SLIDE - An Interactive Slope Stability Program							
	Analysis Description SCJAlliance.BriggsWestKettle.BB'Seismic							
	Drawn By CC	Scale 1:605	Company	GR				
	Date 7/21/2017, 10:32:46 AM	File Name	SCJAlliance.BriggsWestKettle.dcb.slide.slmd

Global Minimum Query (bishop simplified) - Safety Factor: 0.991383
