Appendix B. Detailed Blight Findings

The purpose of Community Renewal Law is to improve blighted areas of municipalities. This appendix describes existing blight conditions within Downtown Olympia. Downtown has a variety of environmental and economic challenges that hinder the ability for the private sector to invest in downtown Olympia, including:

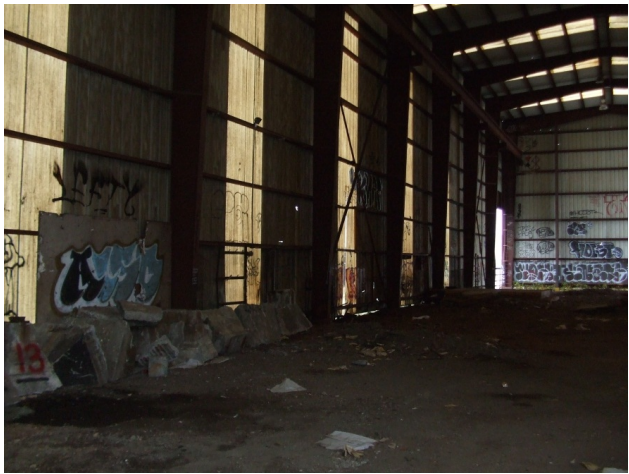
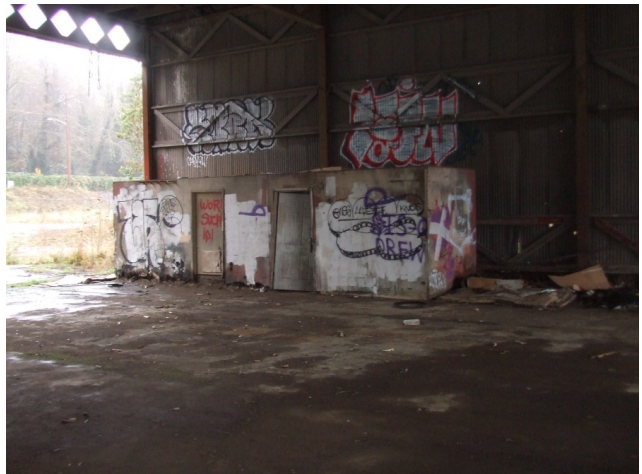
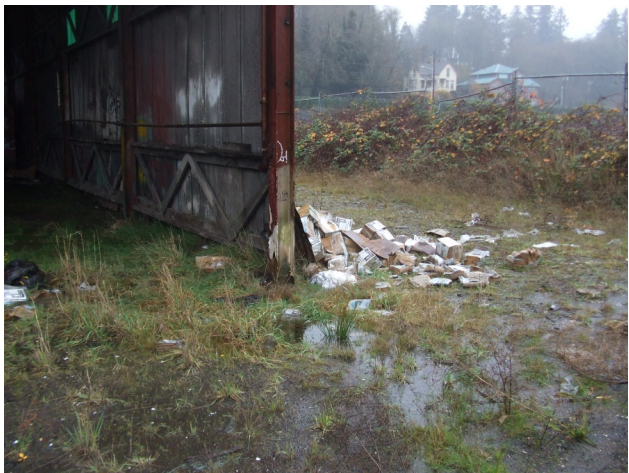
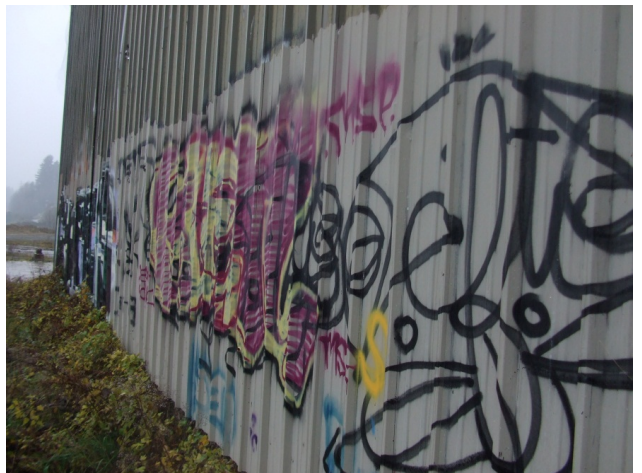
5.1 Reliable Steel

Trash & Debris on Building Exterior (16.06.030.307.1)

Holes on Exterior Walls (16.06.030.304.6)

No Exterior Doors (16.06.030.304.15)

Rodent Infestation (16.06.030.308.1)

Graffiti on Several Walls (16.06.030.302.9)

Leaking Roof (16.06.030.304.7)

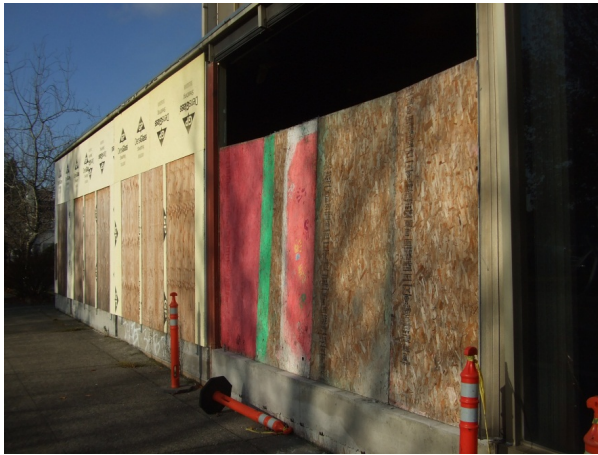
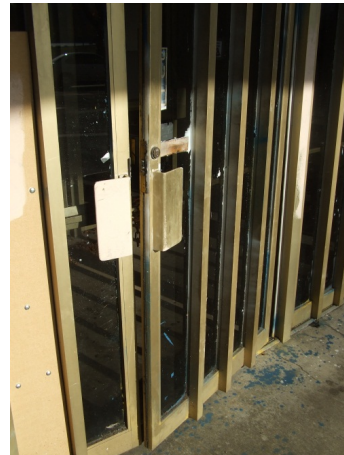
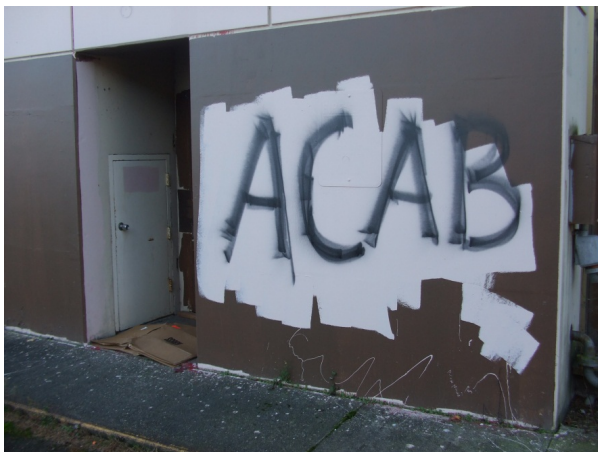
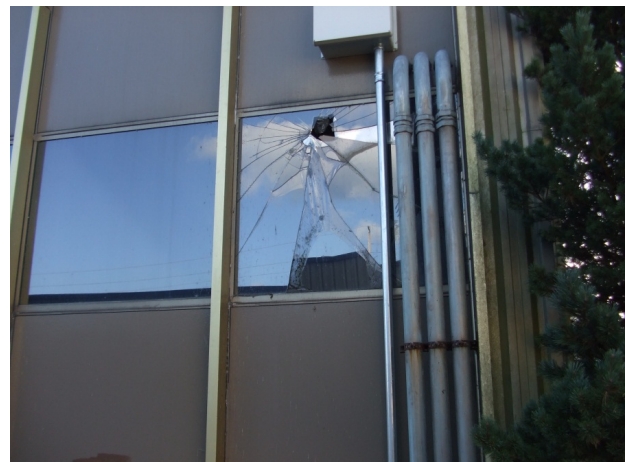
5.2 Capitol Center Properties

Trash & Debris on Building Exterior (160.06.030.307.1)

Holes on Exterior Walls (16.06.030.304.6)

Unsecure Exterior (16.06.030.304.15)

Broken/Boarded Windows (16.06.030.304.13)

Graffiti on Several Walls (16.06.030.302.9)

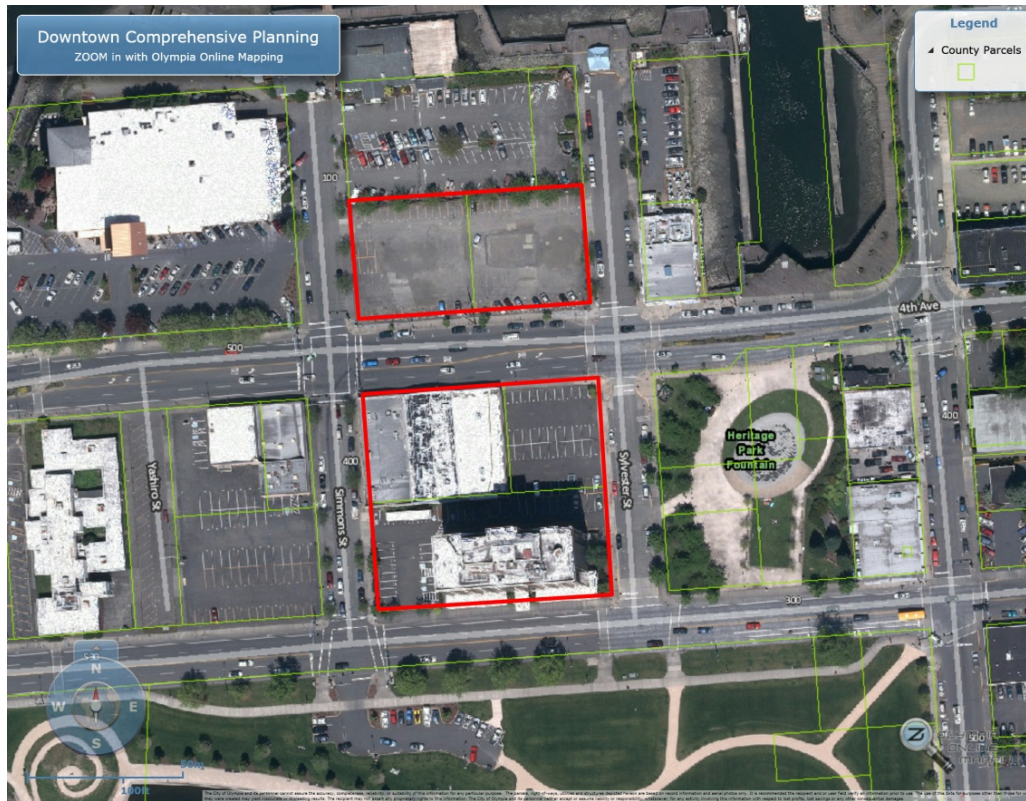
Soil Contamination

The entire property sits on fill. Sea level rise projections show that a small portion of the parcels on the north of 4th Avenue (parking lot) would be submerged at 18.5-foot tide level, about half at 19-foot tide levels, and the approximately 90% at the 19.5-foot level. The parcels on the south side of 4th Avenue would be 75% submerged at the 19-foot tide level. Contaminated soil has been located within 100 feet to the north of the parking lot on the north side of 4th Avenue, and in the northeast corner of the parcels south of 4th Avenue.

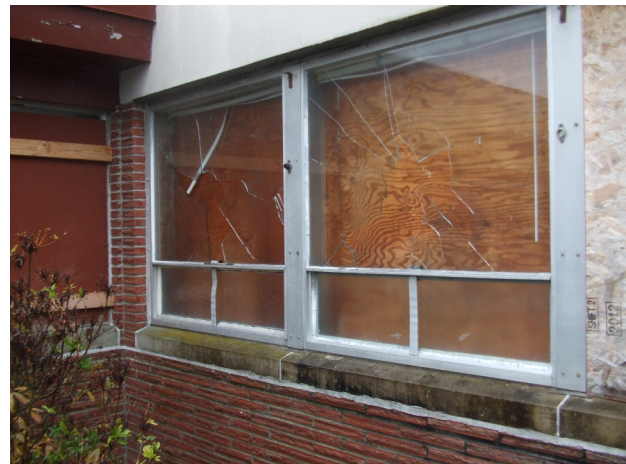
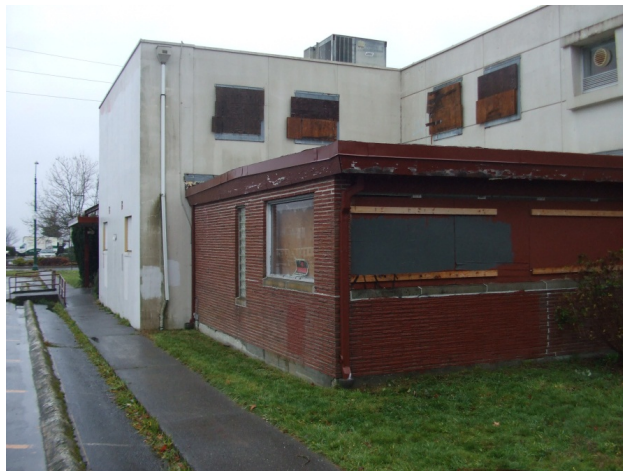
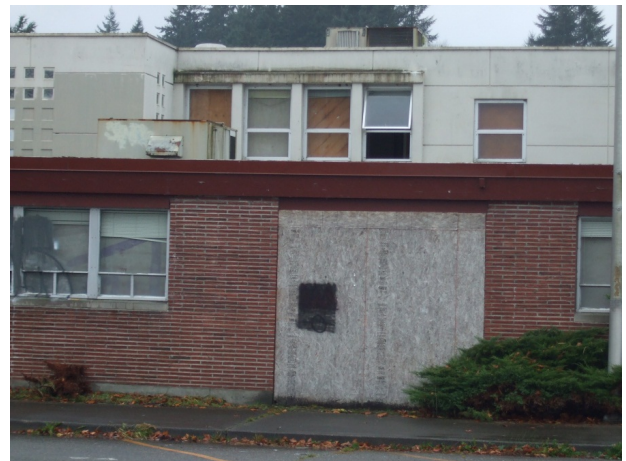
5.3 City-Owned Isthmus Property

Flaking Exterior Surface (160.06.030.304.2)
No Roof (16.06.030.304.7)
Holes, Breaks, Loose, and Deteriorating Exterior Wall (16.06.030.304.6)
Missing/Boarded Windows (16.06.030.304.13)
Graffiti on Several Walls (16.06.030.302.9)

The entire property sits on fill. Sea level rise projections show that nearly 90% of the east parcel would be submerged at the 19-foot tide level. The west parcel (old health department building) would be 75% submerged at the 20-foot tide level. Contaminated soil has been located within 25 feet to the north of the old health department building. City of Olympia staff is currently working on plans and specifications for demolition. The estimated cost of demolition is \$1,000,000. Staff are hopeful to start demolition in Spring, 2014.

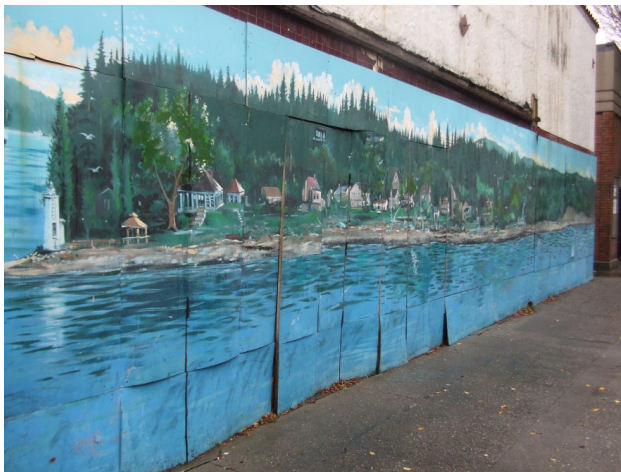
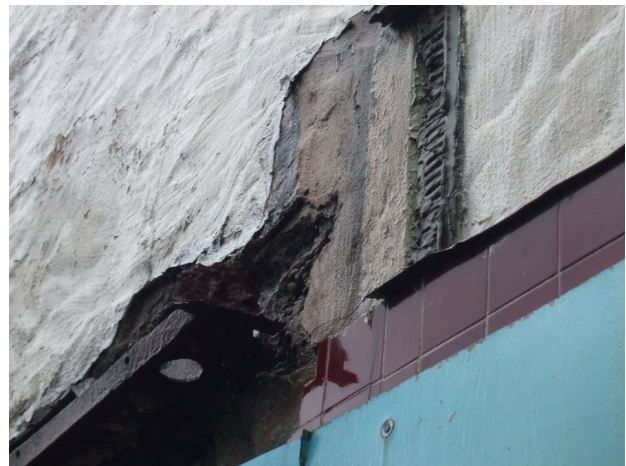
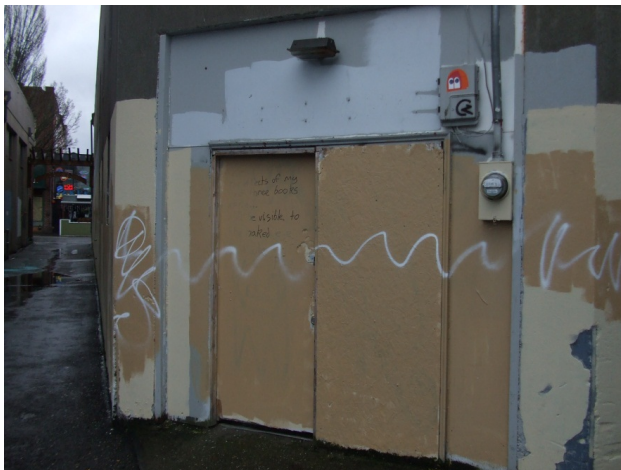
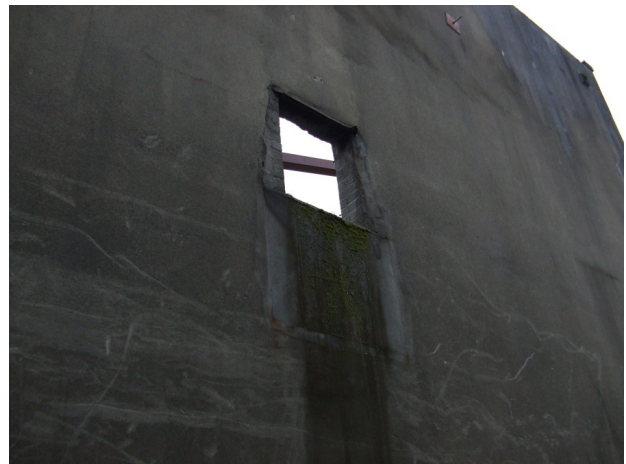
5.4 Griswold's Building

Flaking Exterior Surface (16.06.030.304.2)

No Roof (16.06.030.304.7)

Holes, Breaks, Loose, and Deteriorating Exterior Wall (16.06.030.304.6)

Missing/Boarded Windows (16.06.030.304.13)

Graffiti on Several Walls (16.06.030.302.9)
