Period of Significance (1892 - 1927)

REPLACEMENT MATERIALS

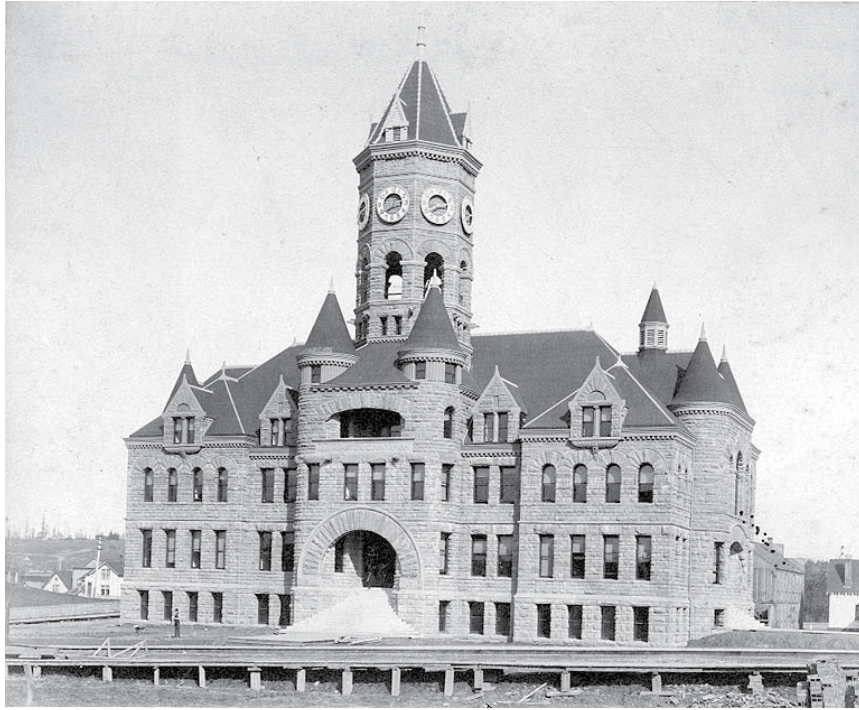
1892

Steel Shingle Roofing

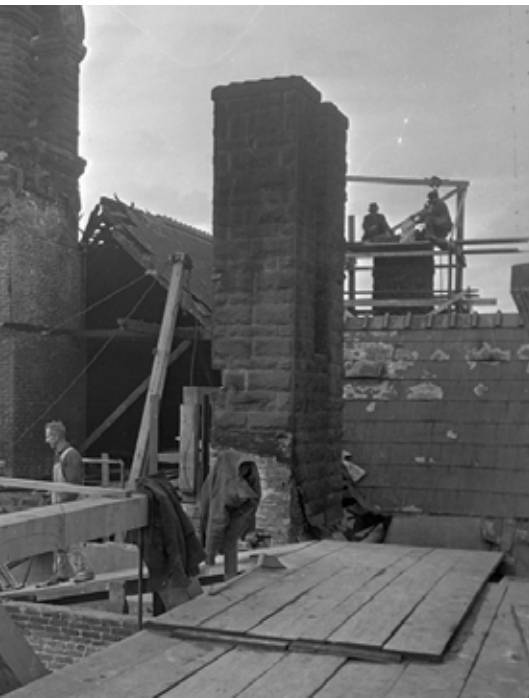
1928

Cement Asbestos Board Shingle

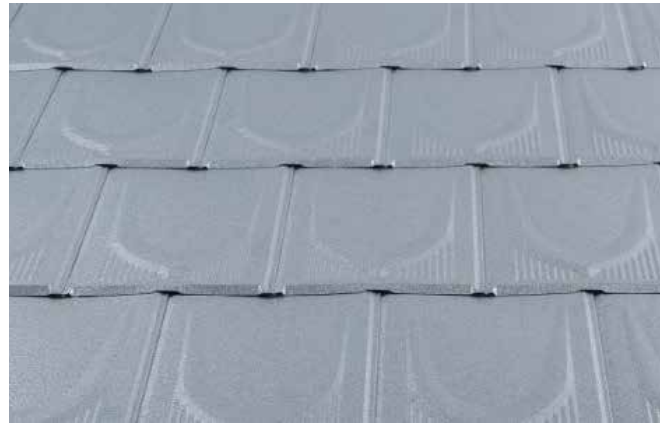
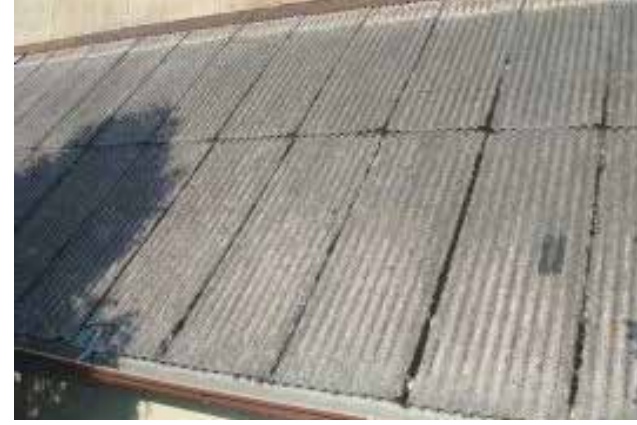
STEEL SHINGLE (GALVANIZED, KYNAR-COATED)

- HISTORICALLY APPROPRIATE FOR PERIOD OF SIGNIFICANCE (1892–1928)
- EASILY MODIFIABLE IN FIELD FOR COMPLEX GEOMETRIES
- HIGH LABOR COST FOR INSTALLATION
- HIGH NUMBER OF PENETRATIONS (2 FASTENERS PER SHINGLE)
- KYNAR COATING WARRANTY TYPICALLY 10 TO 20 YEARS
