Sidewalk Condition Assessment

CITY OF OLYMPIA

Issue Date: March 16, 2025

Cross Reiter Project No. OLY-2401

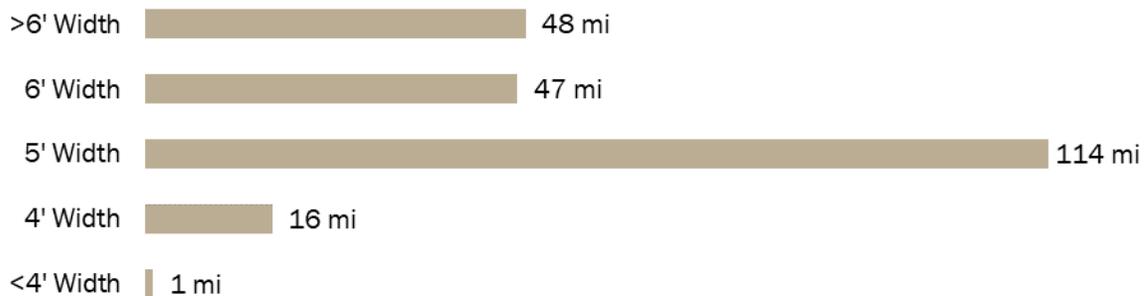
Chart 1. Sidewalk Widths

Cross Reiter recorded observations of average sidewalk widths on an approximately block-by-block basis during our data collection fieldwork. The results are shown in **Chart 1** below and are also depicted on **Figure 2**. Most sidewalks are at least 5 feet wide, especially on arterials and major collectors. Sidewalks with widths of 4 feet or less were only observed in isolated, typically residential, areas.

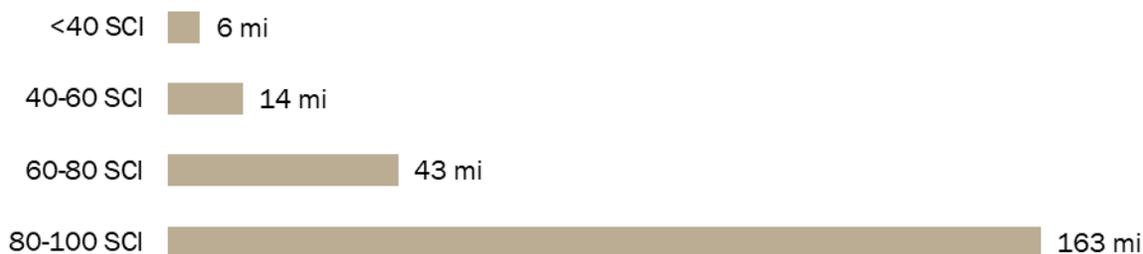
Chart 3. Distribution of Sidewalk Condition Index Scores

Over 70 percent of sidewalks have SCI scores greater than 80. The City’s lowest scoring sidewalks are shown on **Figure 5**. A tabular summary of the lowest scoring sidewalks in the City is included in **Appendix C**. This detailed summary table includes approximately 175 of the lowest scoring sidewalk segments and appurtenant data related to street classification and sidewalk width. The intent of **Appendix C** is to facilitate and support

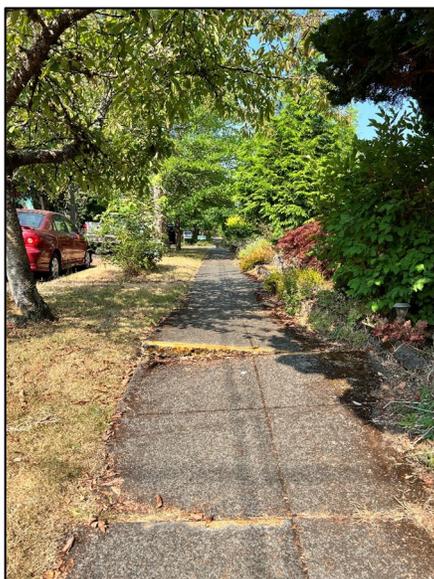
Cross Reiter assessed the relative severity of all points collected under the panel uplift and cracking and/or spalling damage types, which comprised nearly 95 percent of all data points collected for this sidewalk condition assessment. Both qualitative and quantitative criteria were used to assess damage severity, including the extent of vertical and horizontal nonuniformities in the sidewalk surface, risk as a potential tripping hazard, and the extent of required repairs and/or maintenance (refer to **Appendix A** for details). In general, panel uplift points and cracking and/or spalling points with the highest severity ranking represent discrete locations where full replacement of one or more sidewalk panels is likely required to repair the observed damage. Cross Reiter identified approximately 1,458 high severity damage locations that meet this criteria, which comprised about 6 percent of all points collected for the panel uplift and cracking/spalling type categories. All high severity damage locations are shown in **Figure 6**. As can be seen in **Figure 6**, individual high severity damage locations are relatively well distributed across the City sidewalk network. It is important to note that regardless of the aggregate scores presented in **Figure 3** and **Figure 4**, each location shown in **Figure 6** represents severe sidewalk damage. Representative photographs depicting typical high severity damage locations are shown below in **Photographs 1**.

Photograph 1a – High severity panel uplift in South Capitol near 17th Ave SE and Jefferson St SE.

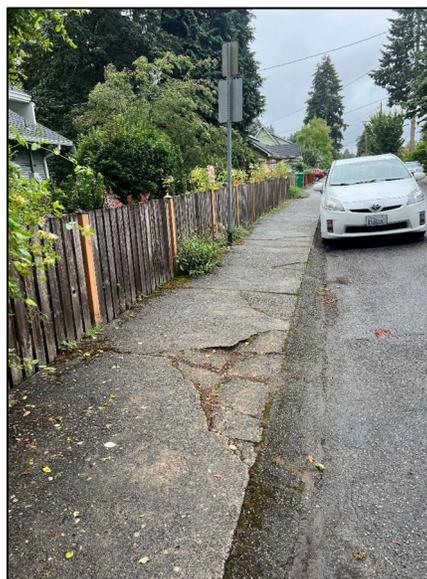
Photograph 1b – High severity cracking near Governor Stevens on Maringo Rd SE.

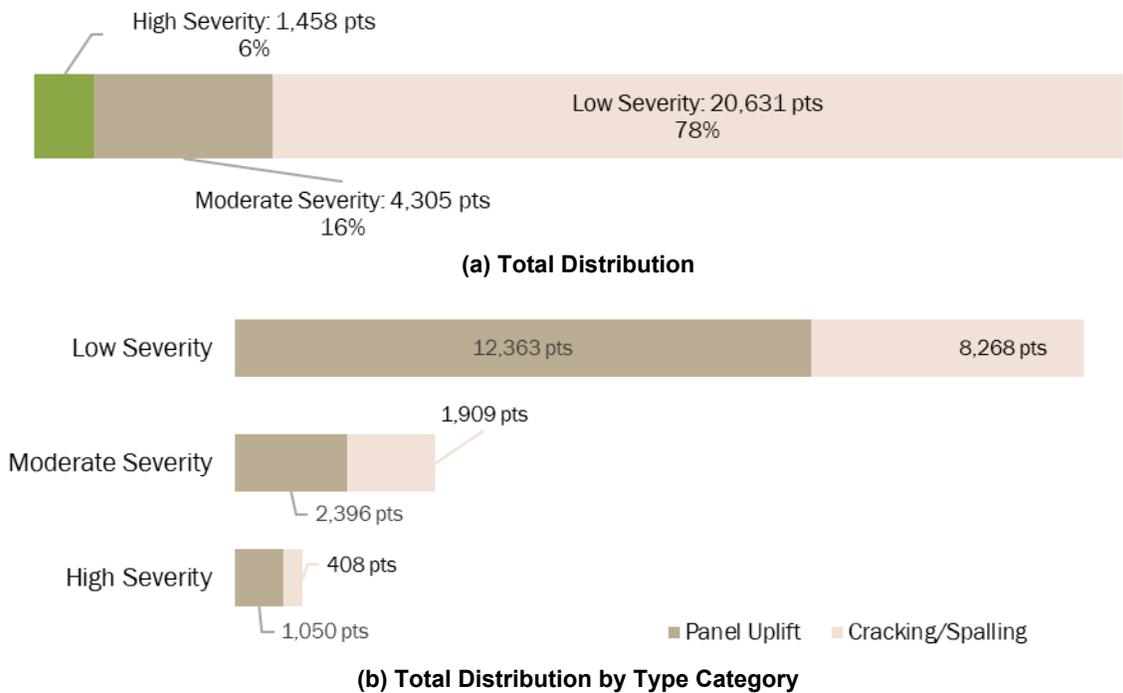
Chart 4. High Severity Sidewalk Damage

Additional details on the distribution of damage severity among the panel uplift and cracking and/or spalling type categories are shown below in **Chart 4**. Panel uplift is the predominant type of sidewalk damage across

the City, especially at high severity damage locations. Of the approximately 1,458 high severity damage locations and 4,305 moderate severity damage locations, nearly 72 percent and 56 percent (respectively) are due to panel uplift.

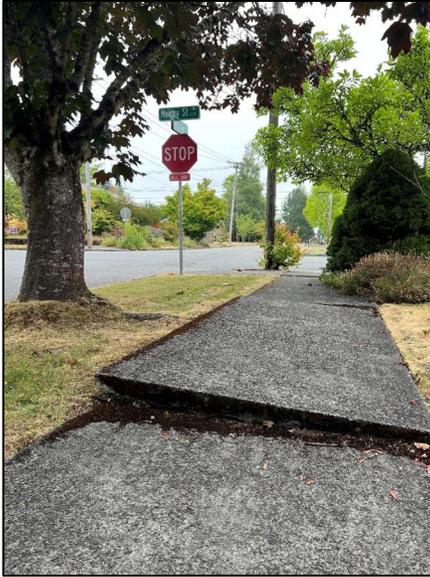
Photograph 2a – High severity uplift caused by tree roots in Southwest Olympia near 6th Ave SW and Milroy St SW.

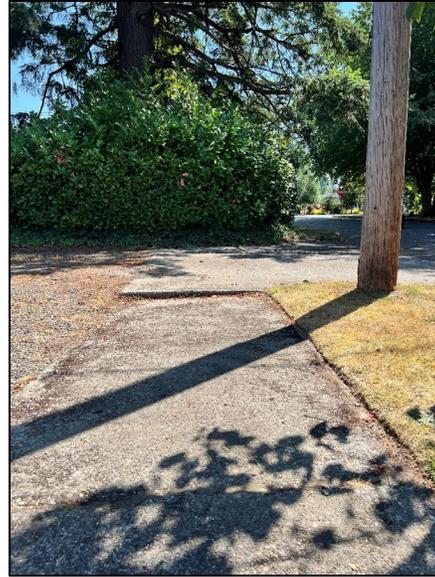
Photograph 2b – High severity uplift caused by differential settlement in Southwest Olympia near 4th Ave W and Thomas St SW.

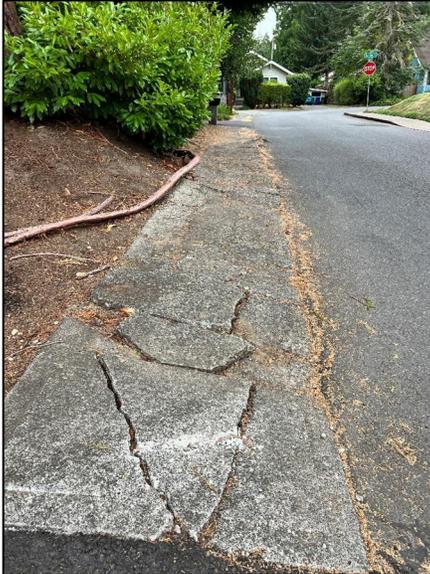
Photograph 3a – High severity cracking in Southwest Olympia caused by ageing and vegetation near 9th Ave SW and Percival St SW.

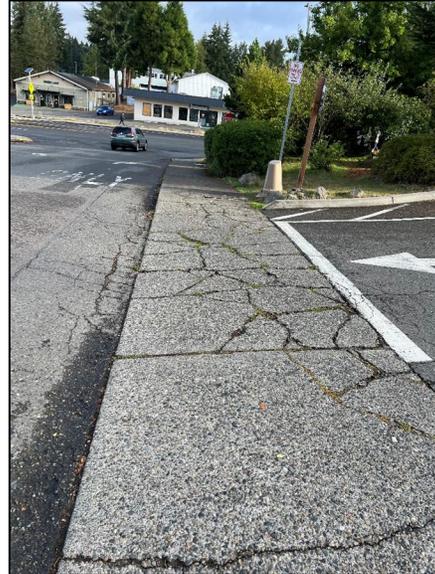
Photograph 3b – High severity cracking caused by vehicular loading near Pacific Ave SW and Lansdale St SE in East Olympia.

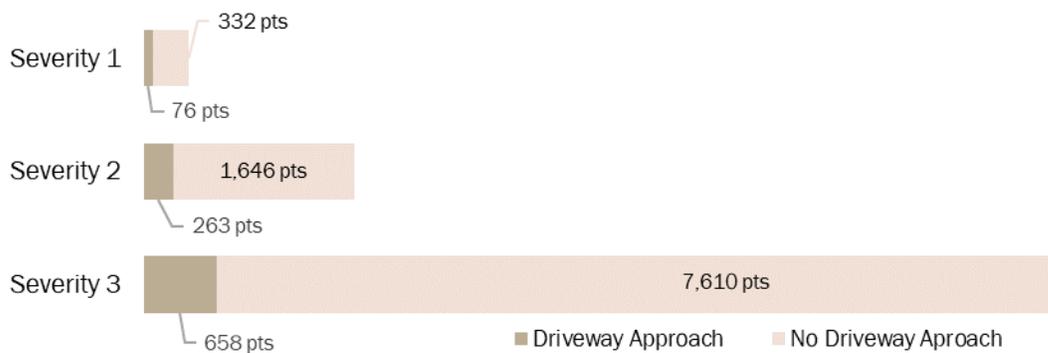
Chart 7. Contribution of Vehicular Loading to Cracking/Spalling

For every cracking and/or spalling observation, Cross Reiter also recorded whether the damage was within a driveway approach or otherwise likely caused by vehicular traffic. This data is presented in **Chart 7** below. Vehicular traffic was not a significant contributor to most cracking and/or spalling damage observed across the City. Instead, cracking and/or spalling across all levels of severity is likely associated with other contributing factors (e.g., construction defects, ageing, drainage issues, or vegetation).

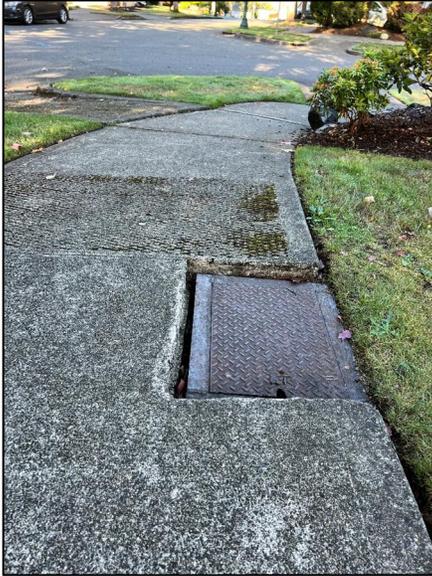
Photograph 4a – Non-flush utility vault in Southeast Olympia near Hoffman Rd SE and 30th Ave SE.

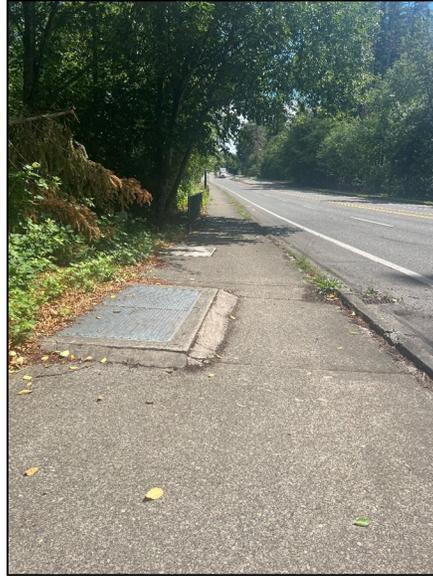
Photograph 4b – Non-flush utility vault in West Olympia near Harrison Ave NW and Yauger Way NW.

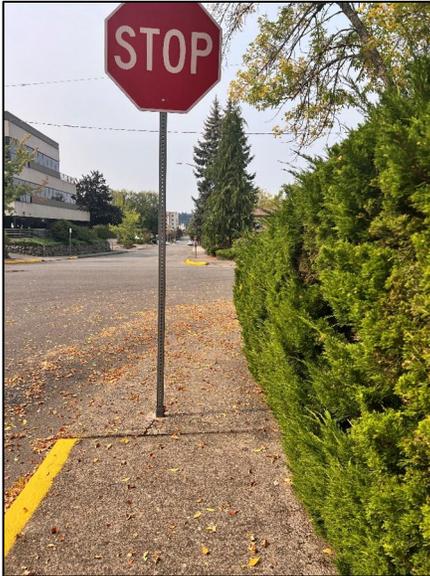
Photograph 5a – Permanent width restriction from a stop sign near Downtown Olympia at 7th Ave SE and Quincy St SE.

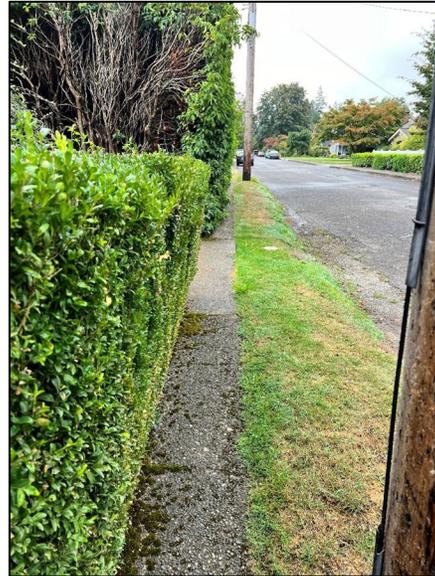
Photograph 5b – Temporary width restriction from overgrown shrubs near Vista Ave SE and Maringo Rd SE near Wildwood.

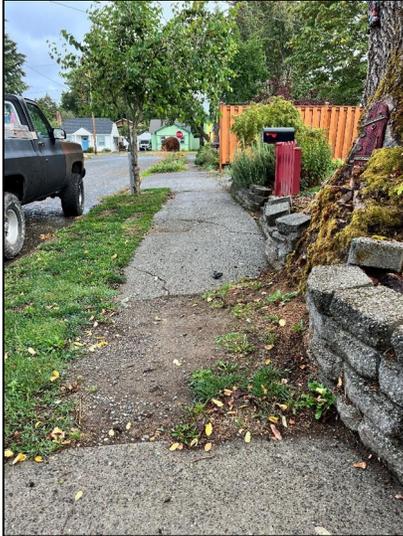
Photograph 6a – Missing sidewalk panel in Bigelow Highlands near State Street NE and McCormick St NE.

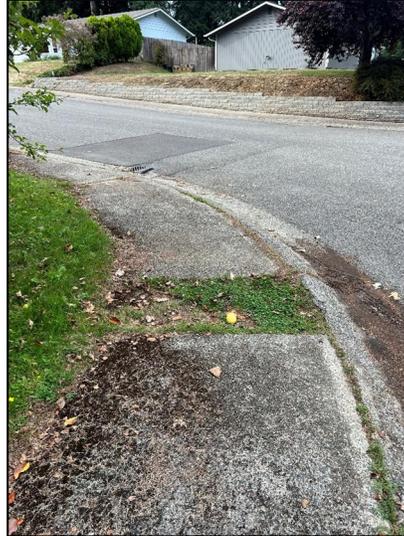
Photograph 6b – Missing sidewalk panel near Landau Ave NE and Stanhope St NE.

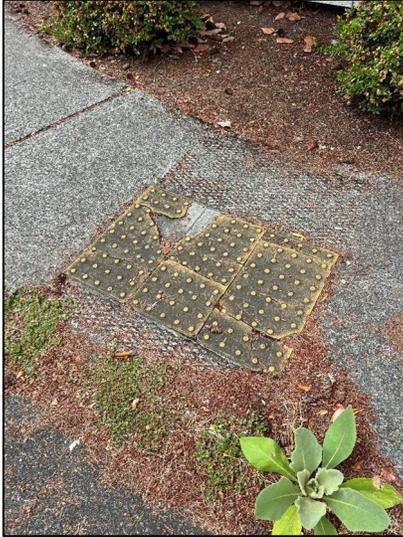
Photograph 7a – Damaged detectable warning surface near Burbank Ave NW and Blossomwood Ct NW.

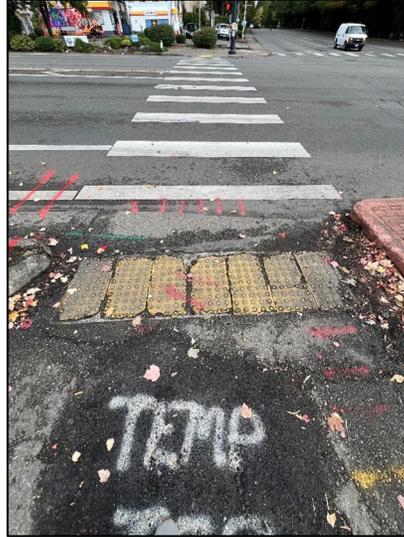
Photograph 7b – Damaged detectable warning surface near Martin Way E and College St NE.

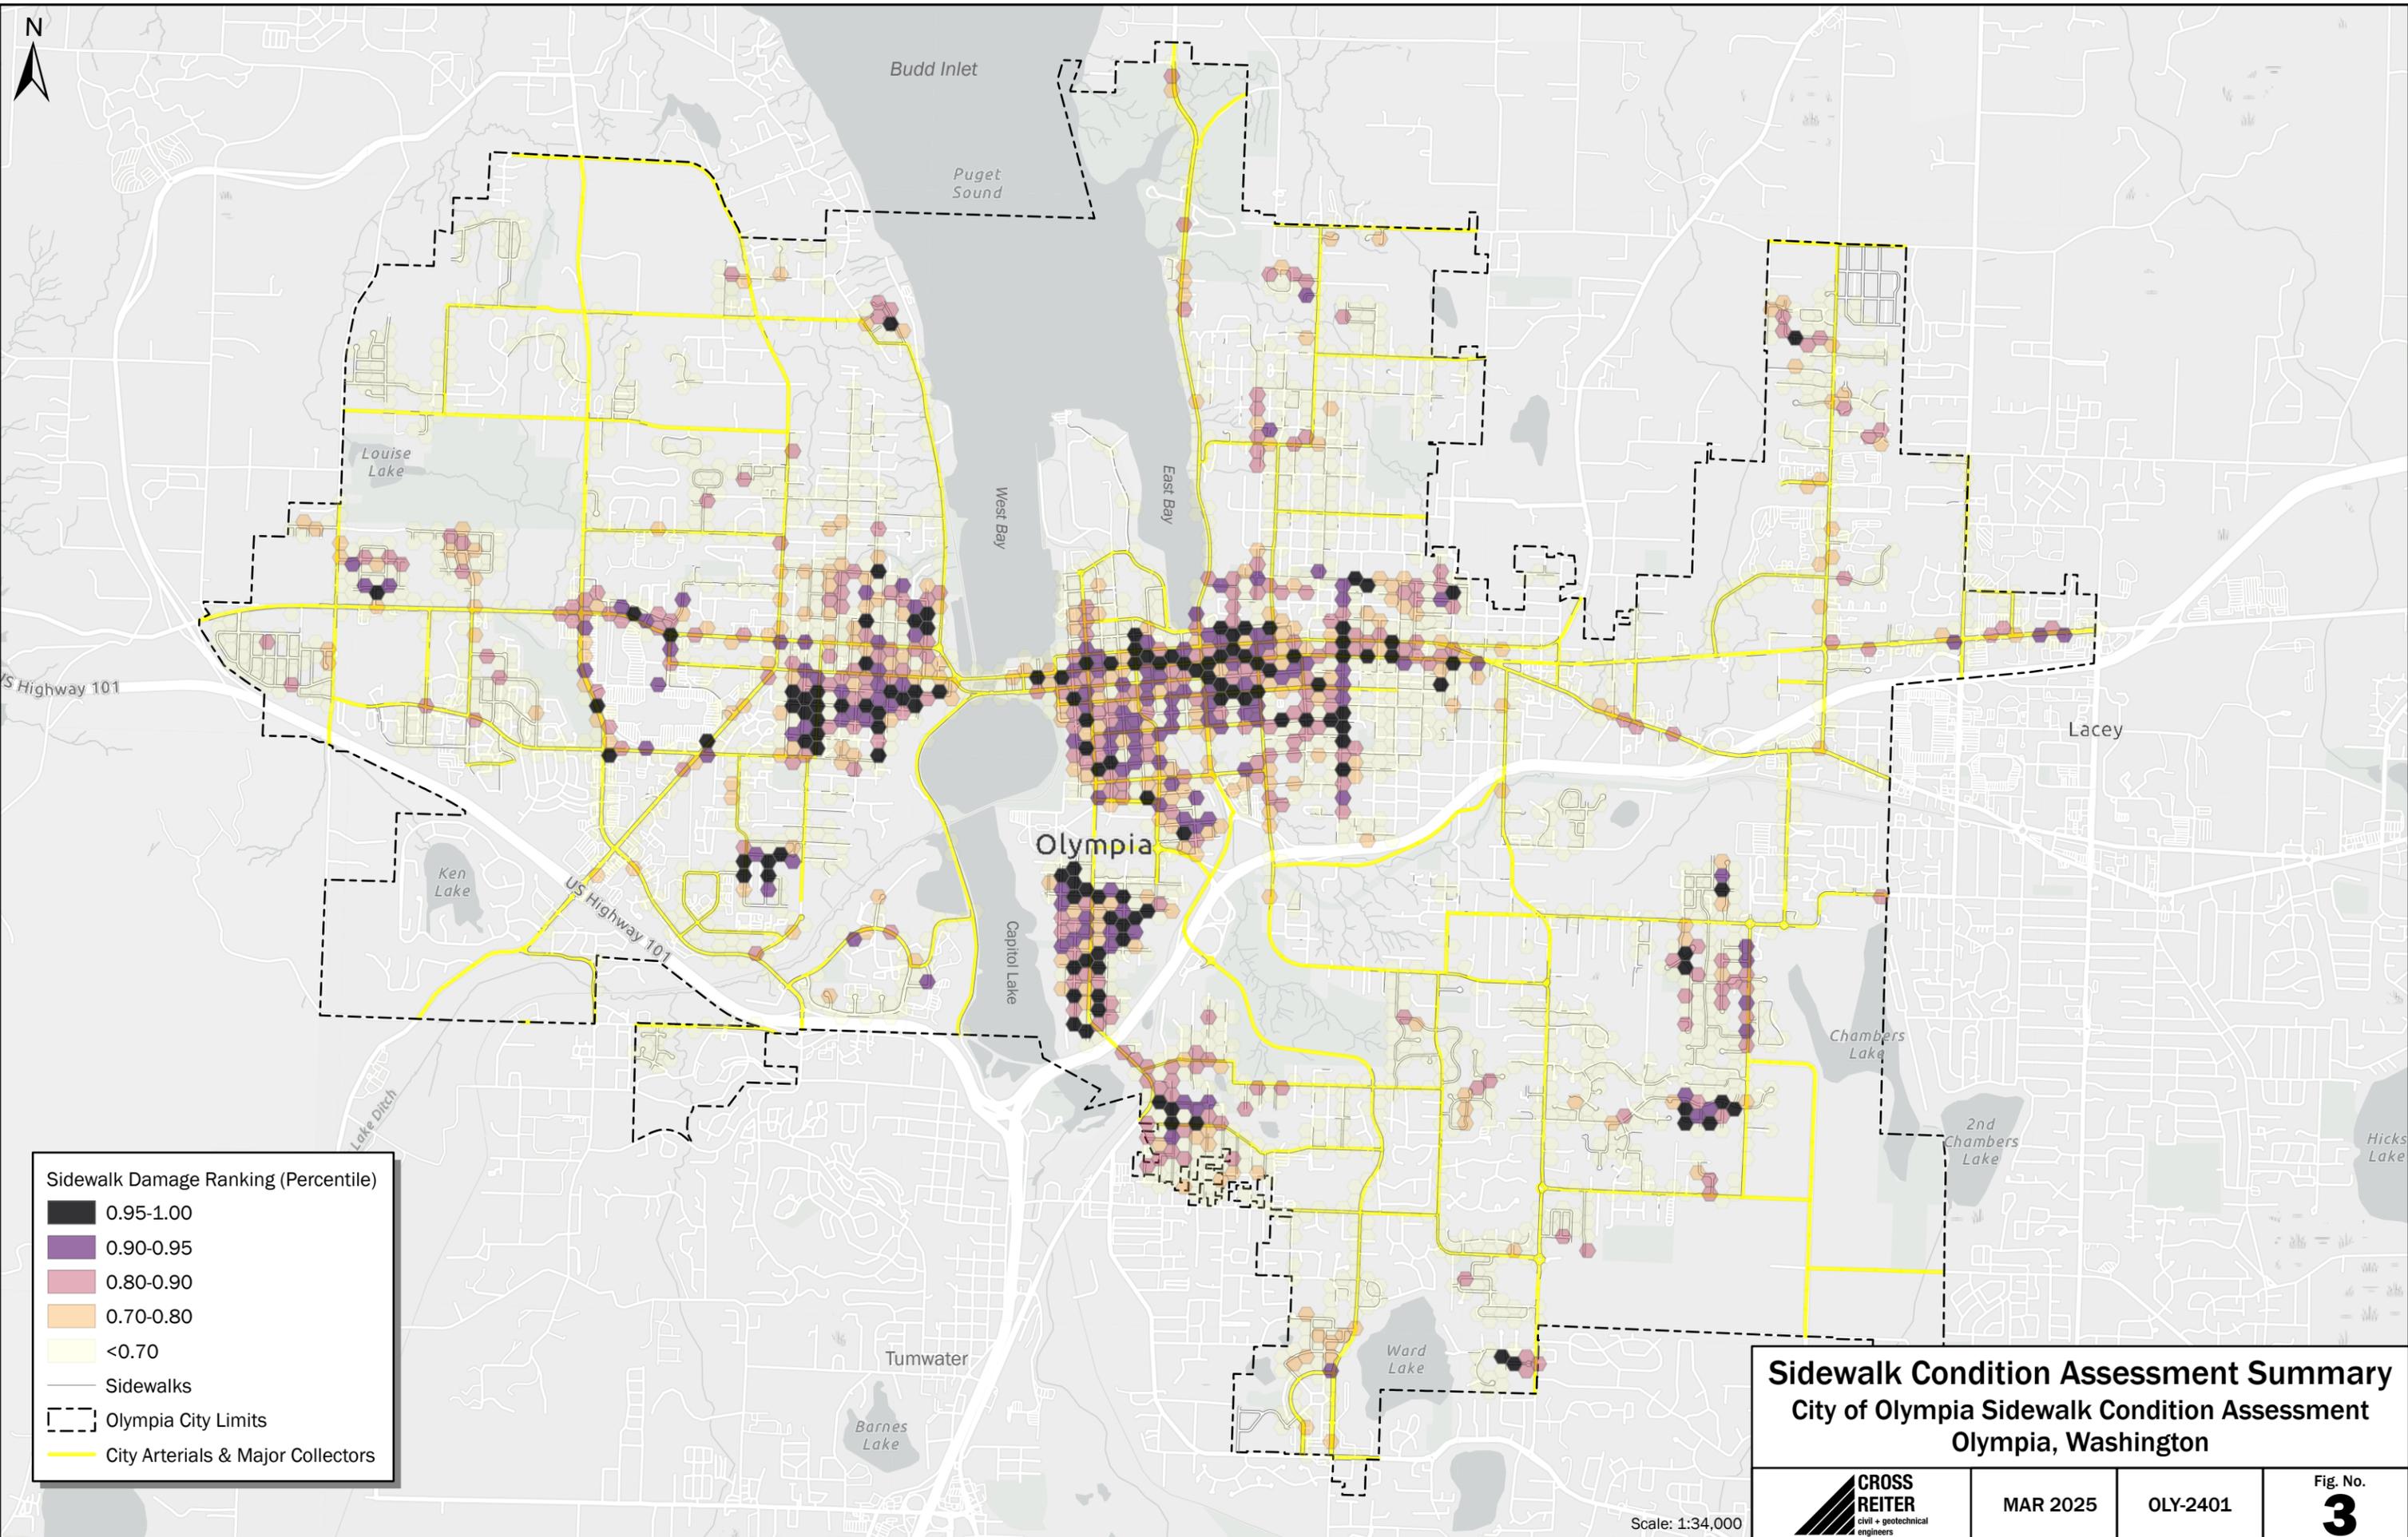
Fig. No. **3**

Figure 3 summarizes the results of the sidewalk condition assessment within a grid of uniform hexagons, each with an area approximately equal to a downtown City block. Hexagonal binning is an effective method for visualizing density patterns in large spatial datasets due to its readability, uniform tessellation, and computational efficiency. The intent of **Figure 3** is to reduce noise in the dataset, minimize the impact of small-scale variability, and highlight broader trends and concentrations of sidewalk damage. This approach allows for the identification of areas with relatively higher levels of sidewalk deterioration across the City. The color of each hexagon represents the relative density and severity of sidewalk damage compared to the rest of the City. The following key trends can be observed in **Figure 3**:

- The 95th percentile of sidewalk damage density and severity are clustered in the following general areas:
 - Downtown Olympia and adjacent portions of the Eastside, particularly along the State Avenue NE, 4th Avenue E, and Legion Way SE corridors (especially between Plum Street SE and Eastside Street SE), as well as along the Capitol Way S and Central Street SE corridors.

- South Capitol, where sidewalk damage is relatively well-distributed around the neighborhood/district.
 - Southwest Olympia between 5th Avenue SW and 9th Avenue SW, especially along Decatur Street SW.

- A few residential subdivisions also exhibit notably dense and severe sidewalk damage, including:
 - The north phase of the Wellington West development in Southwest Olympia (Fern Street SW, Division Street SW, and 15th Avenue SW).

Sidewalk Condition Assessment Summary
 City of Olympia Sidewalk Condition Assessment
 Olympia, Washington

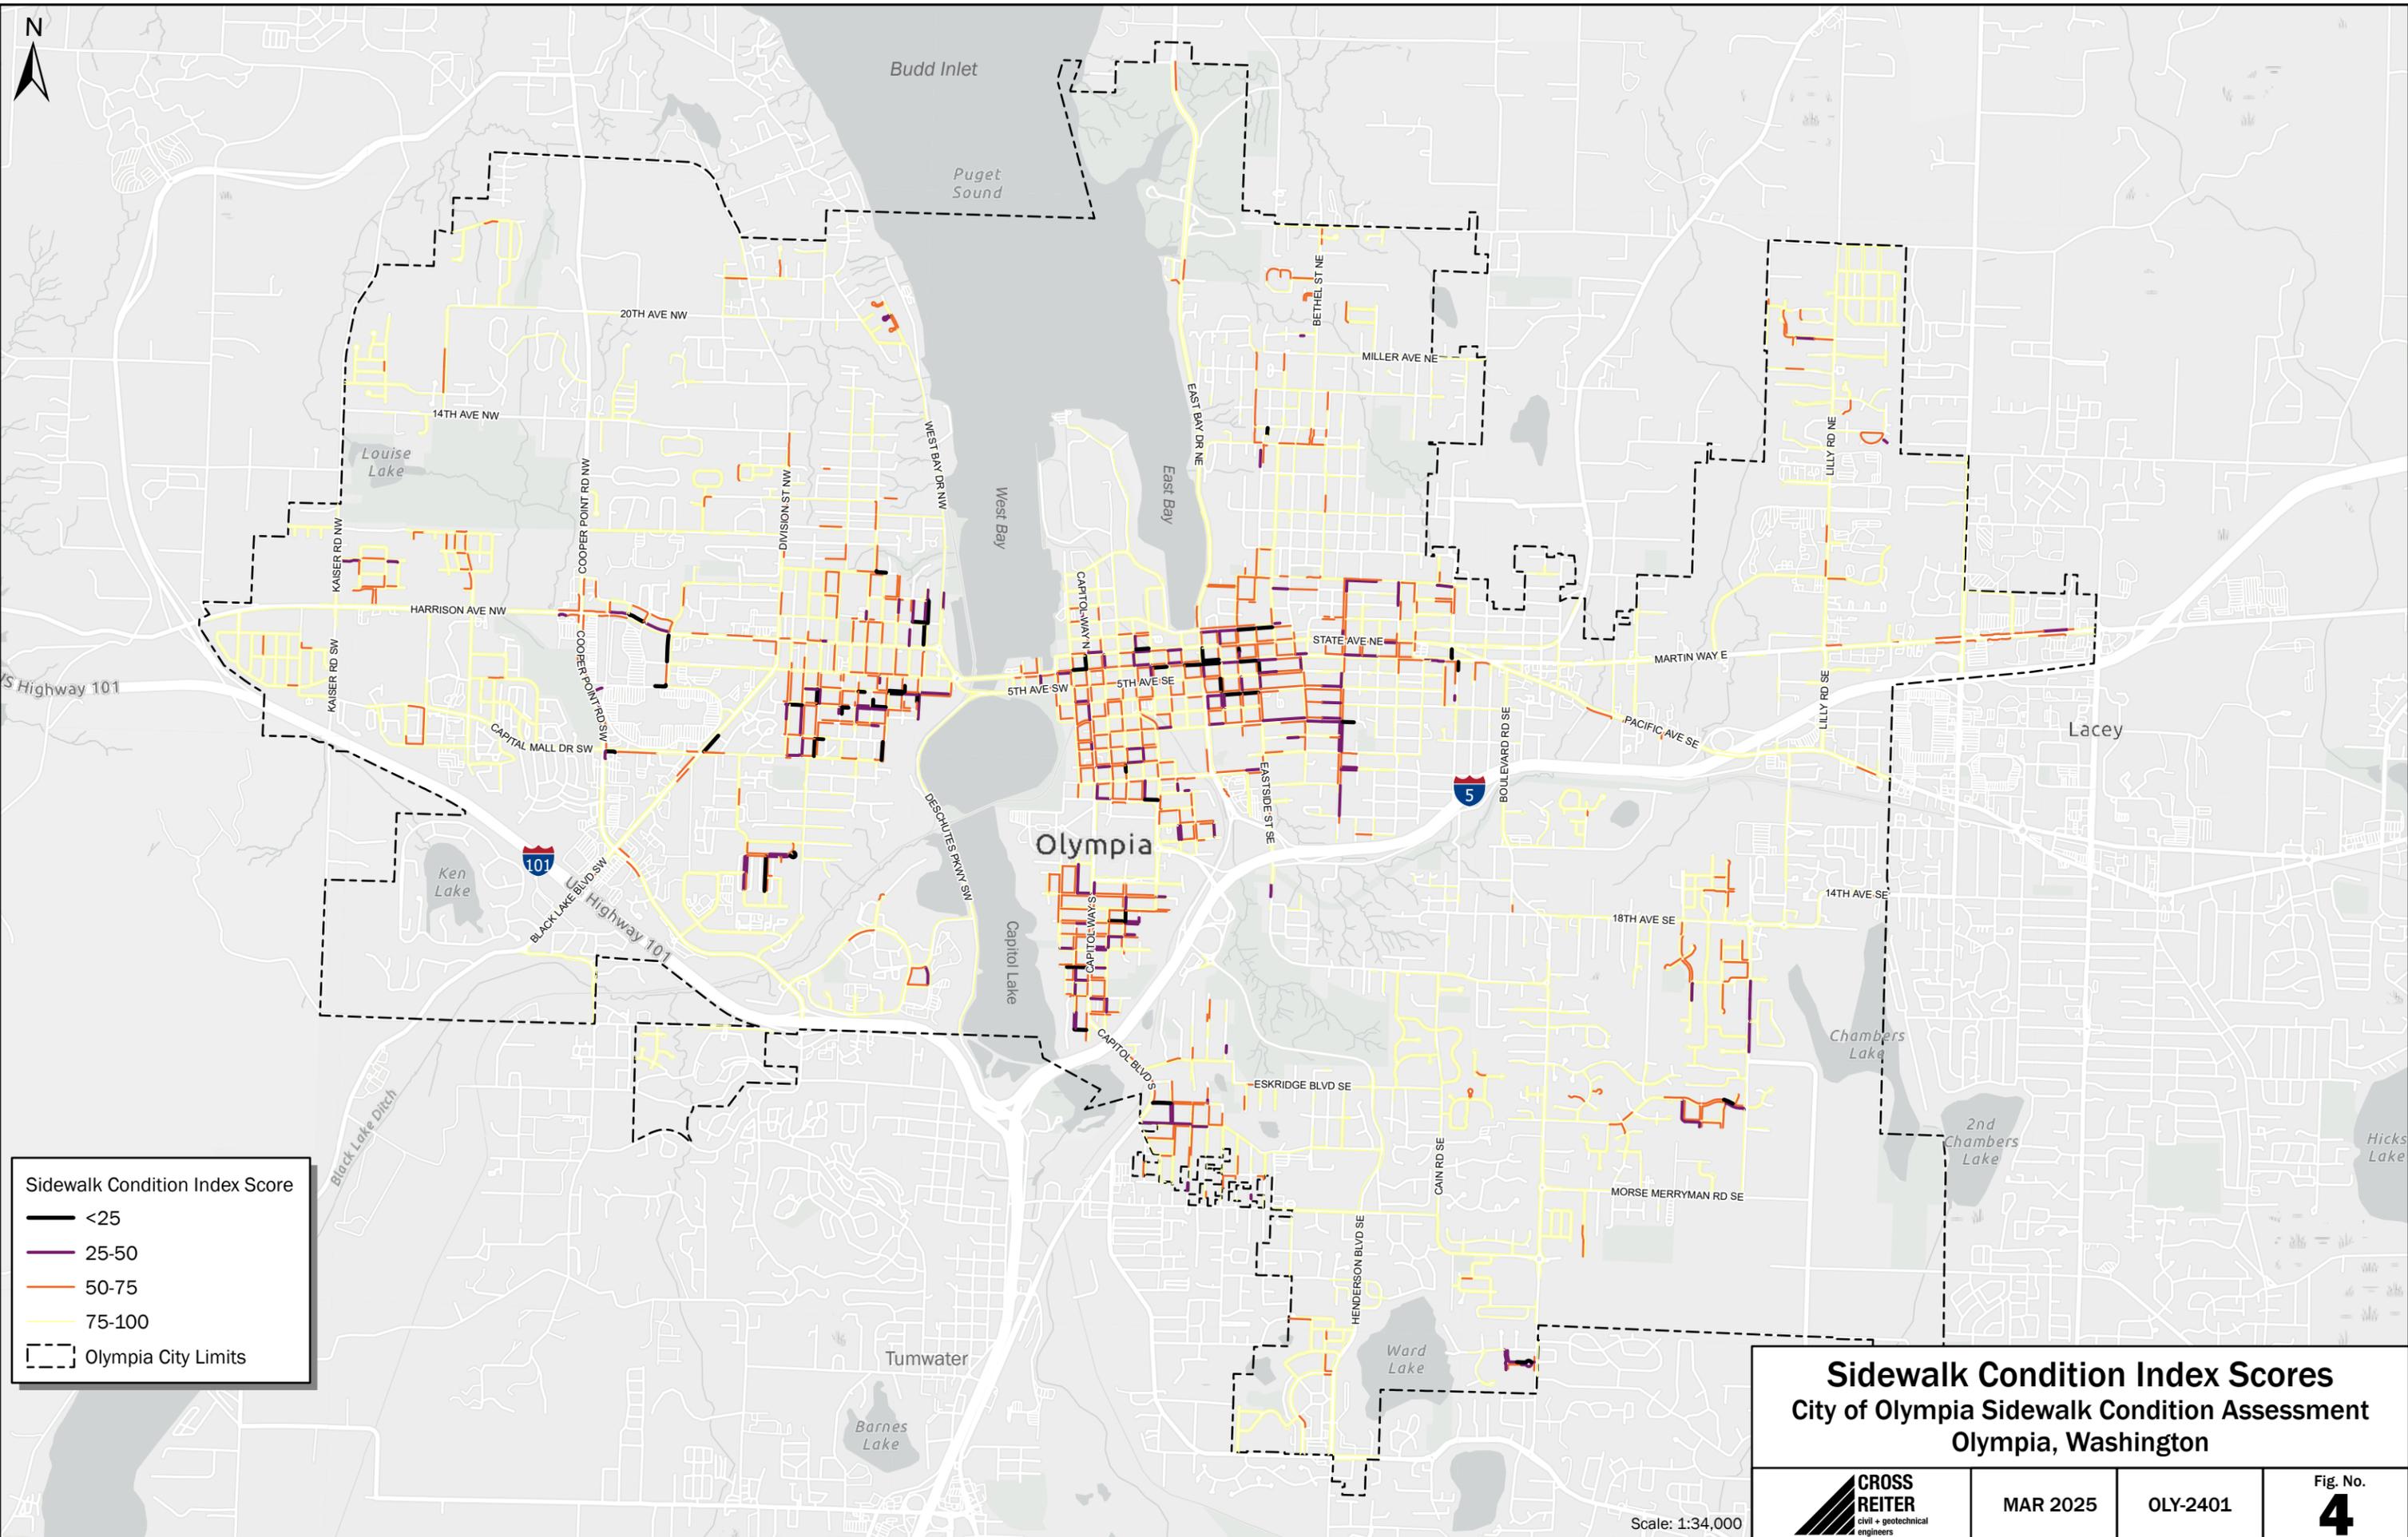
Fig. No.
4

Figure 4 presents an overall Sidewalk Condition Index (SCI) score for each City sidewalk segment, where each segment is approximately the length of a downtown City block. The SCI score ranges from 0 to 100, providing an intuitive metric of sidewalk condition that facilitates comparison of sidewalk conditions across the City on a block-by-block basis. This method is advantageous because sidewalk maintenance and capital improvements can be efficiently executed on a block-by-block basis to consolidate efforts related to contractor mobilization, traffic control, public outreach, and business accommodation. If desired, the City could also elect to require transportation and utility capital improvement projects to incorporate sidewalk improvements if adjacent sidewalks score below a minimum threshold.

In **Figure 4**, the color and thickness of each sidewalk segment corresponds to its SCI score. The following key trends can be observed in **Figure 4**:

- Similar to the discussion in Section 4.1.1 above, the most damaged sidewalks are generally located in Downtown Olympia, close-in portions of the Eastside, South Capitol, Southwest Olympia, Northwest Olympia, and the arterials and major collectors bordering the Capital Mall area. **Table 1** below lists several selected City blocks with notable sidewalk damage. This table is not exhaustive, it is intended to highlight key areas on **Figure 4**. A detailed tabular summary of the lowest scoring sidewalks is included in **Appendix C** and **Figure 5** and described in more detail later in this section.

Sidewalk Condition Index Scores
 City of Olympia Sidewalk Condition Assessment
 Olympia, Washington

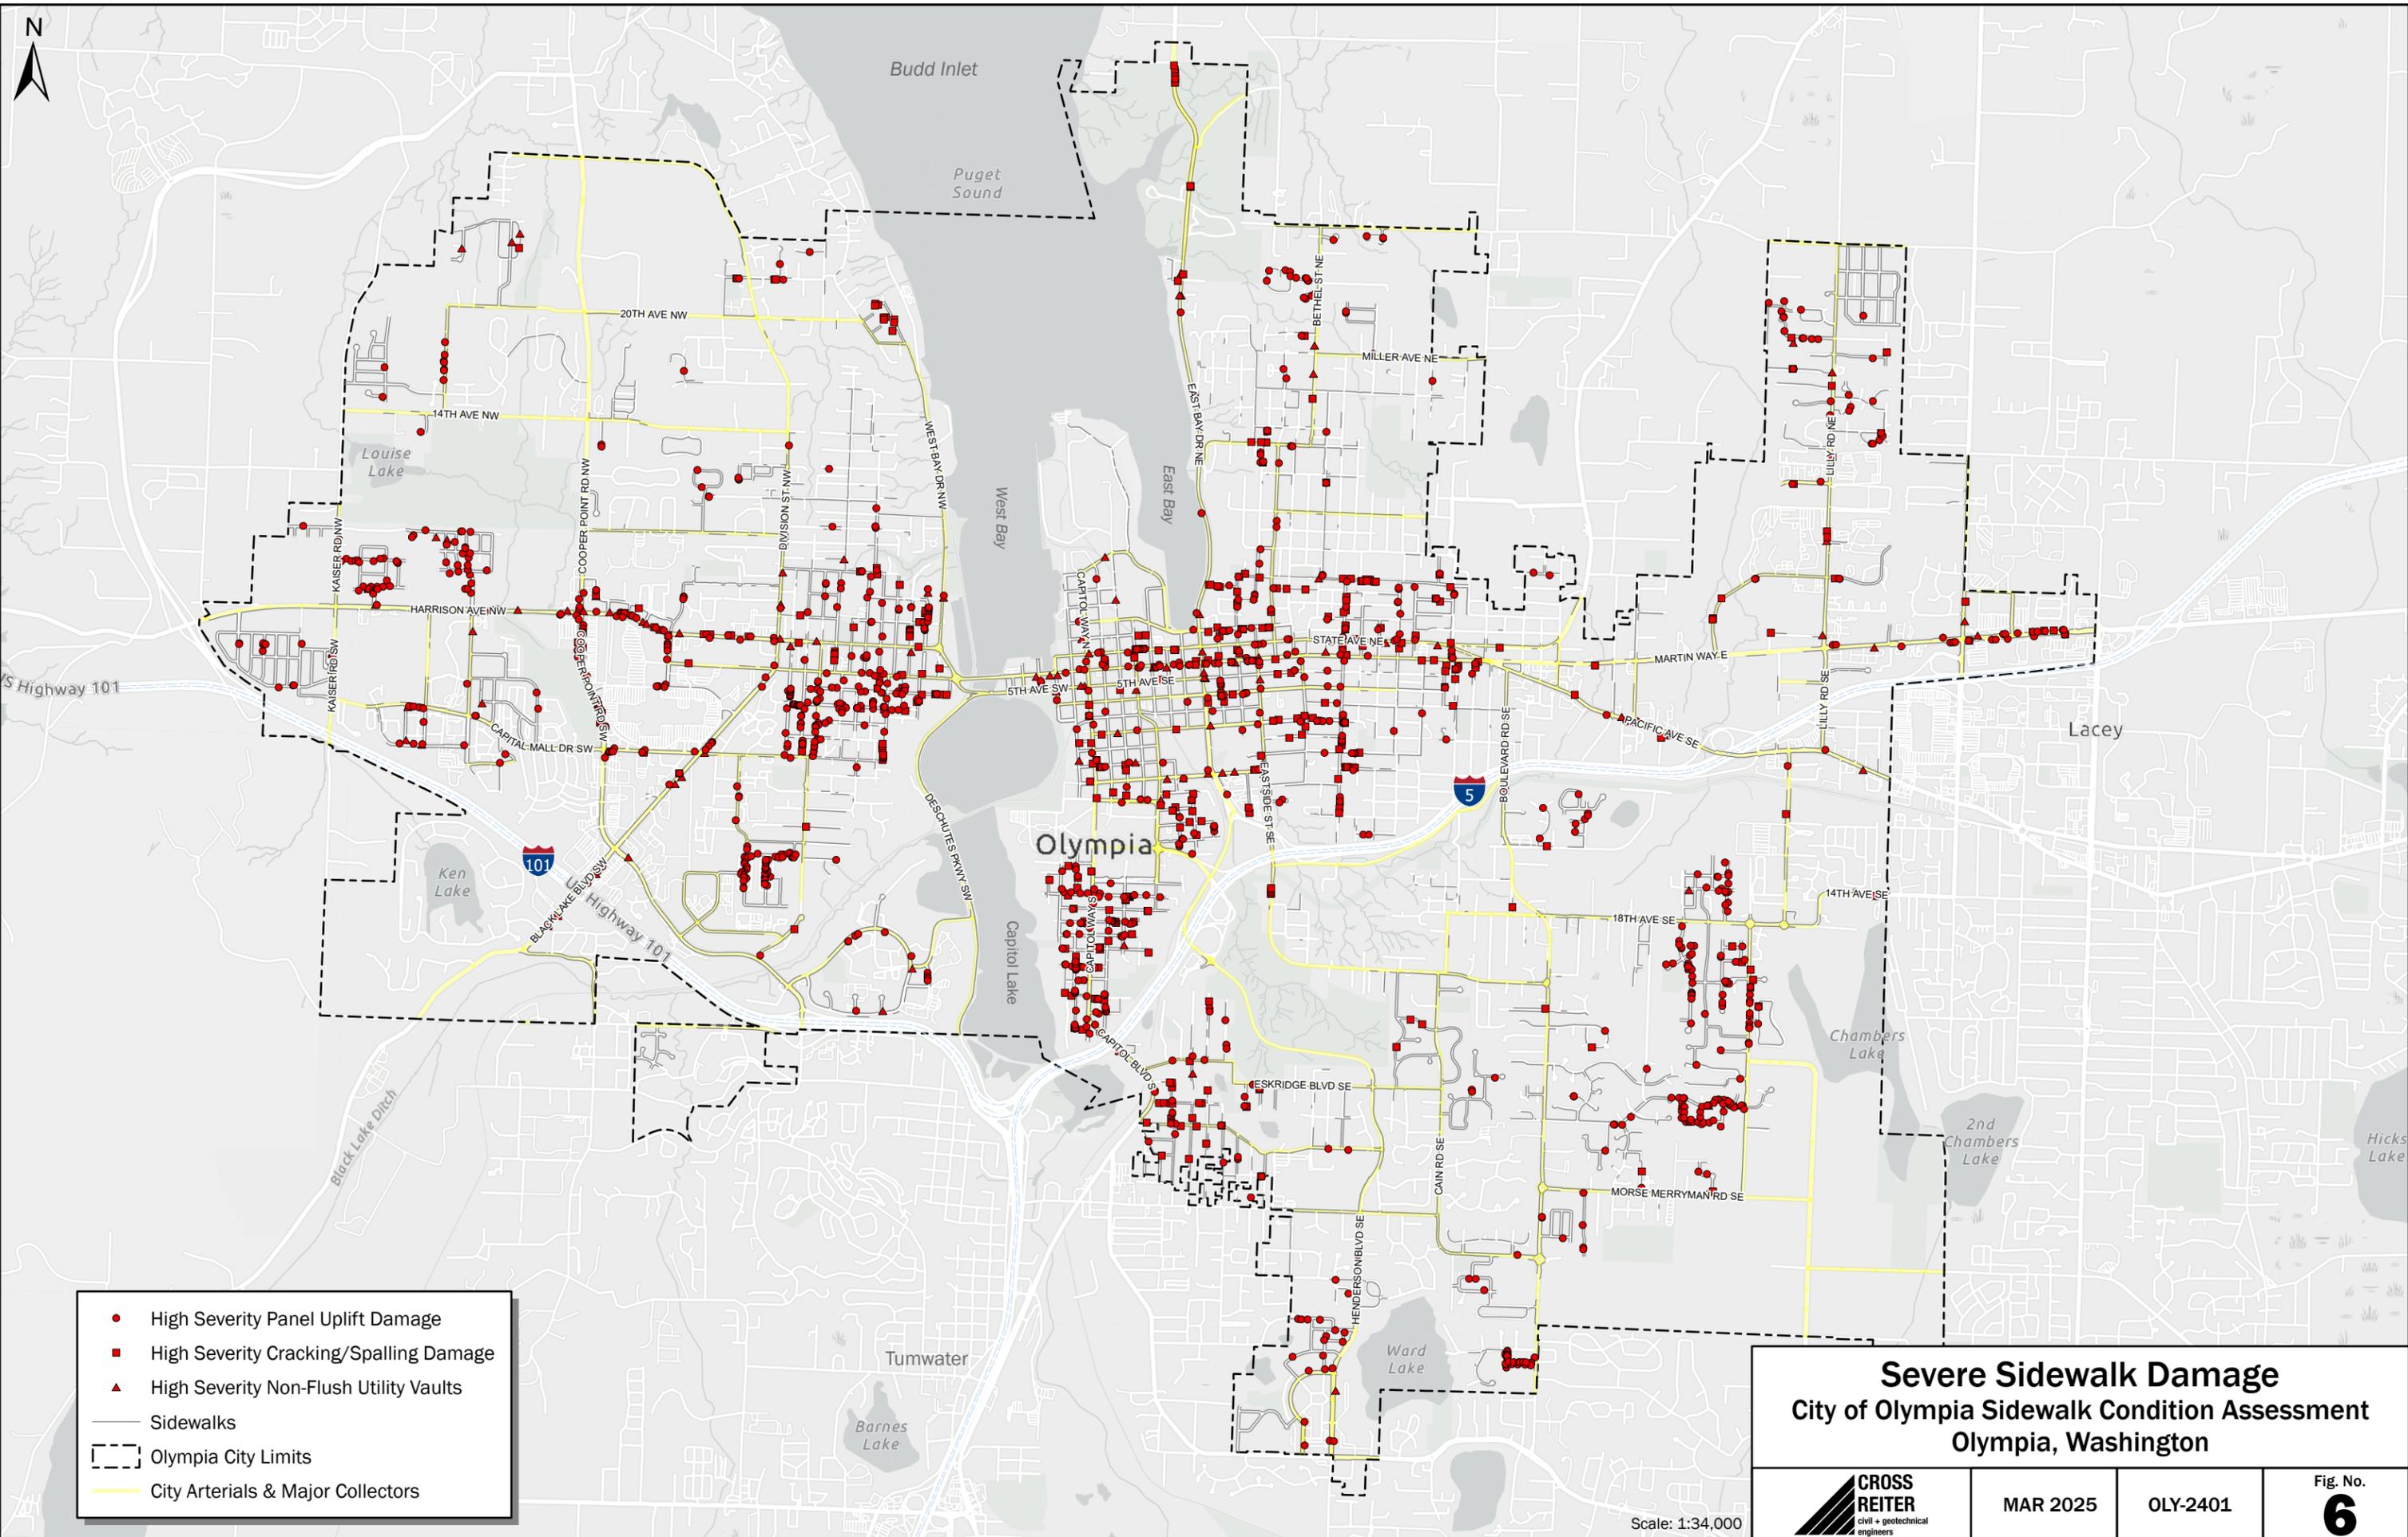
Fig. No.
6

Cross Reiter identified approximately 1,458 high severity damage locations where full replacement of one or more sidewalk panels is likely required. All high severity damage locations are shown on **Figure 6**. An additional 4,305 moderate severity damage locations were observed throughout the City, which may or may not require full panel replacements but are a high priority for timely maintenance or repair (e.g., grinding/beveling uplifted panels, crack repair, partial panel replacements). Together, these 5,763 high severity and moderate severity damage locations comprise a potential scope of high priority sidewalk repair work. Additional data on width restrictions, missing panels, and damaged detectable warning surfaces were also collected for this assessment and are shown on **Figure 8** through **Figure 10**, respectively. Together, these comprise an additional 659 discrete maintenance/repair tasks.

Severe Sidewalk Damage
City of Olympia Sidewalk Condition Assessment
Olympia, Washington

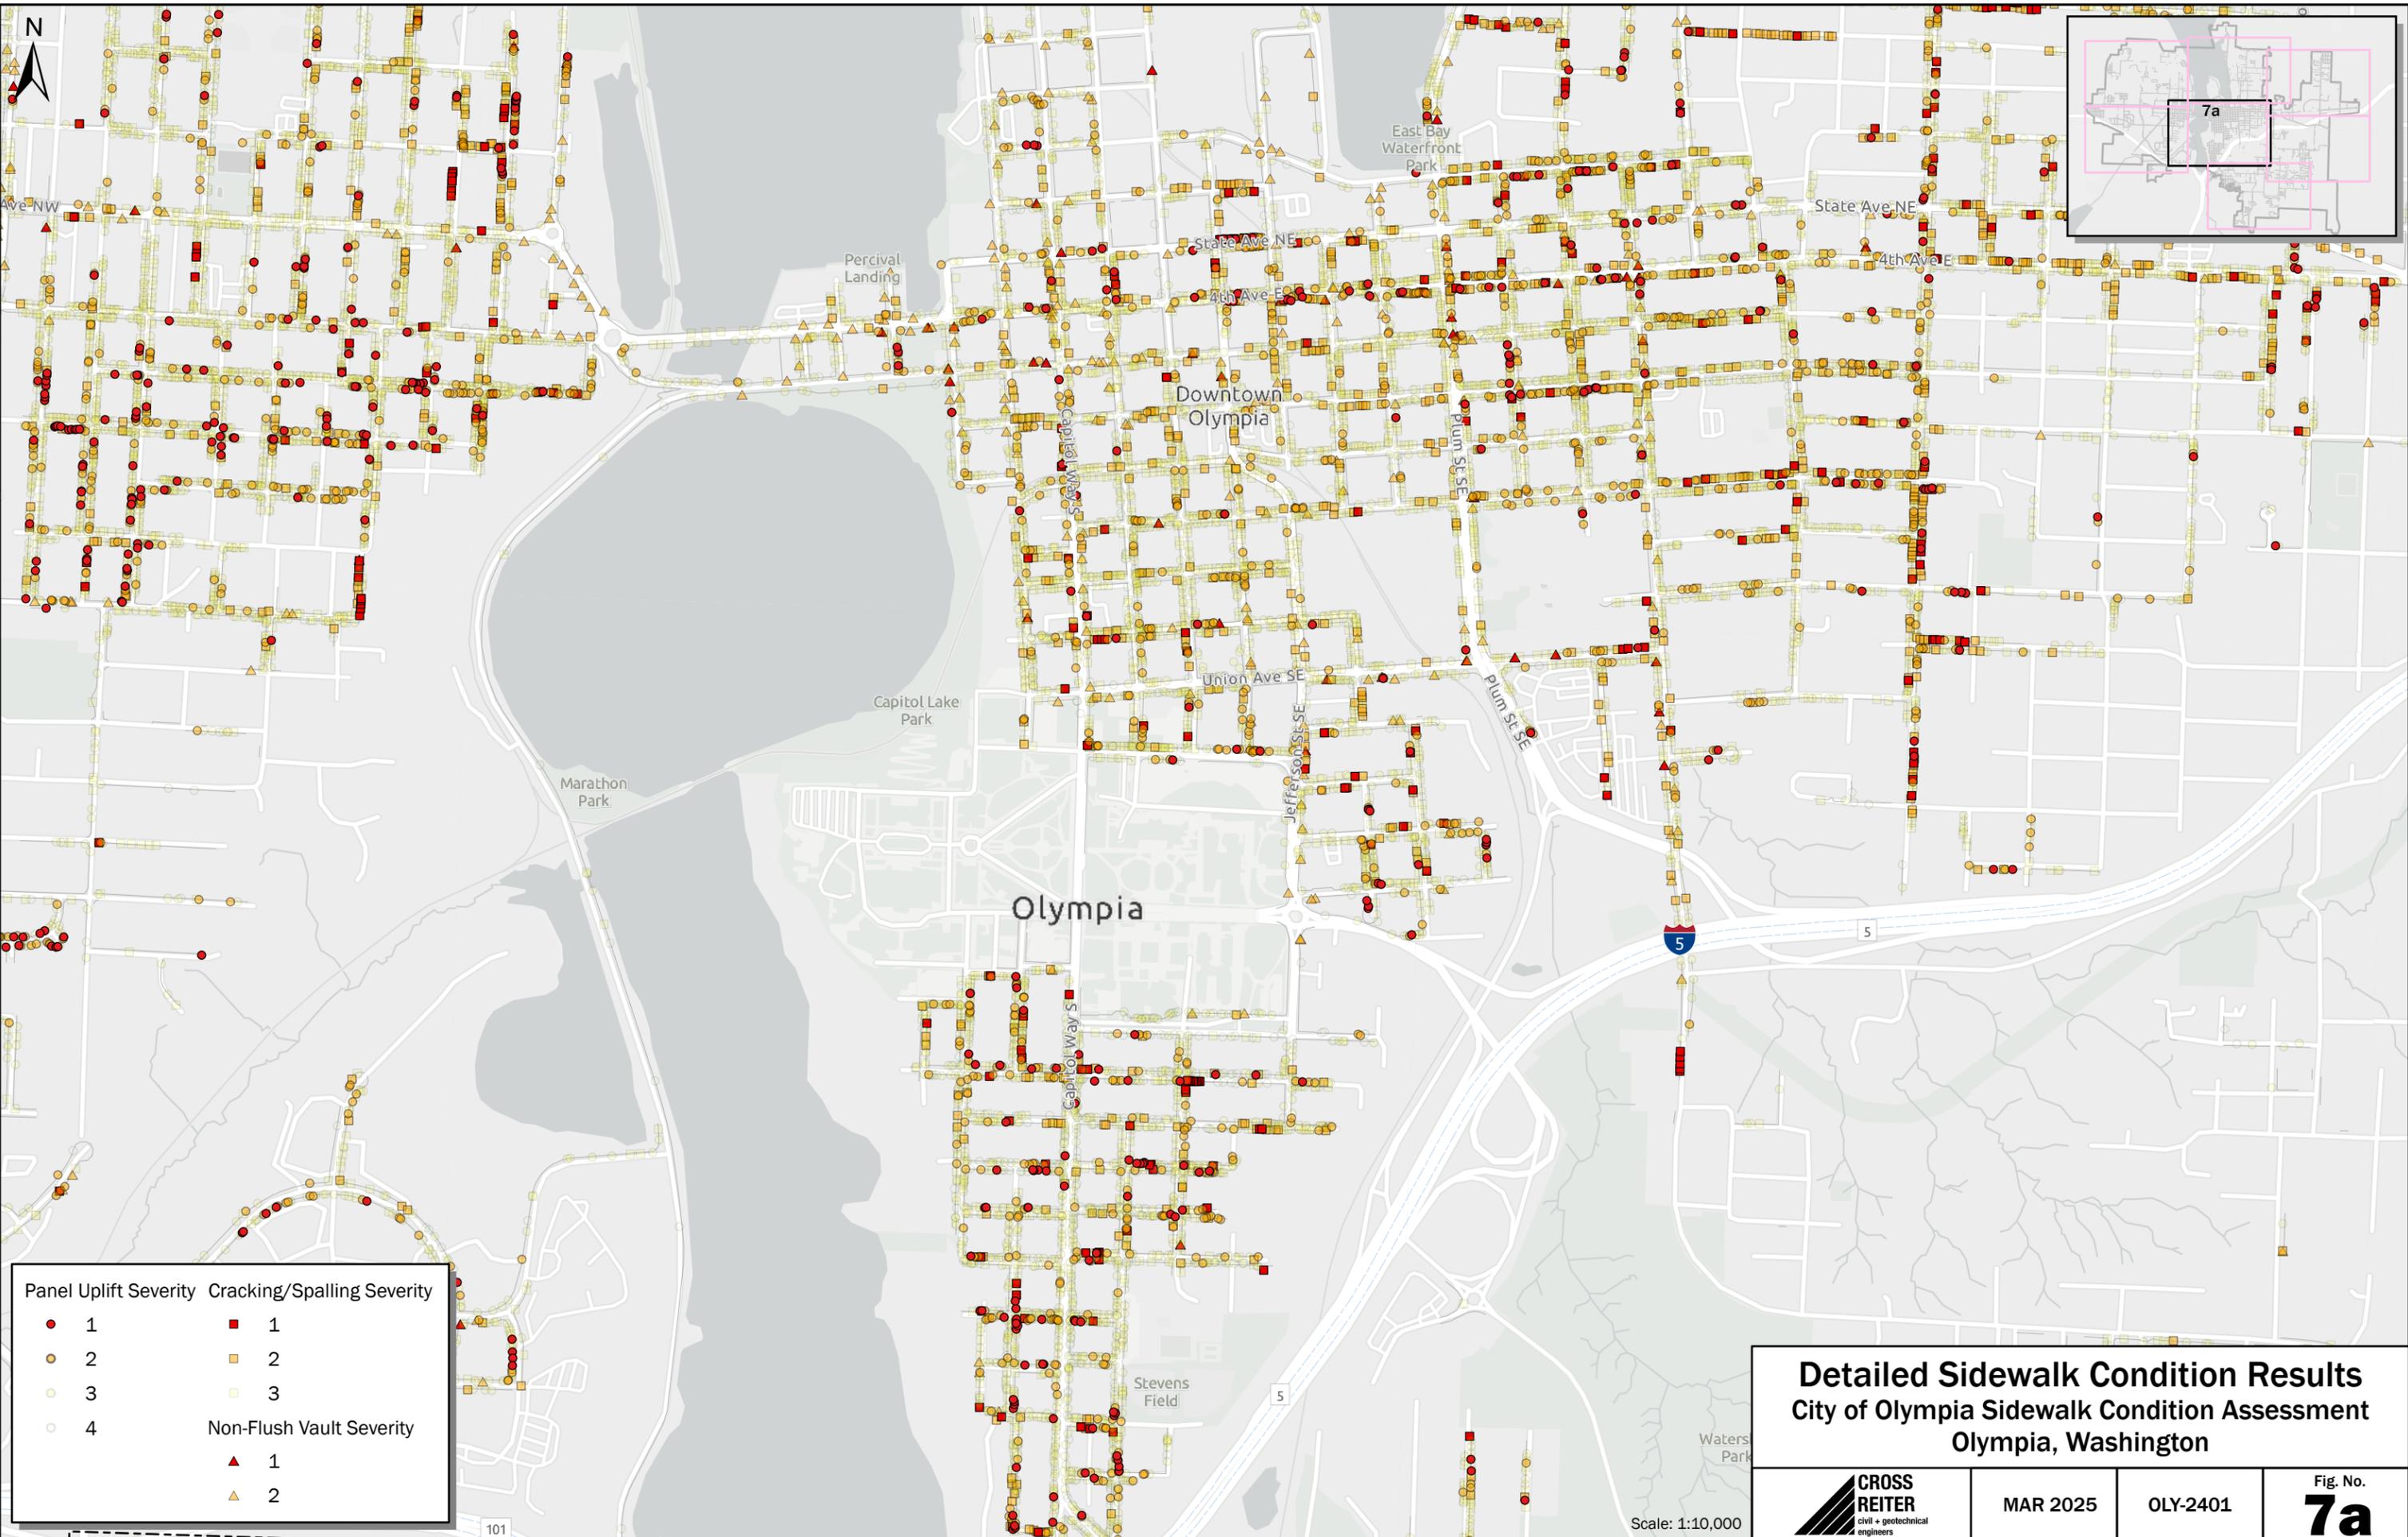
Fig. No.
7a

Details on the location and severity of all points collected under the three damage type categories (1) panel uplift, (2) cracking and/or spalling, and (3) non-flush utility vaults are shown in **Figure 7a** through **Figure 7g**. These points capture the range of concrete distress observed on all sidewalks and comprise nearly 98 percent of the total data collected during this sidewalk condition assessment. It is important to distinguish between each damage type category, because each type of damage has different contributing factors and different maintenance/repair approaches. Each type of damage is described separately below.

Detailed Sidewalk Condition Results
 City of Olympia Sidewalk Condition Assessment
 Olympia, Washington
