Sidewalk Condition Assessment

CITY OF OLYMPIA

Issue Date: March 16, 2025

Cross Reiter Project No. OLY-2401

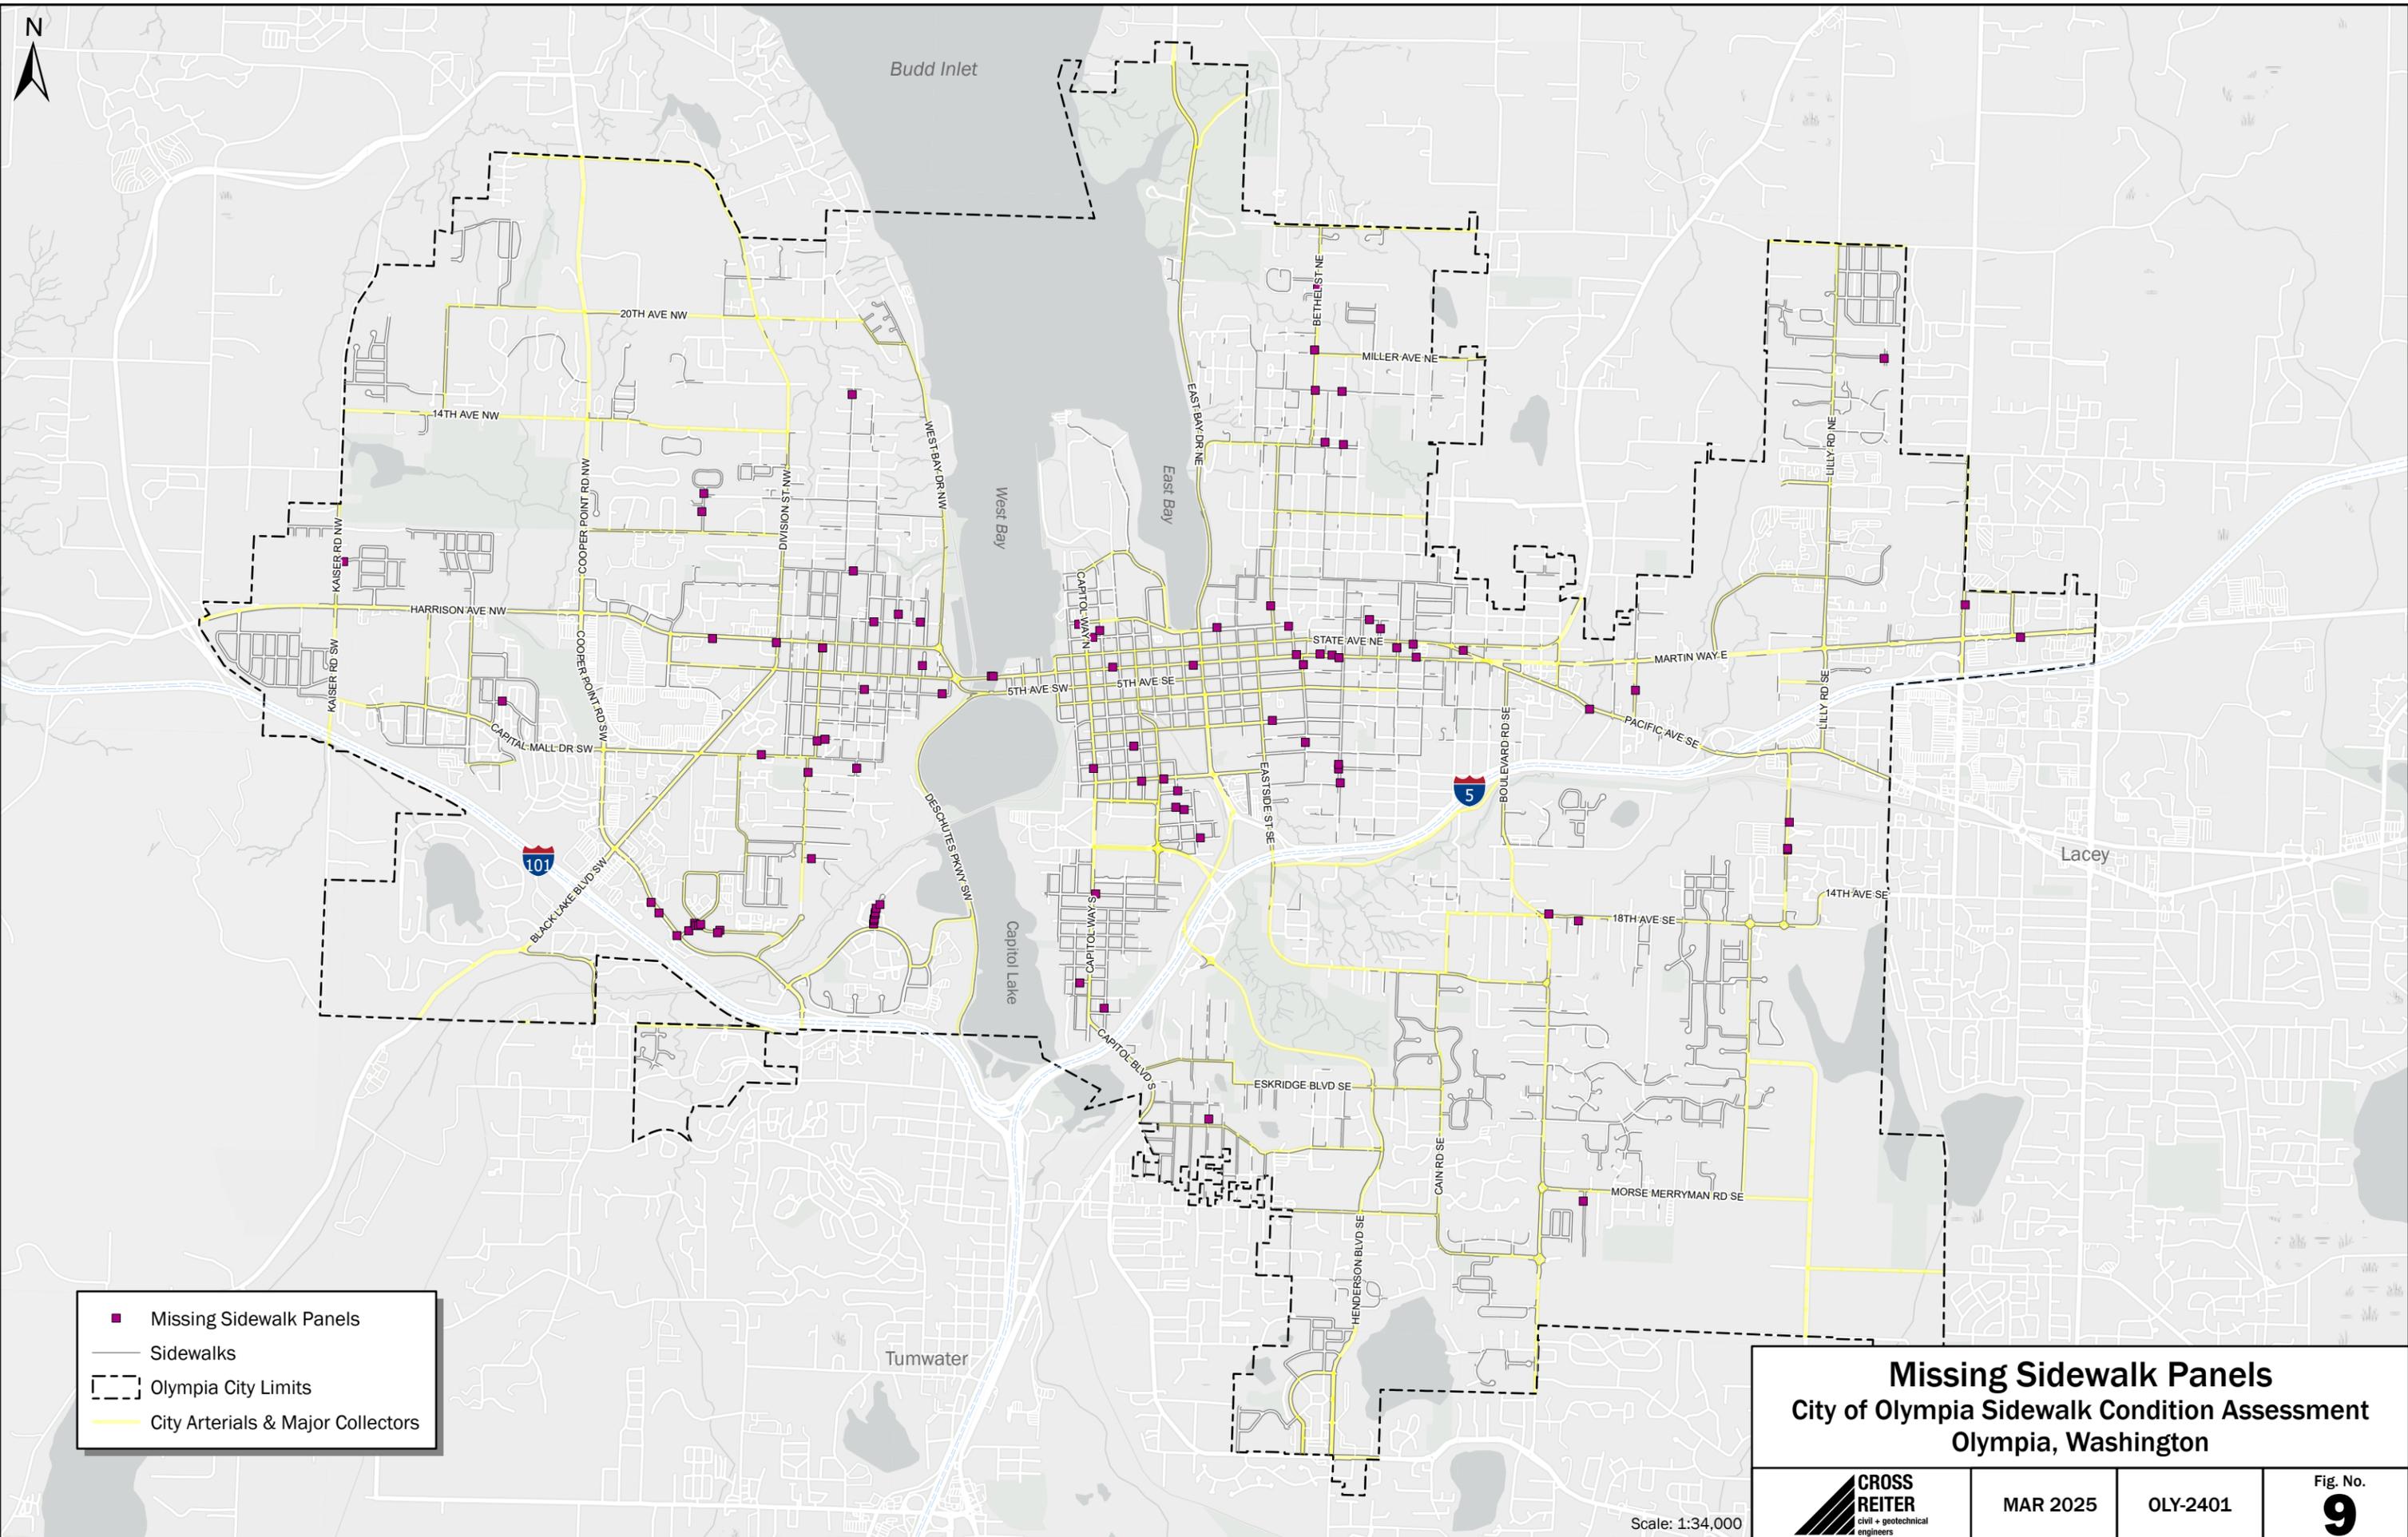
Fig. No. **9**

Cross Reiter identified approximately 94 locations where individual sidewalk panels were missing. Locations of all observed missing sidewalk panels are shown in **Figure 9**. In many cases, missing panels are a result of incomplete repairs or improvements. Representative photographs of typical missing sidewalk panels on sidewalks are shown in **Photographs 6** below.

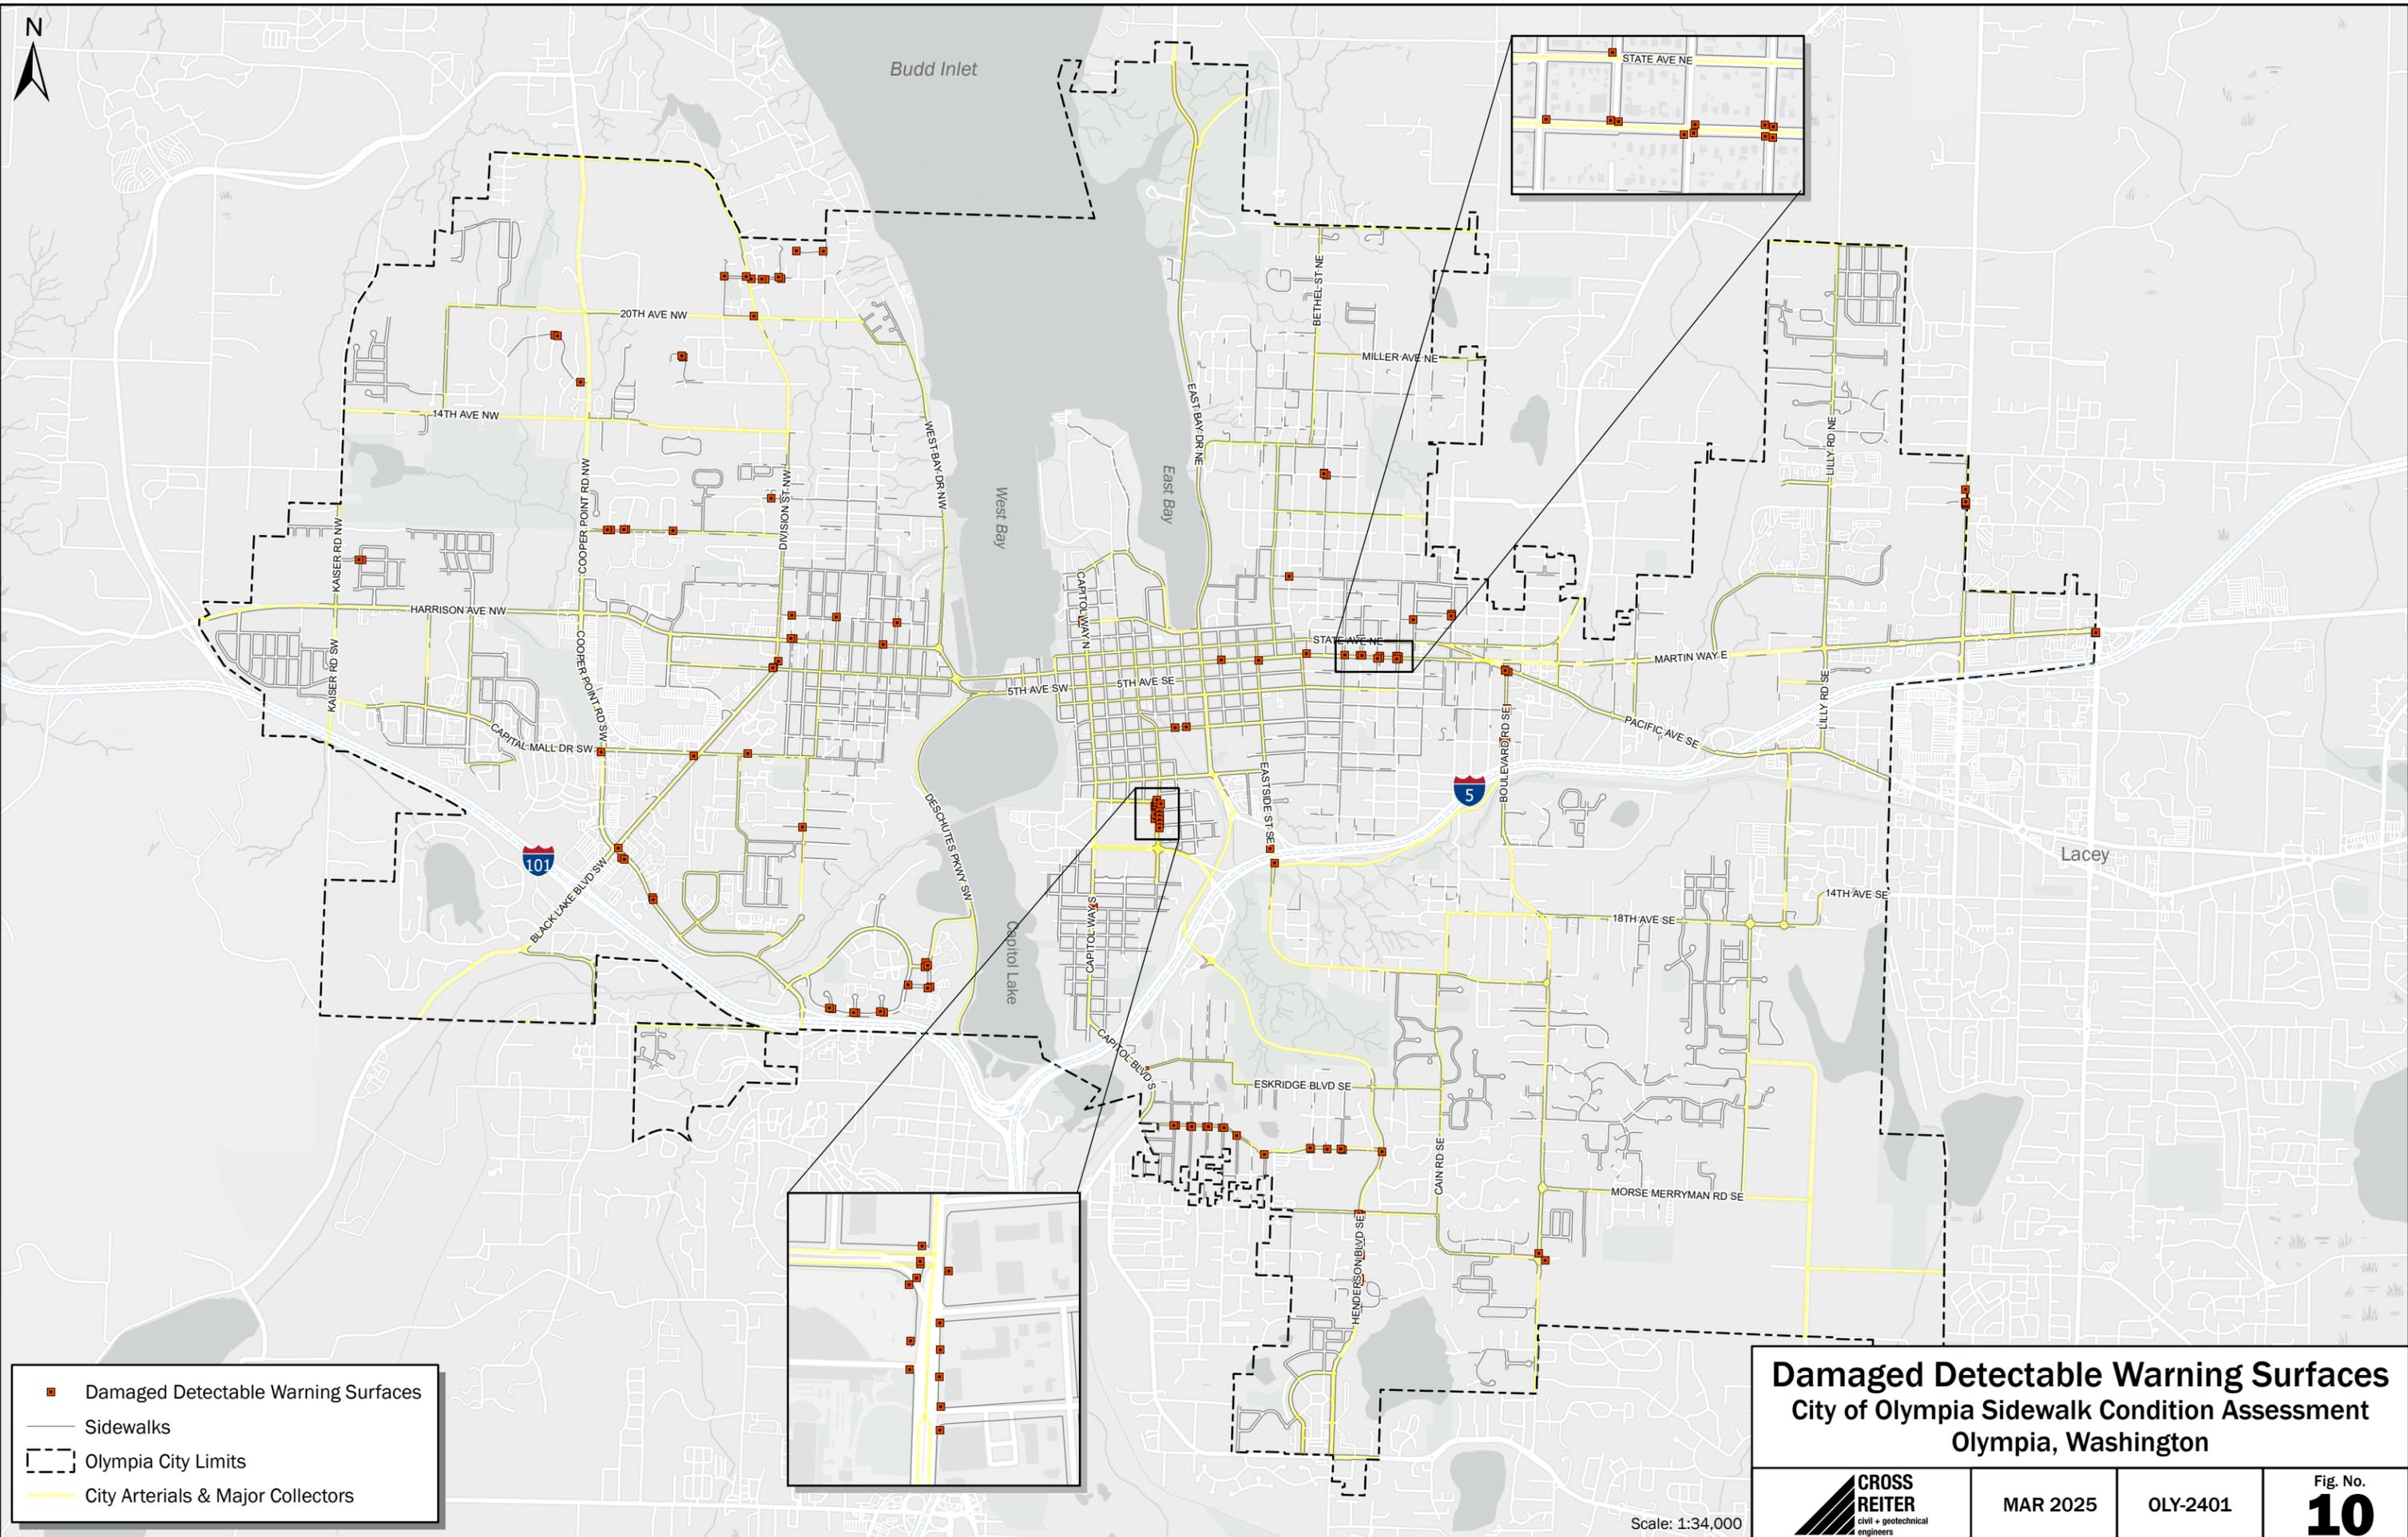
Cross Reiter identified approximately 148 locations where detectable warning surfaces were damaged. These locations are shown on **Figure 10**. Virtually all damaged detectable warning surfaces consisted of the self-adhesive style (i.e., peel-and-stick) that had degraded over time. A few selected arterials and major collectors with a notable quantity of damaged detectable warning surfaces include 4th Avenue E from Fir Street NE to Pear Street NE, Boulevard Road SE south of Pacific Ave SE and north of I-5, Jefferson Street SE between 11th Ave SE and 13th Ave SE, Conger Ave NW from Cooper Point Road NW to Division Street NW, Cooper Point Road SE near Black Lake Boulevard SW, Carlyon Ave SE, and Henderson Boulevard SE south of N Street SE.

Damaged Detectable Warning Surfaces
 City of Olympia Sidewalk Condition Assessment
 Olympia, Washington

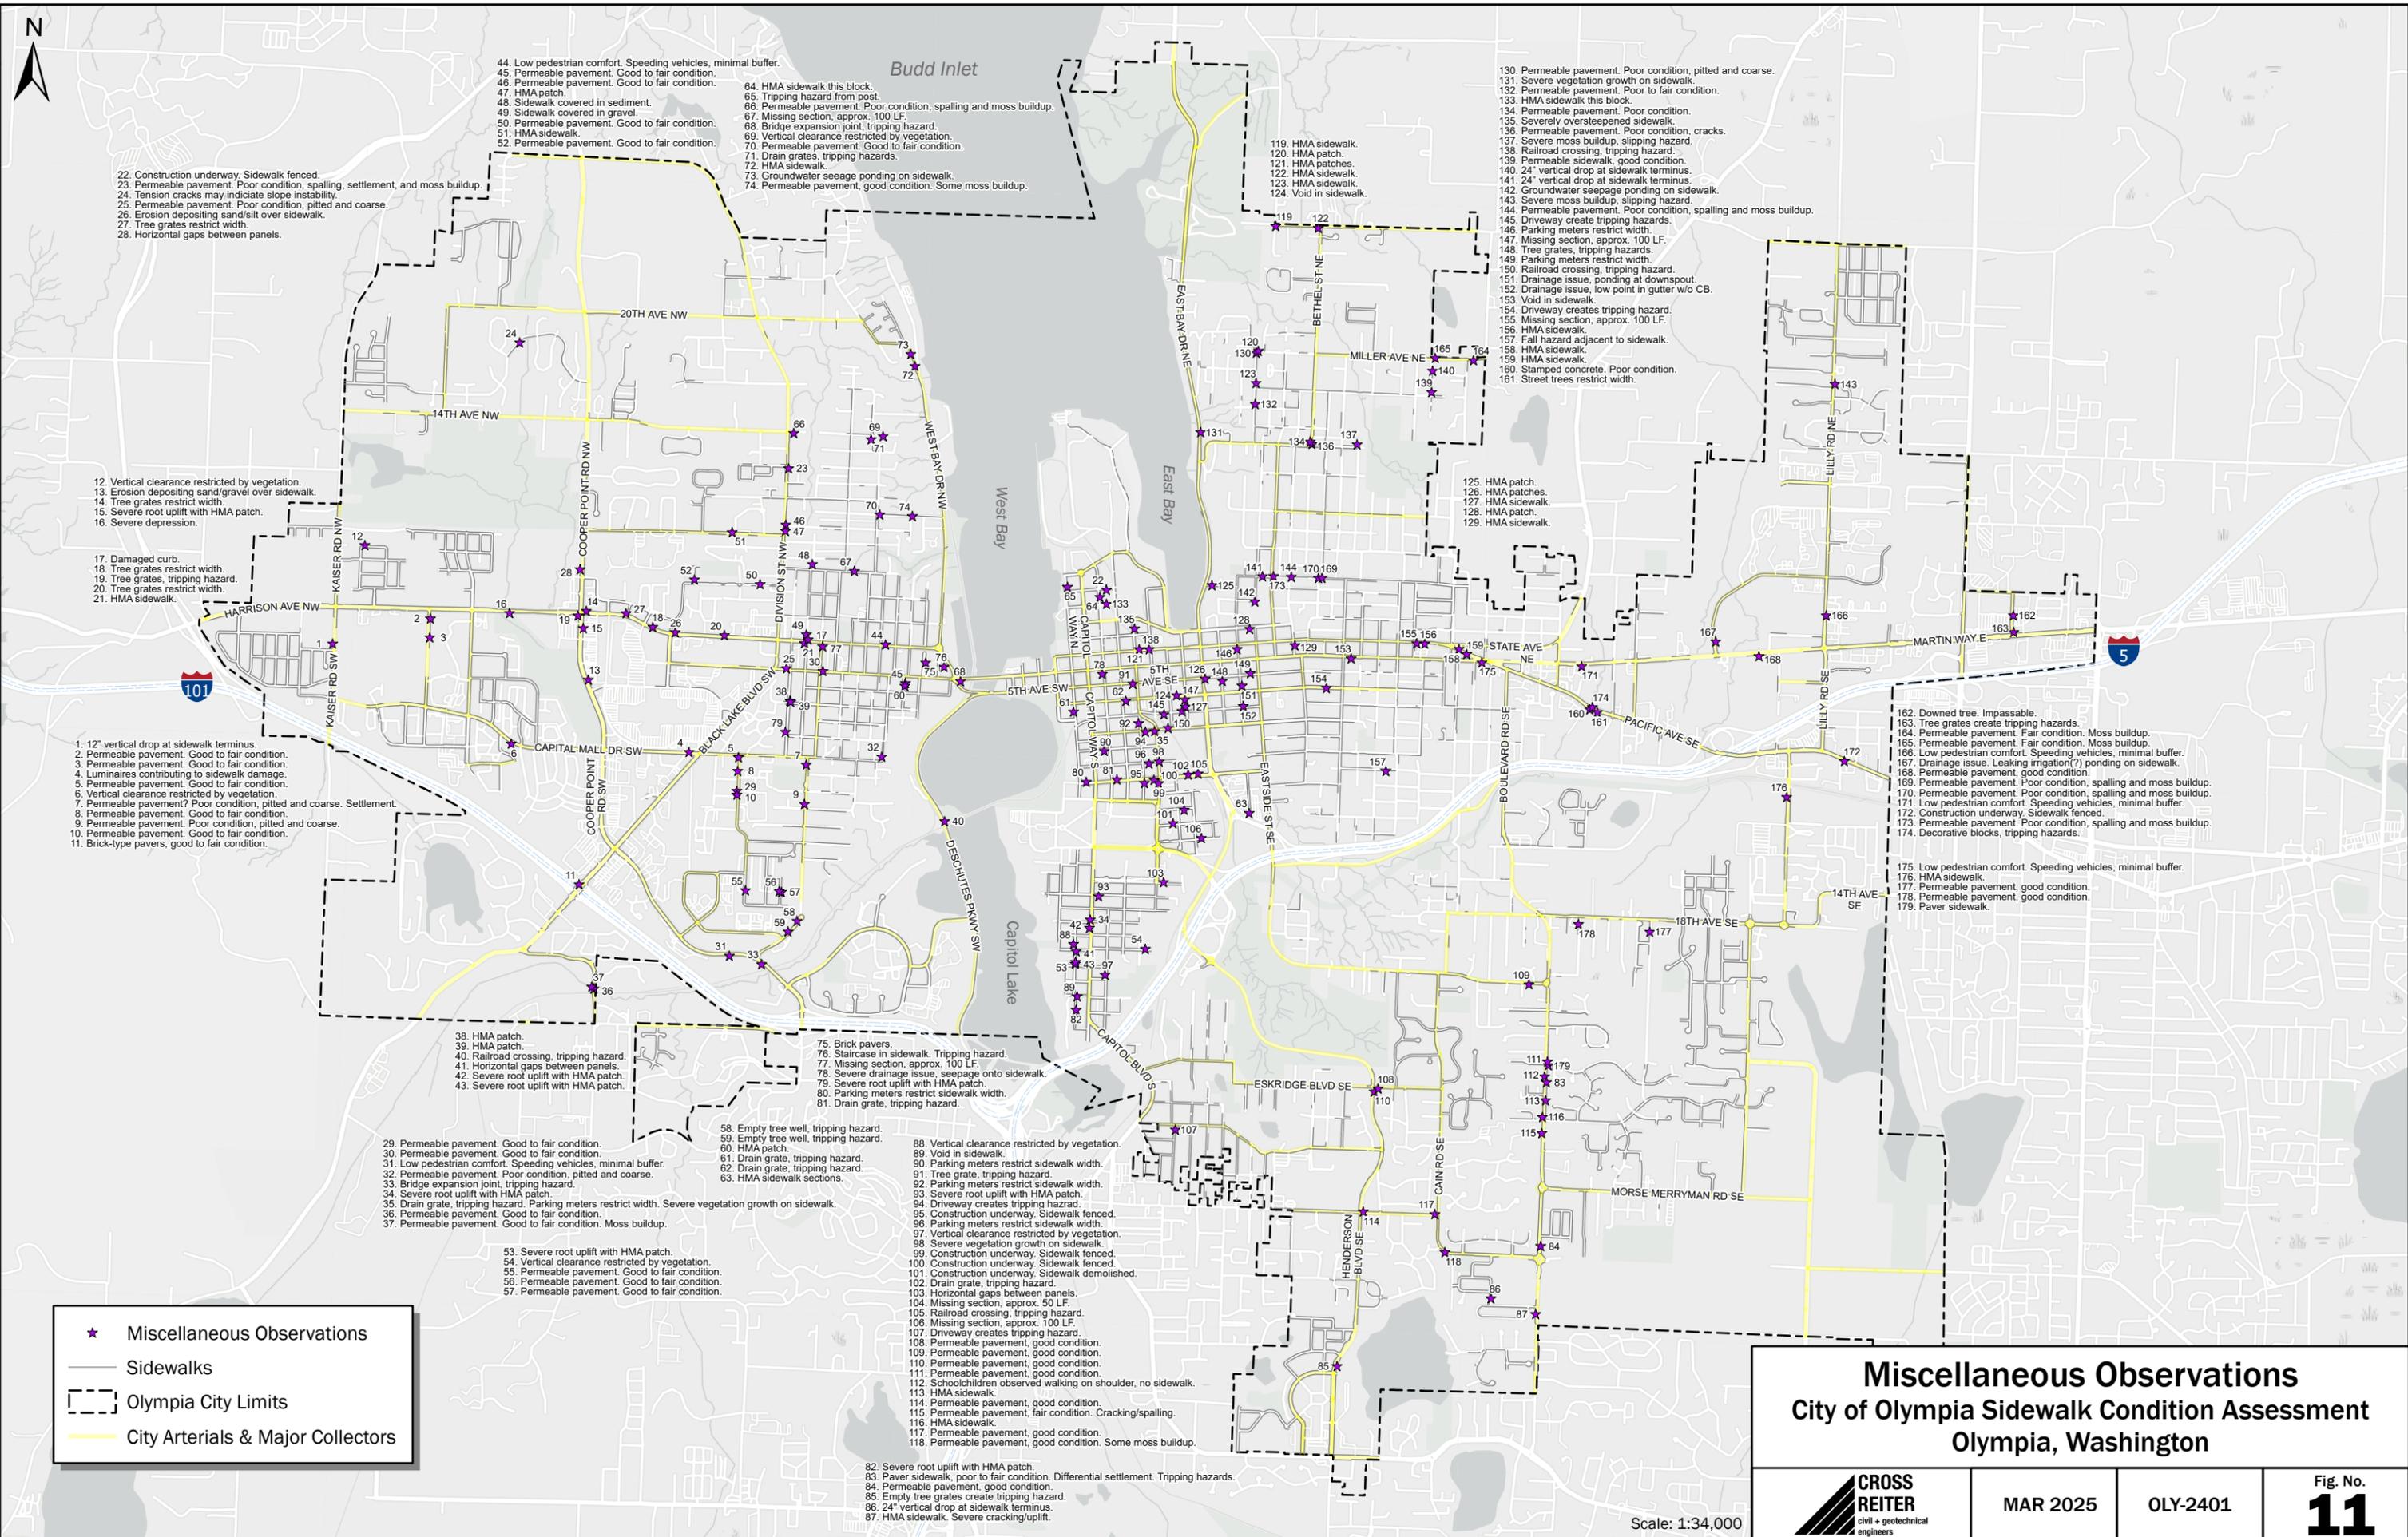
During the course of the fieldwork efforts, Cross Reiter engineers also documented approximately 179 miscellaneous observations related to the City’s sidewalk network. These miscellaneous observations and the corresponding locations are shown on **Figure 11**. The individual observations are diverse, and vary from notes documenting discreet drainage issues, unique tripping hazards, the locations and condition of permeable concrete pavement sidewalks, and overall observations of pedestrian comfort on the City’s sidewalk network.

- 22. Construction underway. Sidewalk fenced.
- 23. Permeable pavement. Poor condition, spalling, settlement, and moss buildup.
- 24. Tension cracks may indicate slope instability.
- 25. Permeable pavement. Poor condition, pitted and coarse.
- 26. Erosion depositing sand/silt over sidewalk.
- 27. Tree grates restrict width.
- 28. Horizontal gaps between panels.

- 12. Vertical clearance restricted by vegetation.
- 13. Erosion depositing sand/gravel over sidewalk.
- 14. Tree grates restrict width.
- 15. Severe root uplift with HMA patch.
- 16. Severe depression.

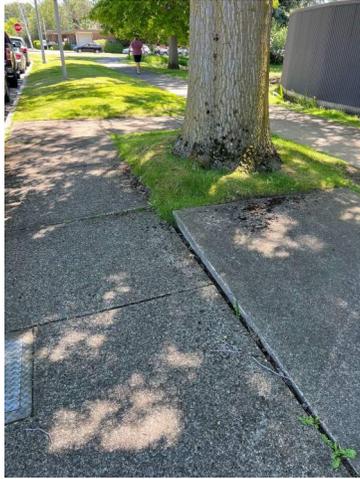
Severity 1

Panel Uplift

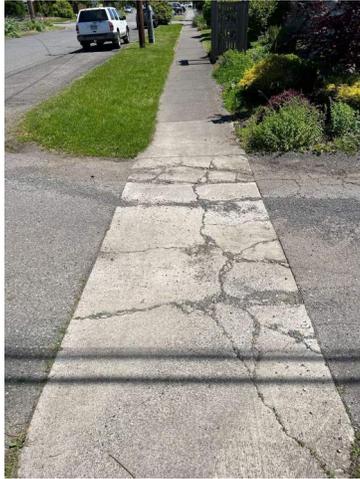
Severity 1

Cracking and/or Spalling

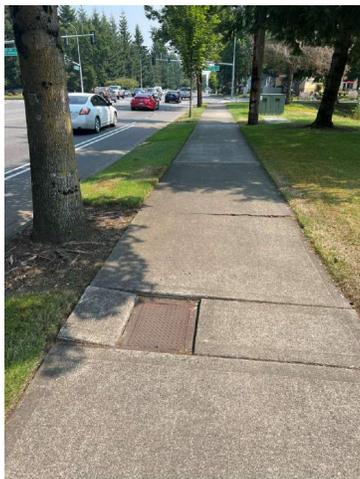
Severity 1

- **Non-Flush Utility Vaults:** Utility vaults or subsurface structures (e.g., junction boxes, manholes) that are not flush with the sidewalk surface, caused primarily by construction defects or differential settlement. Assessed on a scale of 1 (most severe) to 2 (least severe).

Non-Flush Utility Vault

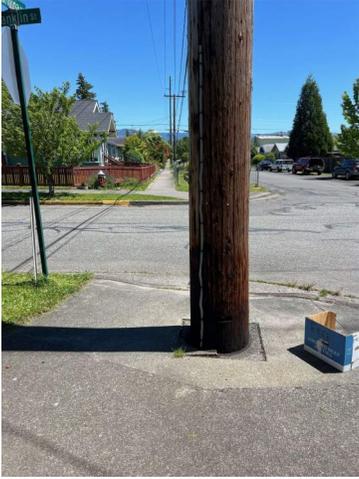
| <p>Width Restriction</p> | | | - |
| | <p>Permanent</p> | <p>Temporary</p> | - |

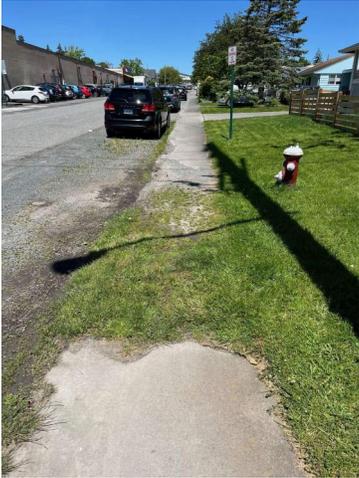
| <p>Missing Panel</p> | | - | - |

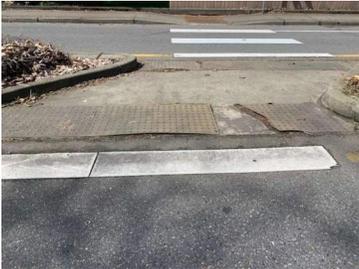
| <p>Missing Panel</p> | | - | - |
| | - | - | - |
| <p>Truncated Dome Types</p> | | | |
| | <p>"Peel-and-Stick"</p> | <p>"Set-in-Place"</p> | <p>"Anchored"</p> |
