Firefighting and Exterior Insulation Finishing Systems

01/29/2015

By Ronald R. Spadafora

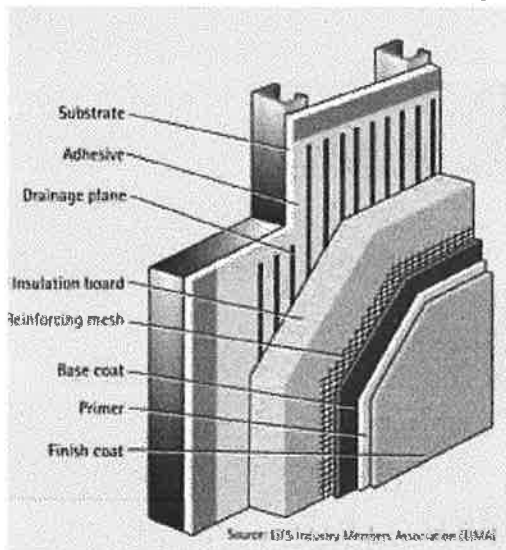
Figure 1. Exterior Insulation Finishing System (EIFS)

A typical EIFS composition, starting from the wall studs, consists of a plywood or oriented strand board (OSB or particleboard) substrate. Adhesive or mechanical fasteners attach the substrate to rigid polystyrene foam insulation. A reinforcing fiberglass mesh is next, followed by a base coat that is applied to the insulation through the mesh. Finally, a finish coat is applied. In the past, Portland cement was the coating; now, polymer-based (PB) or polymer-modified (PM) synthetic materials are used (Figure 1).

An EIFS system using a $\frac{1}{16}$ -inch thick, reinforced PB coating applied to polystyrene insulation before the finish coat is applied is the most common type. The PM system has a nominally $\frac{3}{16}$ -inch- to $\frac{1}{2}$ -inch-thick reinforced base coat applied to the polystyrene insulation before the finish coat is applied.

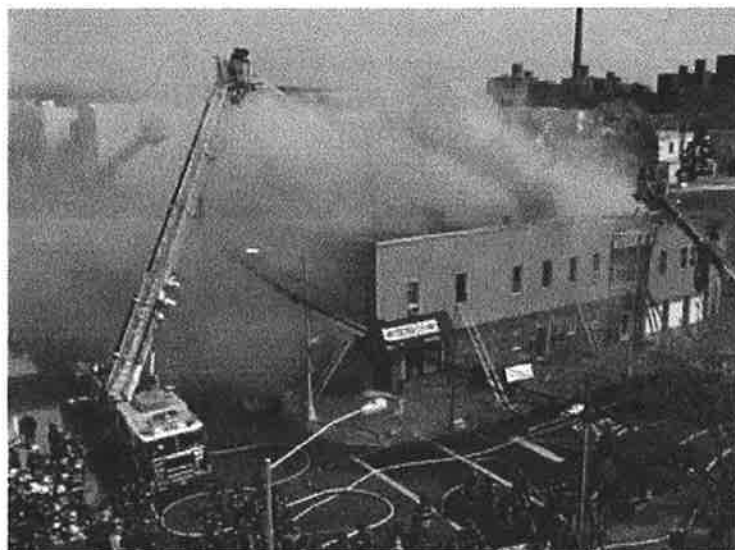
(1) At the four-alarm fire in the Bronx, the original fire building was a 150-year old, three-story balloon-frame (Type V) structure. The corner building was clad with EIFS. (Photos 1-2 by Olaf Huth.)

While on duty as the command chief for the Fire Department of New York (FDNY), I responded to an early afternoon fire in April 2012 in the Bronx on Van Nest Avenue. Extinguishment ultimately required multiple alarms and approximately 200 firefighters in many buildings. First-arriving units encountered a large exterior fire in an alley between two three-story, wood-frame (Type V) buildings. Fire quickly spread to both structures and eventually extended to a two-story ordinary (Type III) building that was fully clad with EIFS.

Combined with the asphalt material underneath (never removed), the EIFS contributed to rapid fire spread. When the fire caught hold of the exterior wall, the building quickly became involved, leading to the transmission of a fourth alarm.

Firefighters performing operations on the top floor inside the EIFS building were seriously threatened by the neighboring fire since it literally melted the exterior walls. Fire and dense black smoke entered the second floor, rapidly creating an untenable condition. I ordered all members out of the building by radio and instructed the safety battalion chief to personally go to the floor to ensure compliance (photos 1-2).

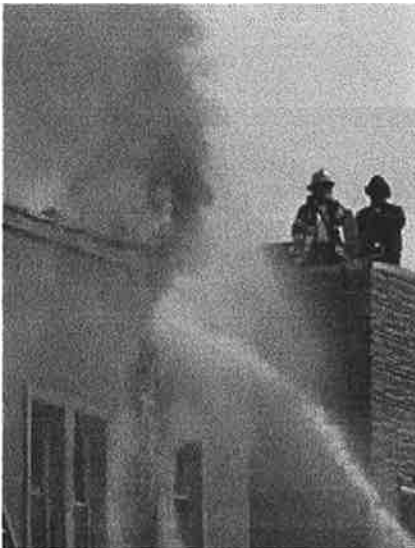
(2) Flames burn vigorously above the roof line of the EIFS-clad structure, causing untenable heat and smoke conditions inside the building.

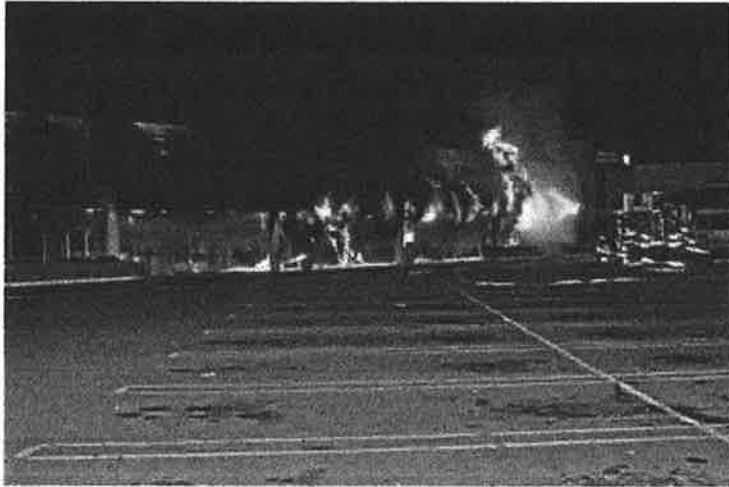
(3) In Queens, FDNY units responded to a store fire, one of eight mercantile occupancies located within a minimall of noncombustible (Type II) construction (*Photos 3-5 by Fred Bacchi*).

In the early morning hours of November 2, 2008, in Queens, FDNY units responded to a store fire, one of eight mercantile occupancies within a minimall of noncombustible (Type II) construction. The one-story commercial building was 250 feet long and 100 feet deep. The heat from the fire broke the glass storefront windows before firefighters could apply water. The fire autoexposed to the exterior front wall and a 10-foot-deep overhang that projected out from the building along its full length. The wall and overhang were clad with EIFS. The fire intensified and spread across the building's entire frontage.

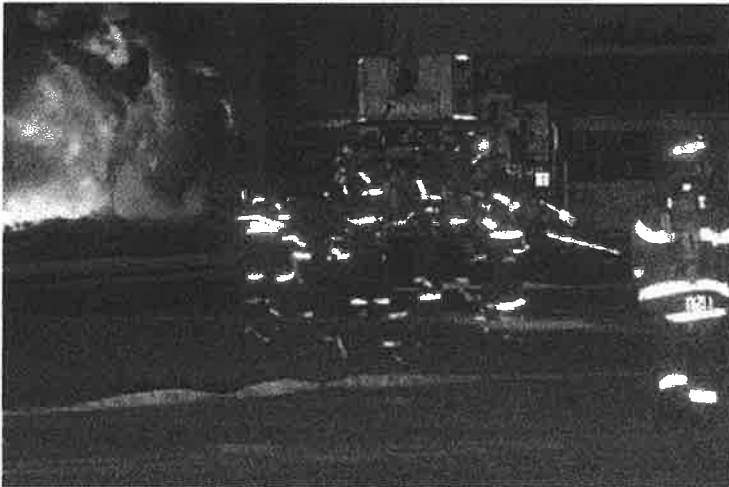
(4) The walls and front overhang were clad with EIFS. At the Queens minimall fire, flames filled the overhang and extended above the parapet. Firefighting operations (forcible entry, search and rescue, hoseline interior attack, roof ventilation, and ladder placement) were suspended until outside streams were started.

Flaming liquefied EPS rained down on firefighters trying to enter the building. Flames filled the overhang and extended above the parapet. Firefighting operations (forcible entry, search and rescue, hoseline interior attack, roof ventilation and ladder placement) were suspended until outside streams were started. In addition, the structural engineers needed to inspect the building's load-bearing elements to determine stability. A two-alarm assignment was required to bring this fire under control (photos 3-5).

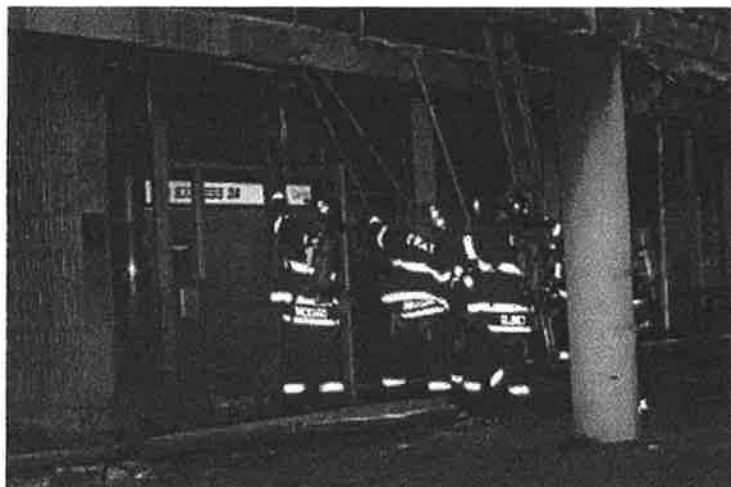
(5) Extensive overhaul operations were required at the Queens multiple-alarm fire involving the overhang area clad in EIFS.

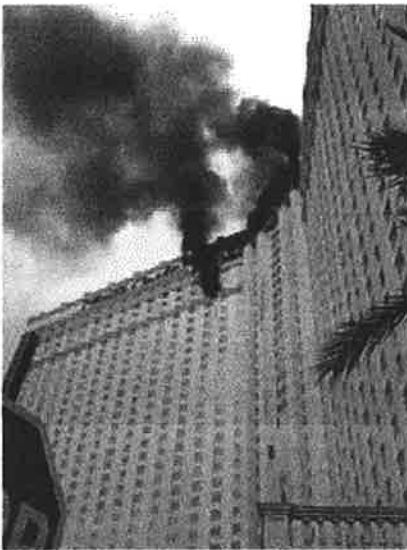
(6) The Monte Carlo Hotel fire involved EIFS installed on the exterior of the building. (*Photo by Dave Connell.*)

On the morning of January 25, 2008, in Las Vegas, Nevada, a fire occurred at the Monte Carlo Hotel & Casino, a 32-story, fire resistive construction (Type 1) building. The fire, apparently started by workers on the roof area, spread over the upper portions of the south and west tower walls, which were clad in EIFS. Wind helped to spread the fire laterally over the exterior wall surfaces for approximately 170 feet! Flaming droplets or pieces of decorative polystyrene foam insulation ignited the façade materials on the horizontal cornice between the 28th and the 29th floors. Samples of the exterior façade taken from the fire area for laboratory qualitative analysis revealed that the EIFS did not have the correct thickness of lamina (finish coat, base coat, and reinforcing mesh). Additionally, large components not covered with EIFS lamina, containing significant thicknesses of polystyrene foam, were installed on the claddings.

At the incident, fire department officials ordered media helicopters to stay clear of the hotel; they were worried that the turbulence from the blades would fan the flames and further spread the fire. Firefighters took elevators to within two and four floors of the fire and carried their folded hose lengths the last two and four floors to the roof. Not all of the fire area could be reached by hose streams from the roof. Guest room windows were deliberately broken to get a better vantage point. Firefighters on the nozzle, leaning precariously out of windows, were kept safe by fellow members and webbing. For more than an hour, the fire continued to spread both horizontally and vertically across the exterior cladding until it was finally brought under control (photo 6).
