Title of Report: Cultural Resource Assessment for the Views on 5th Development
Project Olympia, Thurston County, Washington

**Cultural Resource Assessment
for the
Views on 5th Development Project
Olympia, Thurston County, Washington**

Report # TH-02-17
DAHP Project Tracking Code: 2017-07-05018

September 29, 2017

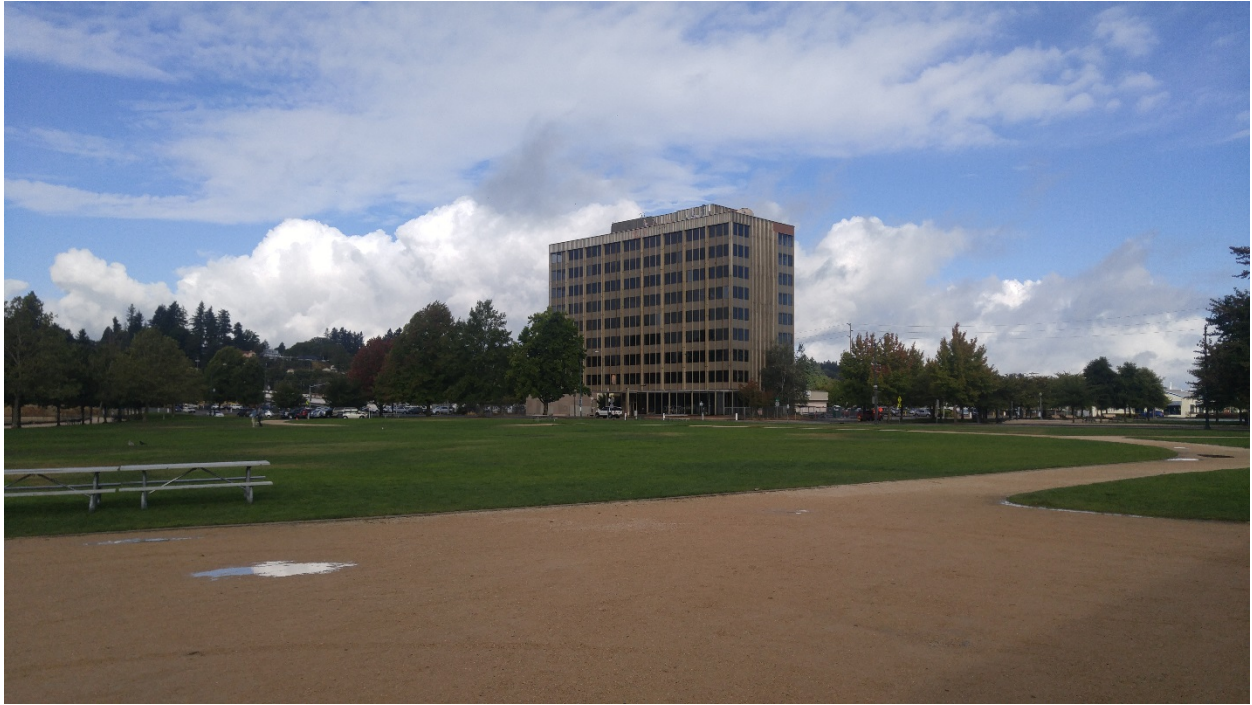
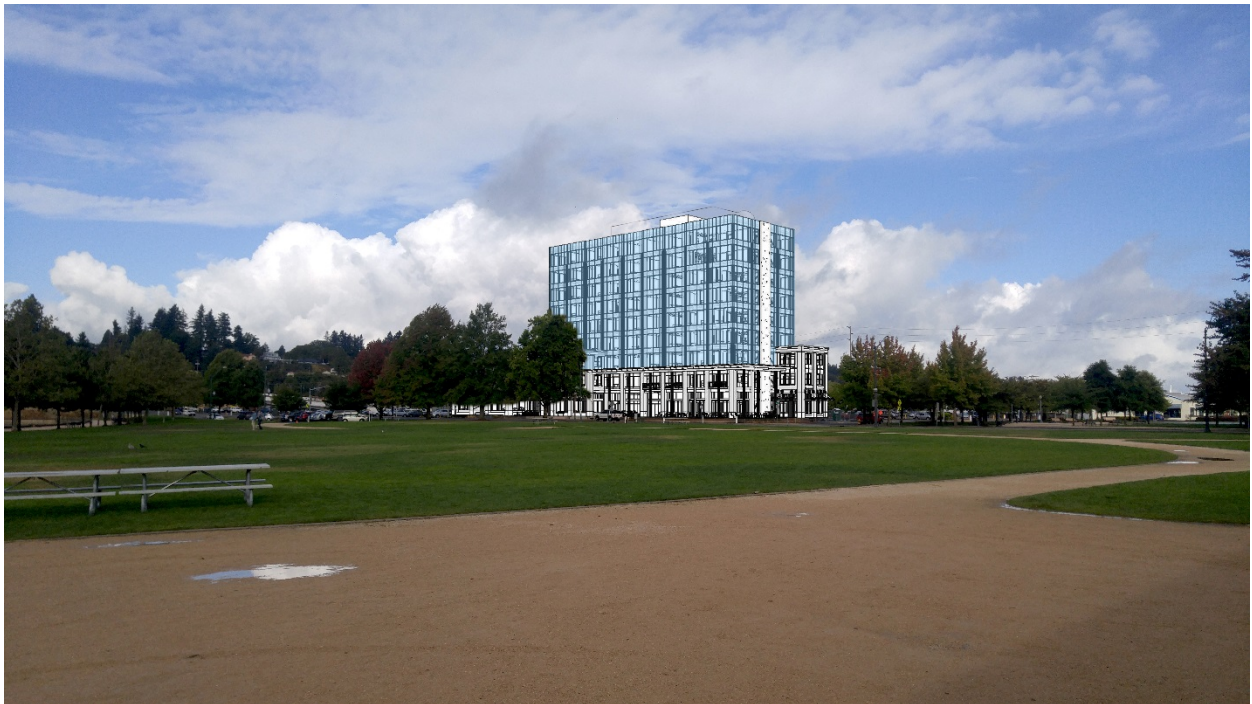
VIEW 1: View from Capitol Lake Bath House.

The existing view impact on the skyline is reduced with the removal of a large portion of the existing mechanical room on the roof.

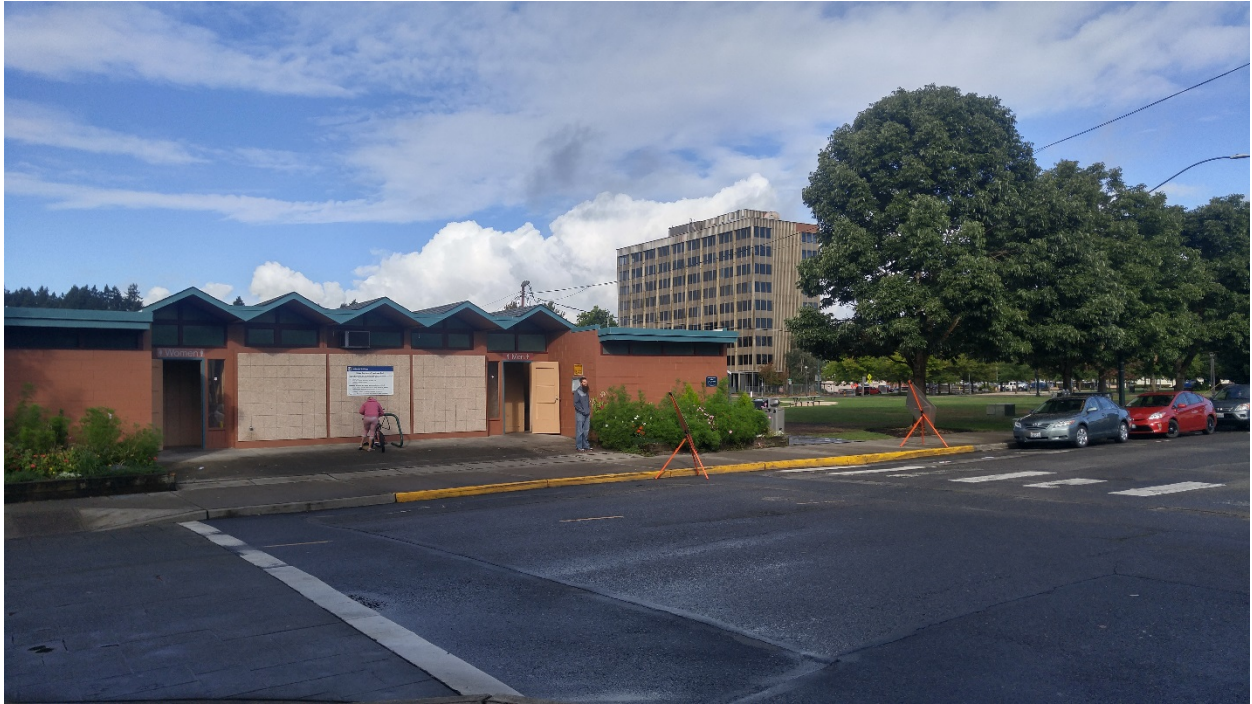
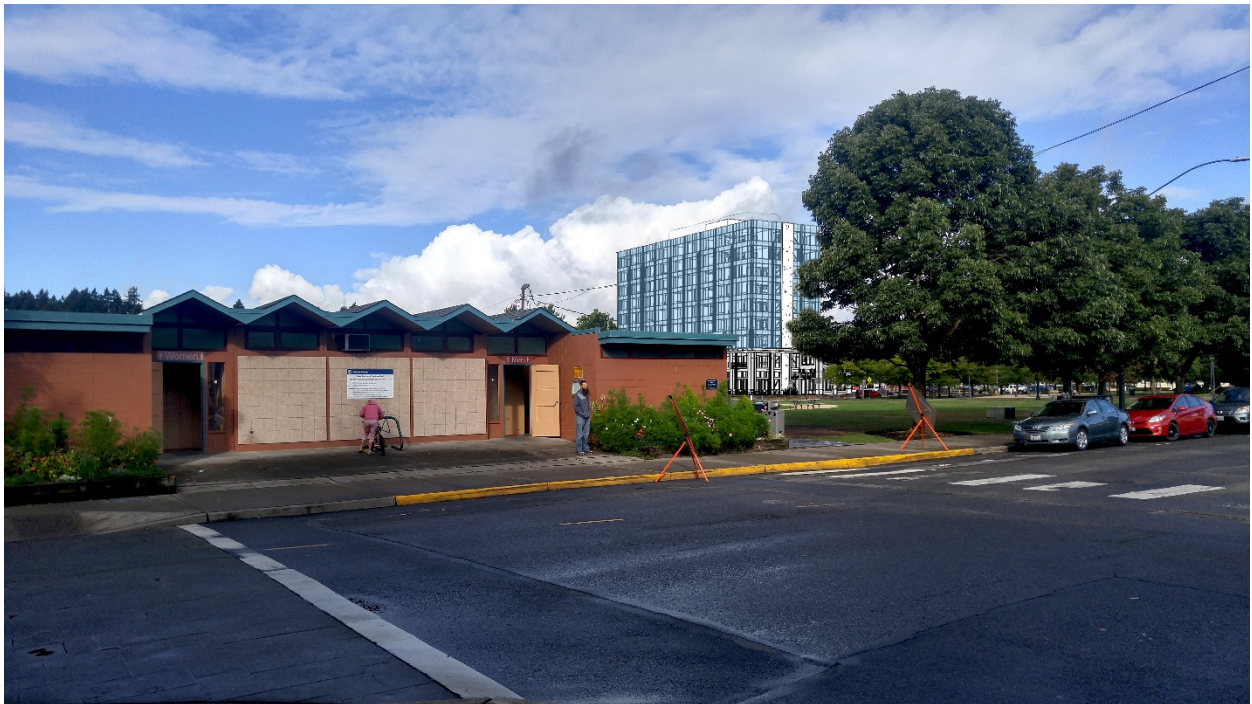
VIEW 2: View from the American Legion Hall.

The existing view impact on the skyline is reduced with the removal of a large portion of the existing mechanical room on the roof.

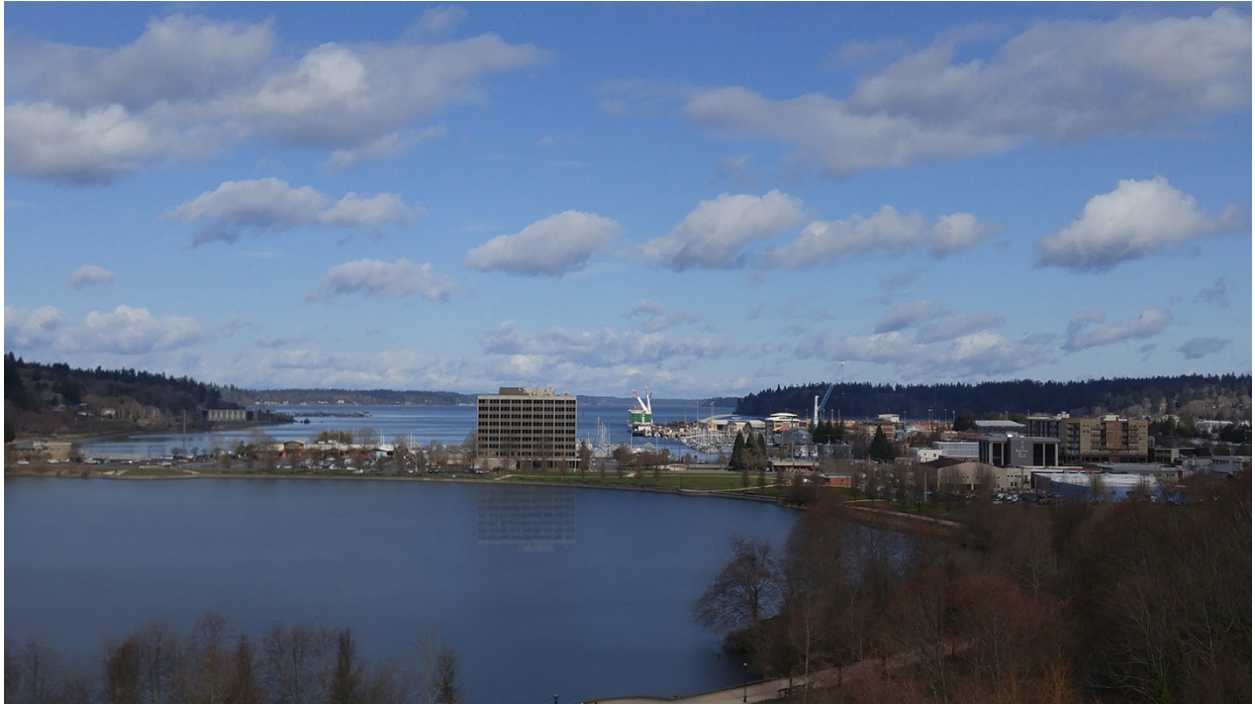
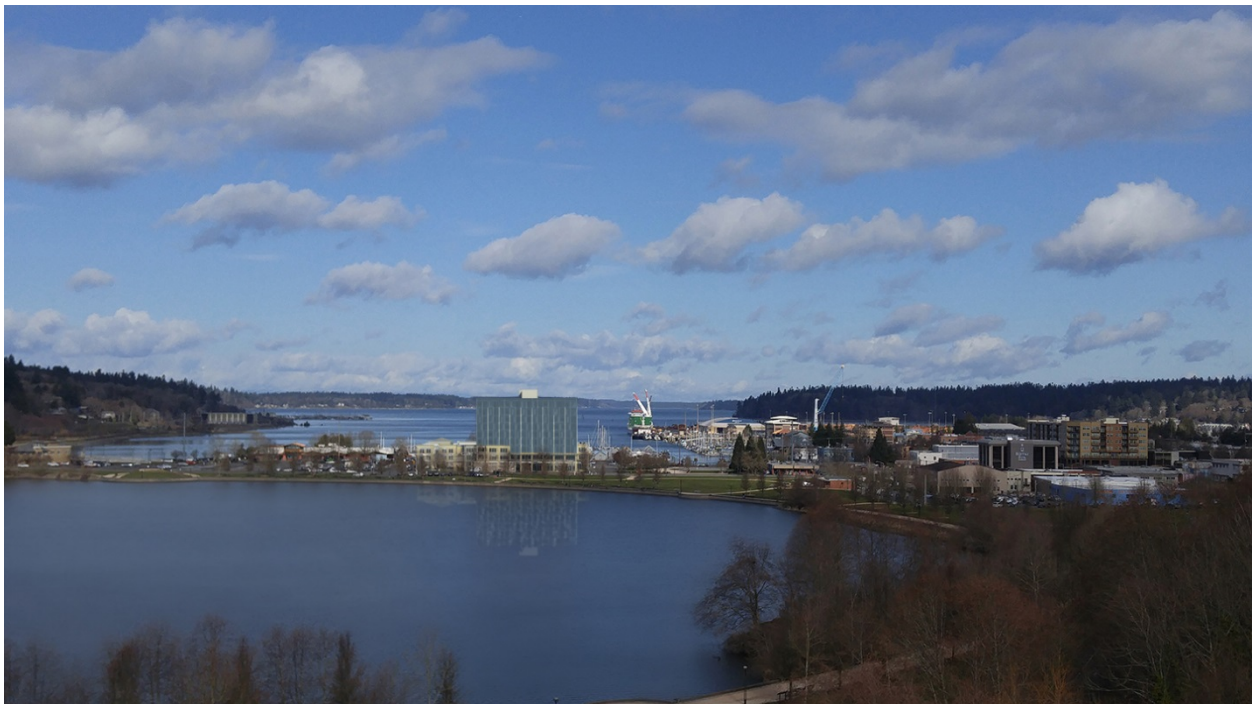
VIEW 6: View from the Capitol Hill.

The existing view is unchanged with the project. The new curtain wall façade on the tower structure will include a glazing system to help reflect the natural settings and further blend the existing tower with the water and sky.
