Technical Memorandum

TO: Brandon Smith, Milestone Companies West Bay Development Group, LLC
FROM: Daniel Simpson, PE, and Calvin McCaughan, PE
DATE: August 27, 2020
RE: **Preliminary Geotechnical Engineering Recommendations
West Bay Yards
Olympia, Washington
Project No. 1912001.010.011**

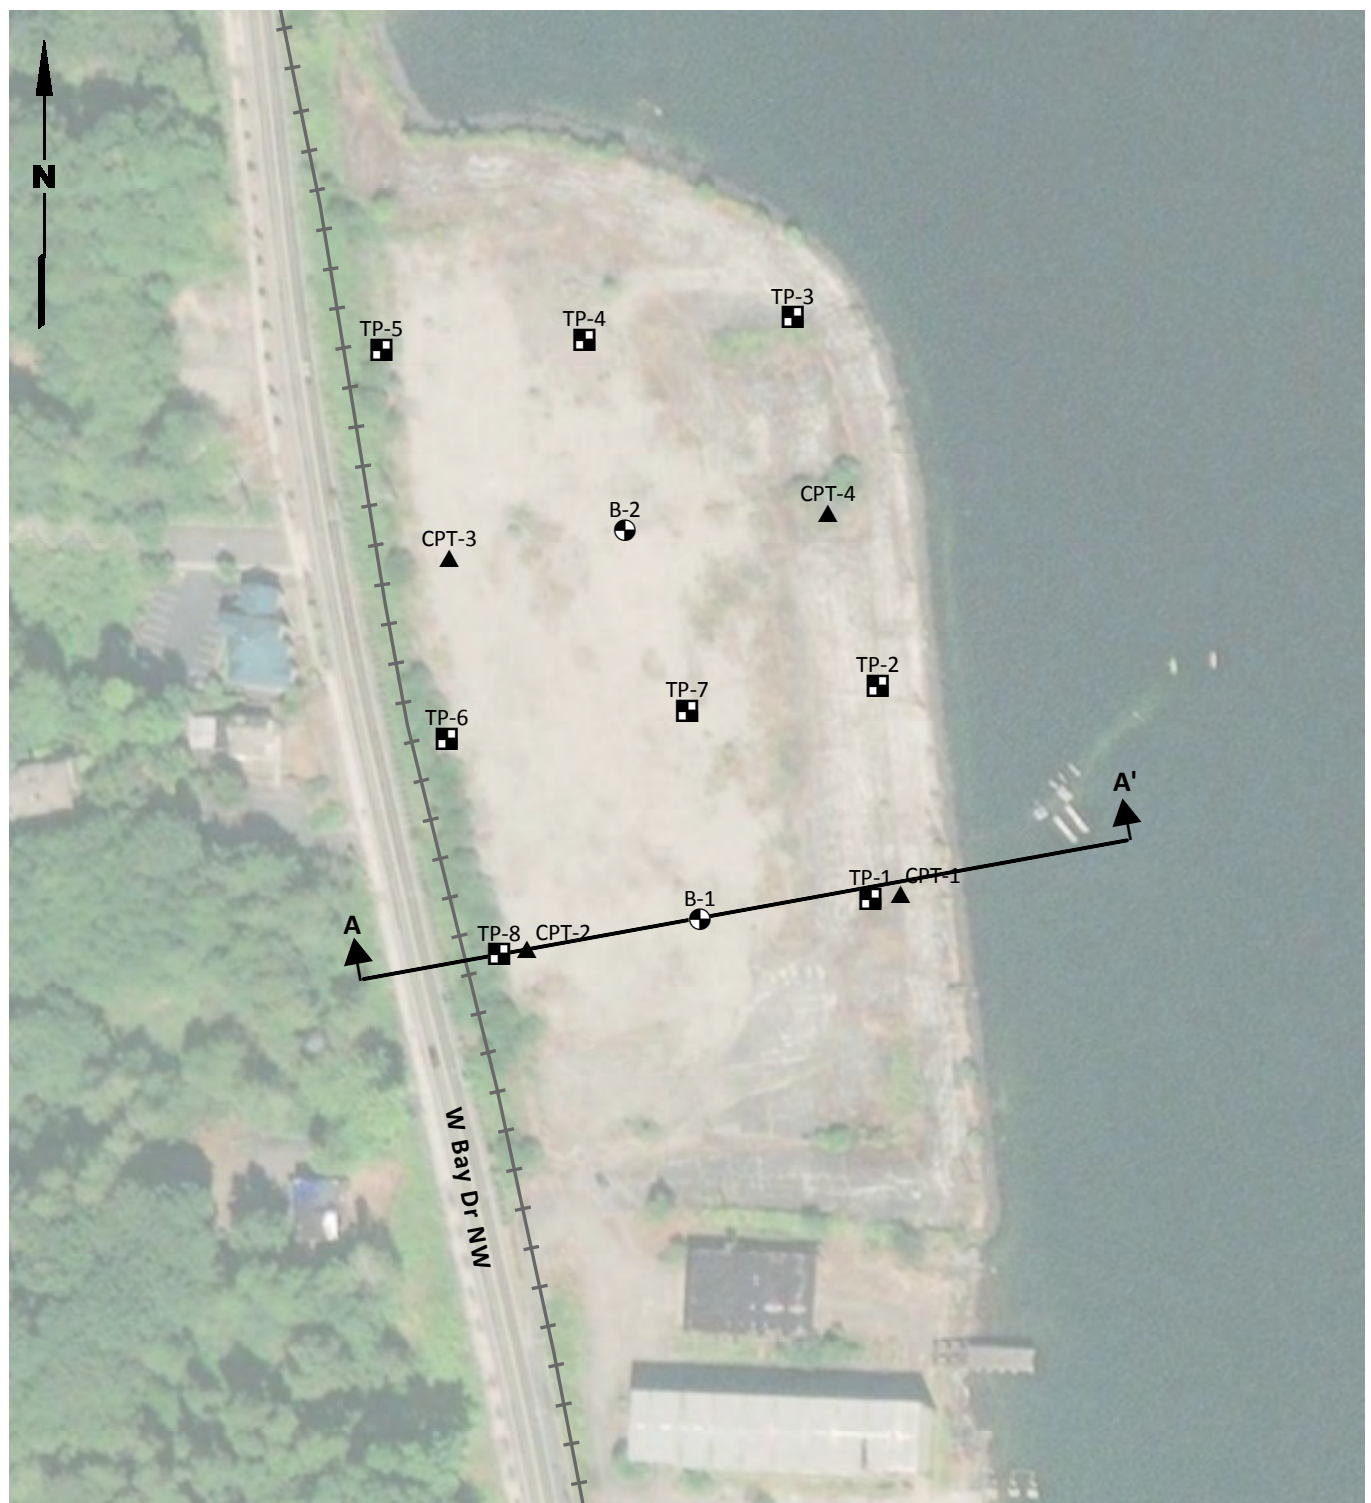
Figure
2

Site and Exploration Plan

LAI explored site subsurface conditions on May 4 through May 6, 2020 by advancing eight test pits, two hollow-stem auger borings, and four cone penetration tests (CPTs). The approximate locations of

the explorations are shown on Figure 2. Representative soil samples were collected from the explorations and transported to LAI's soils laboratory for further examination and testing. Details about the field explorations are included in Attachment 1; details about the geotechnical laboratory testing program are included in Attachment 2.

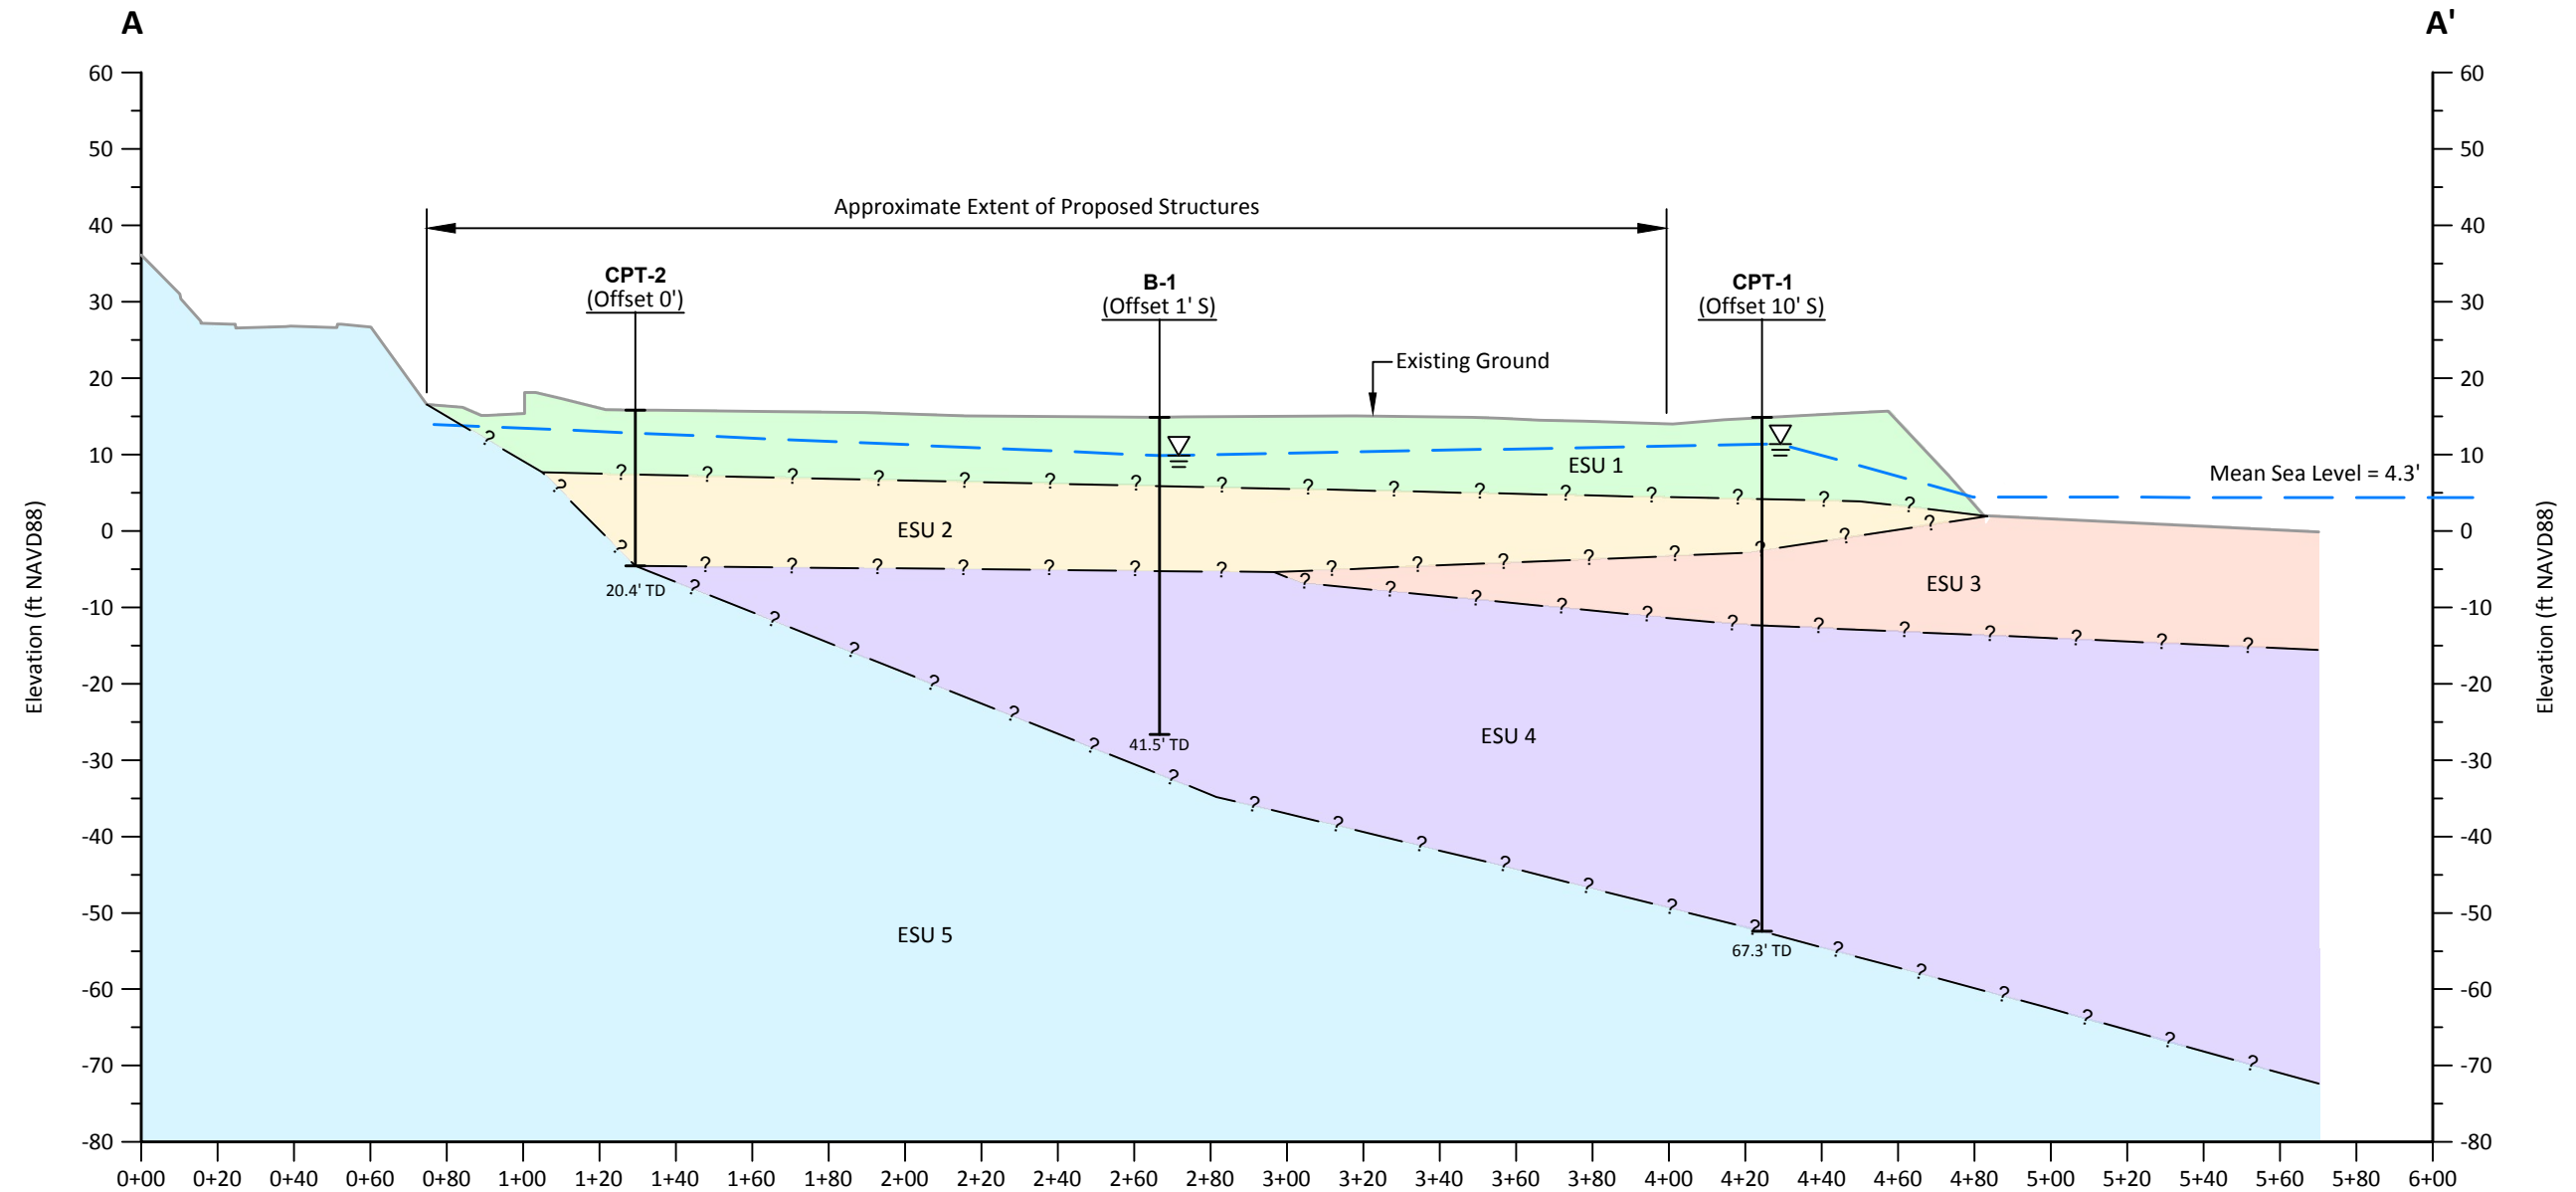
West Bay Yards Olympia, Washington	Geologic Cross Section A-A'	Figure 3
---------------------------------------	------------------------------------	--------------------

Geologic Cross Section A-A'

Horizontal Scale in Feet: 1"=50'
Vertical Scale in Feet: 1"=25'

Generalized site subsurface conditions are shown on Figure 3 and include the following engineering stratigraphic units (ESUs):

- **ESU 1:** undocumented fill;
- **ESU 2:** wood debris;
- **ESU 3:** very soft to soft, fine-grained, cohesive/plastic native soil;
- **ESU 4:** very loose to loose, non-plastic silt or sandy native soil; and
- **ESU 5:** very dense glacially consolidated soil.

GI buttress with deep foundations. With this approach, GI would be installed along a swath, approximately 50 to 75 ft wide and 700 to 800 ft long. The swath would be located along the upland area of the site, immediately adjacent to Budd Inlet. GI would be used to buttress the site and reduce lateral spreading. Structures would likely require deep foundations, such as driven piles, to mitigate static and liquefaction settlement. For the purpose of cost-estimating, LAI has assumed that open-end pipe piles, with 16-inch diameters and $\frac{3}{8}$ -inch-thick walls, will be driven 10 ft into ESU 5 and will have an allowable bearing capacity of 250 kips. (Refer to Figure 3 for estimated pile lengths.)

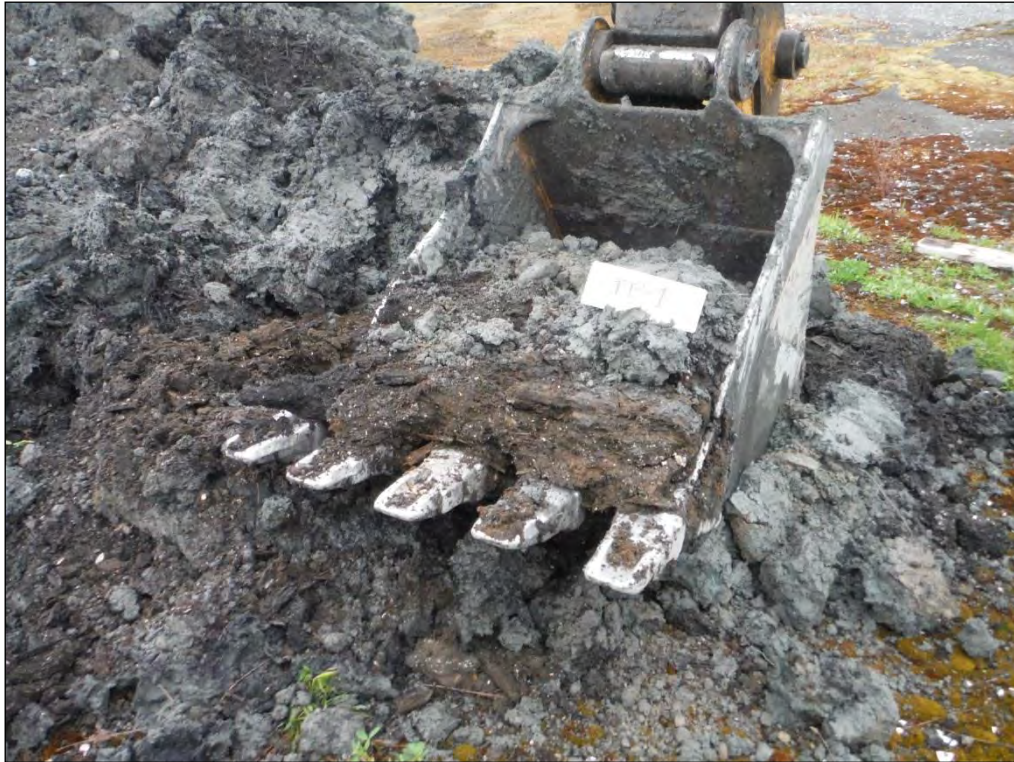
3. Test pit TP-1.

ESU 1. The site is capped with approximately 8 to 12 ft of undocumented fill. During the 2010 site cleanup, soils in contamination hotspots were excavated and replaced with fill that consisted of sandy gravel to gravelly sand. Based on site observations and cleanup documentation, some of the fill also consisted of crushed concrete. Surface fill that was not placed during the 2010 site cleanup generally consists of silt or sand with gravel and debris. This fill was also found to contain occasional larger debris, such as concrete blocks and timber piles. Typical ESU 1 spoils from the test pit excavations are shown on Figures 4a through 4j.

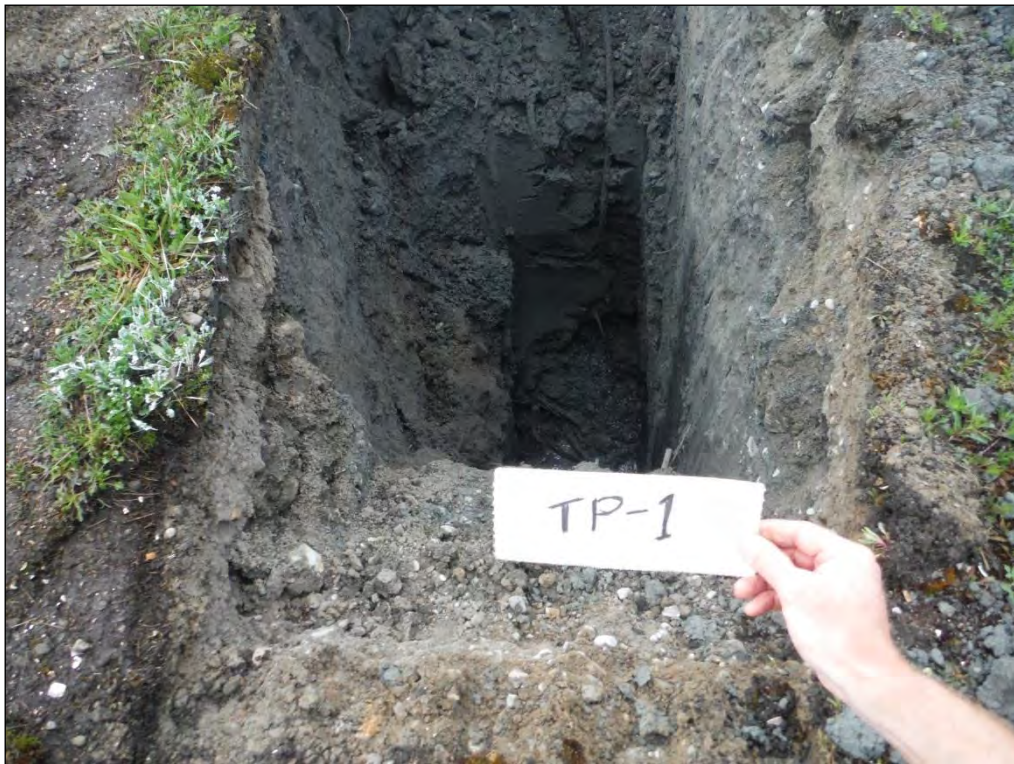
4. Test pit TP-1.

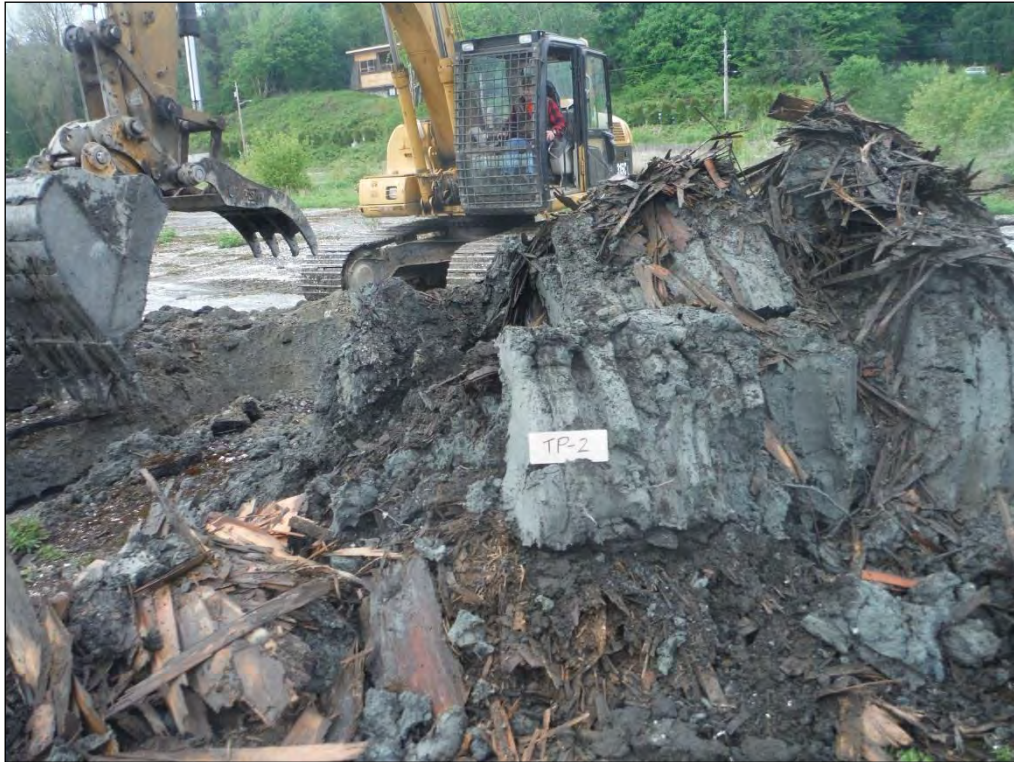
5. Test pit TP-2.

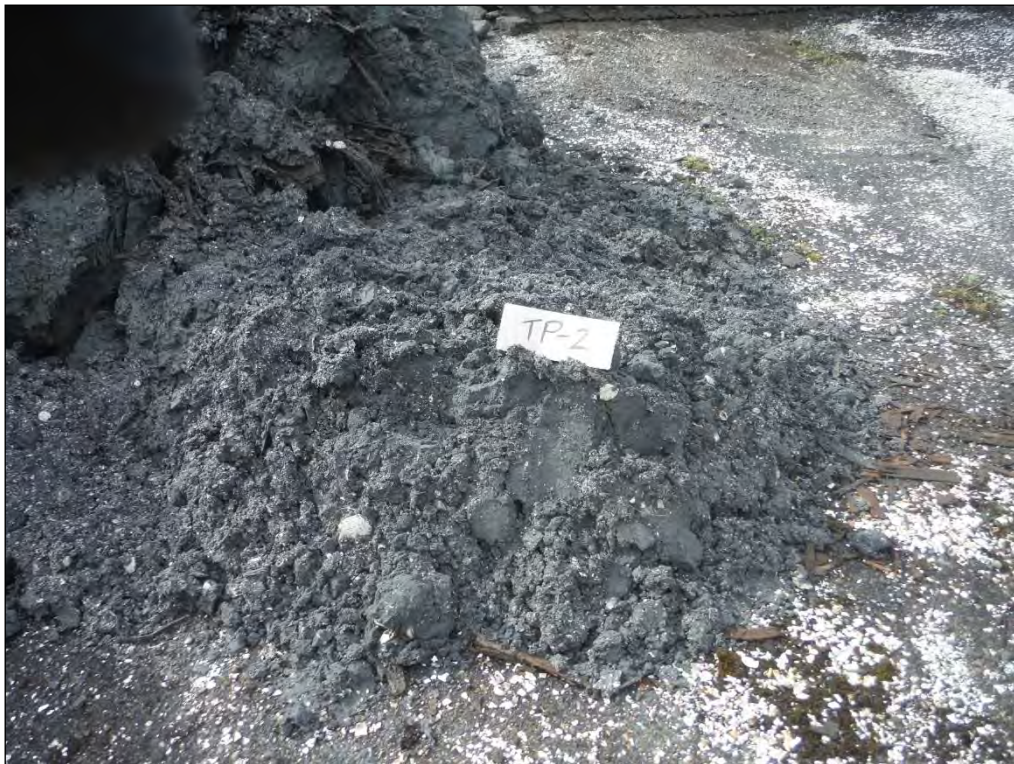
6. Test pit TP-2.

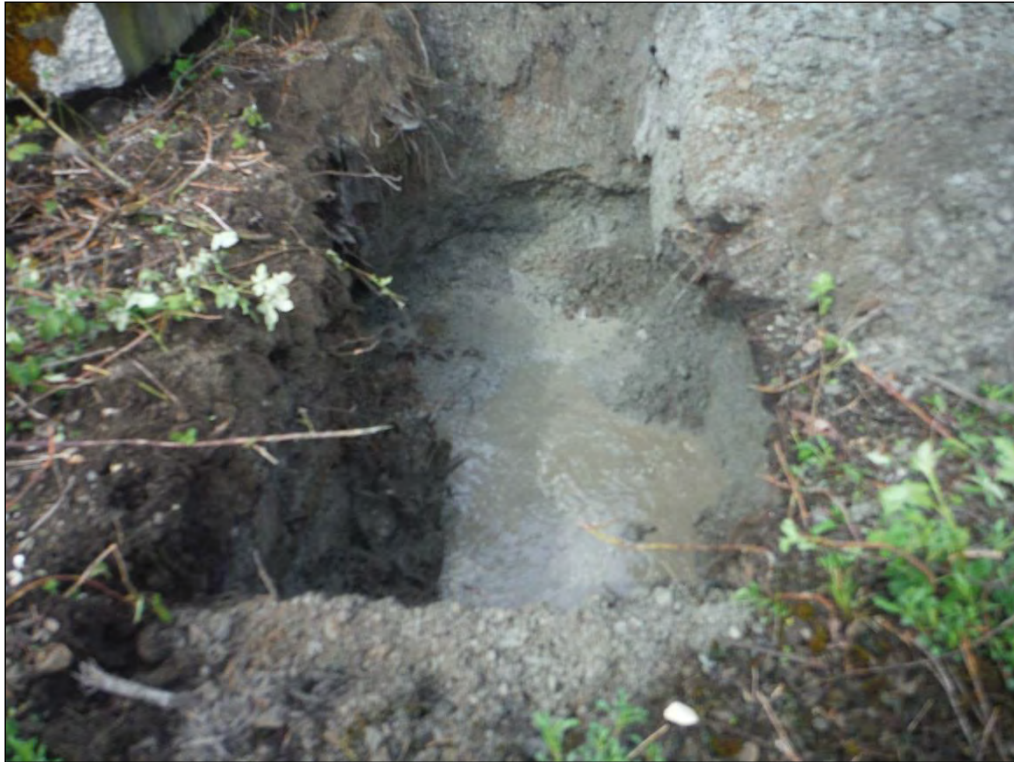
7. Test pit TP-3.

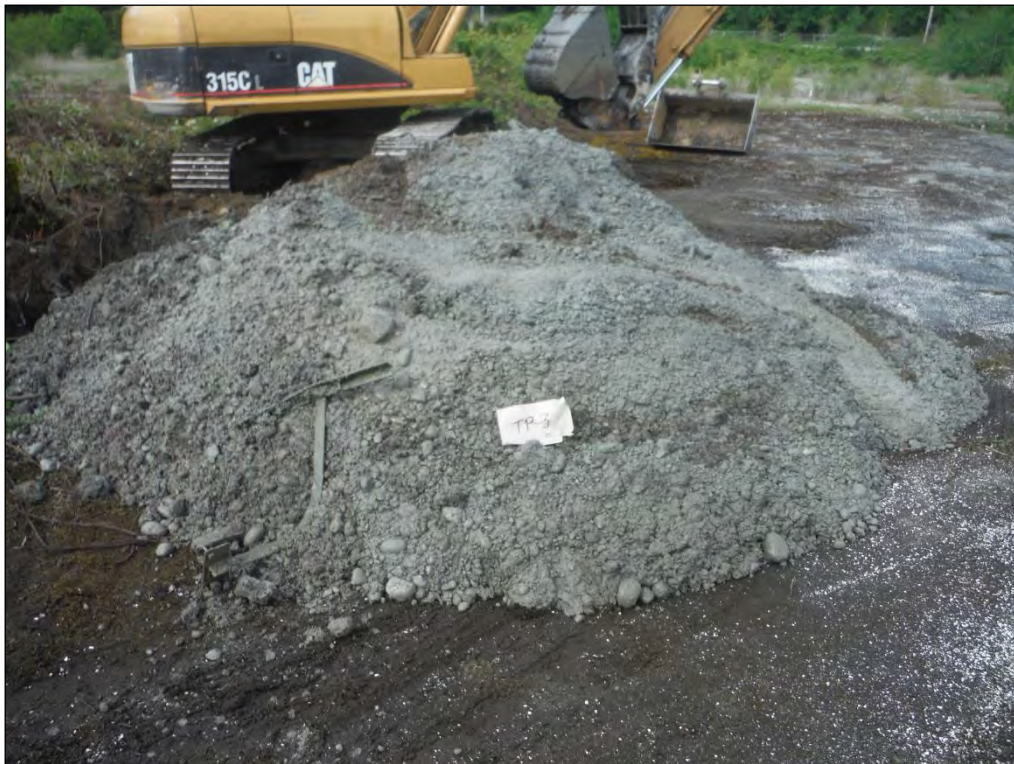
8. Test pit TP-3.

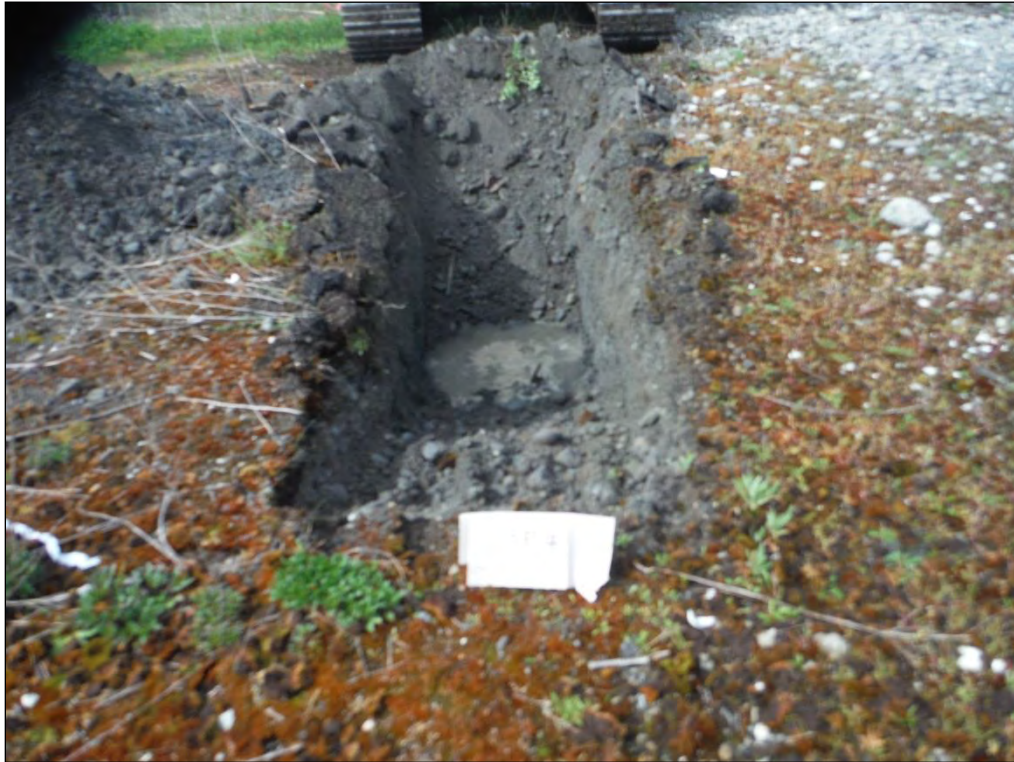
9. Test pit TP-4.

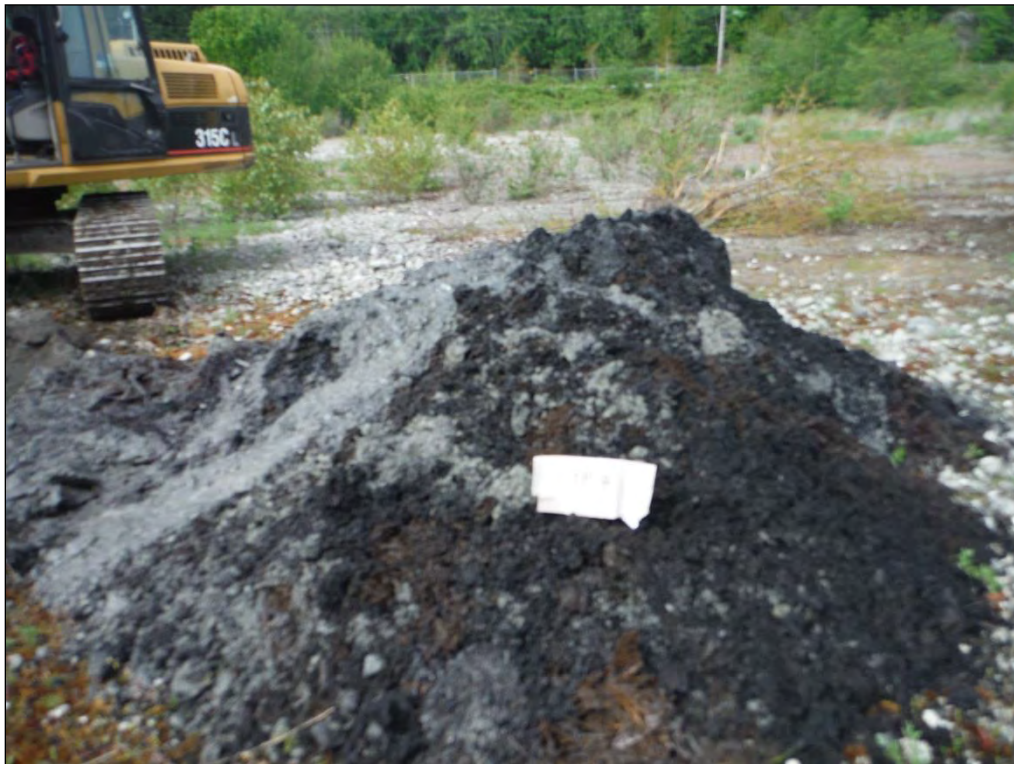
10. Test pit TP-4.

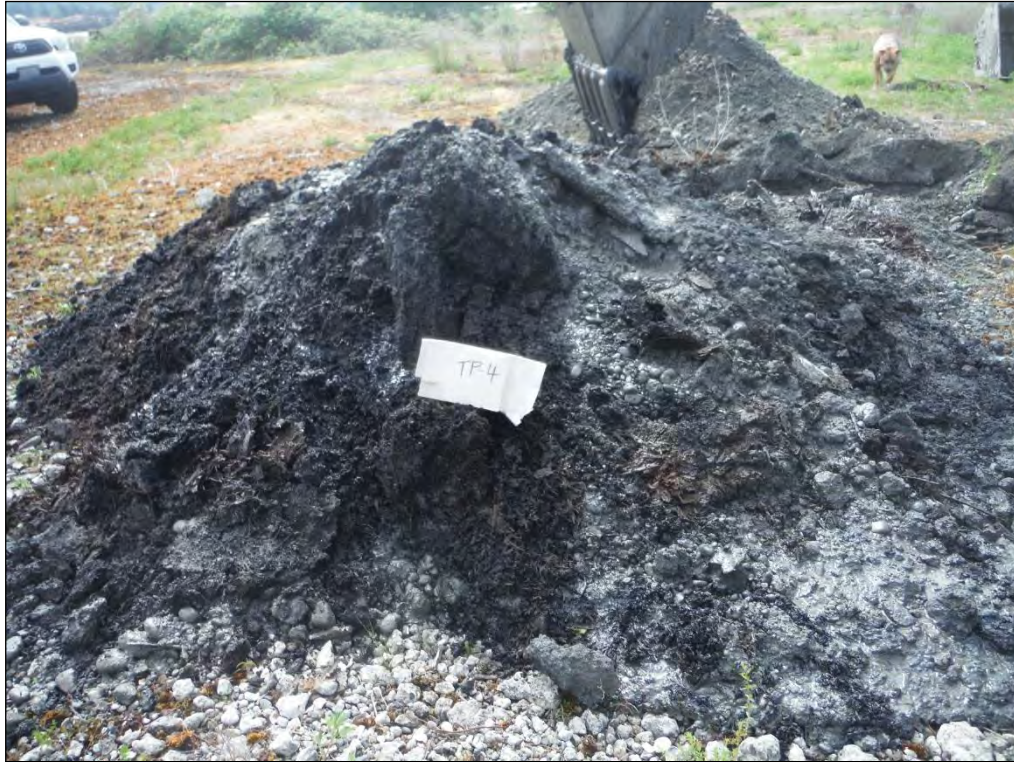
11. Test pit TP-4.

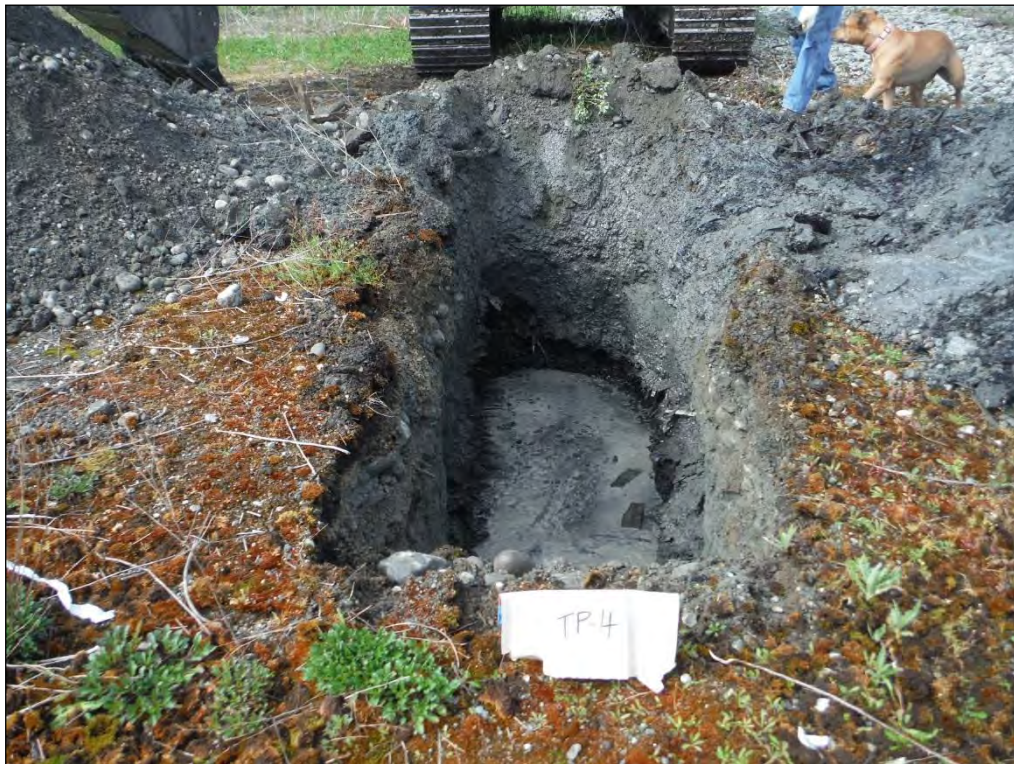
12. Test pit TP-4.

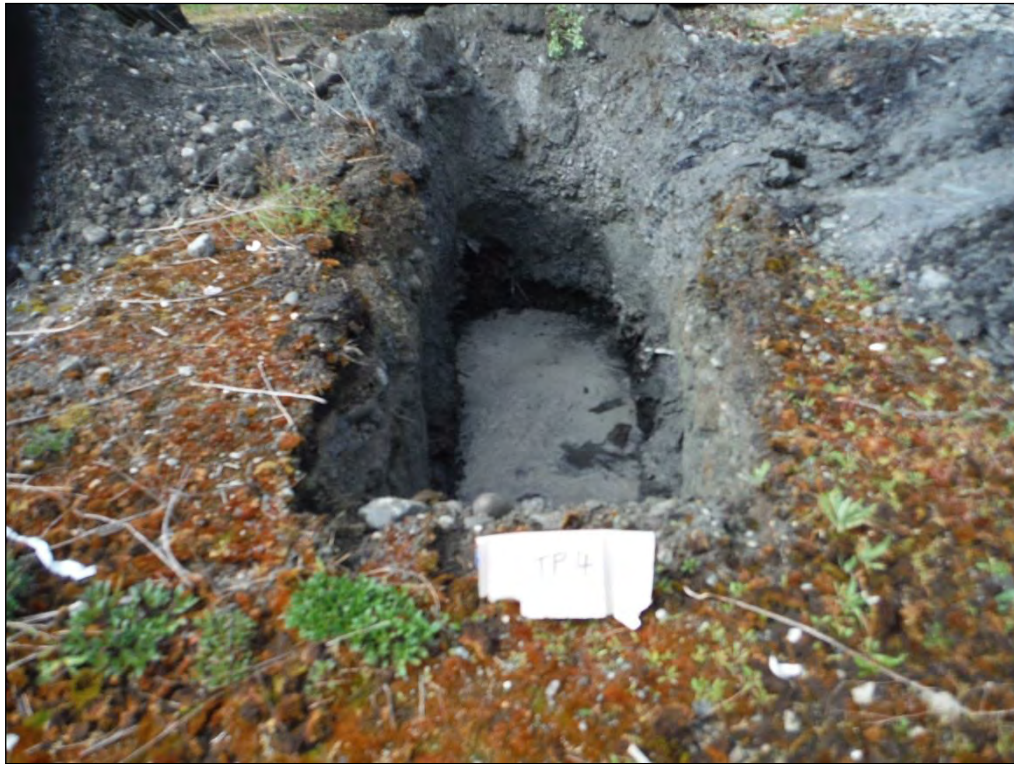
13. Test pit TP-4.

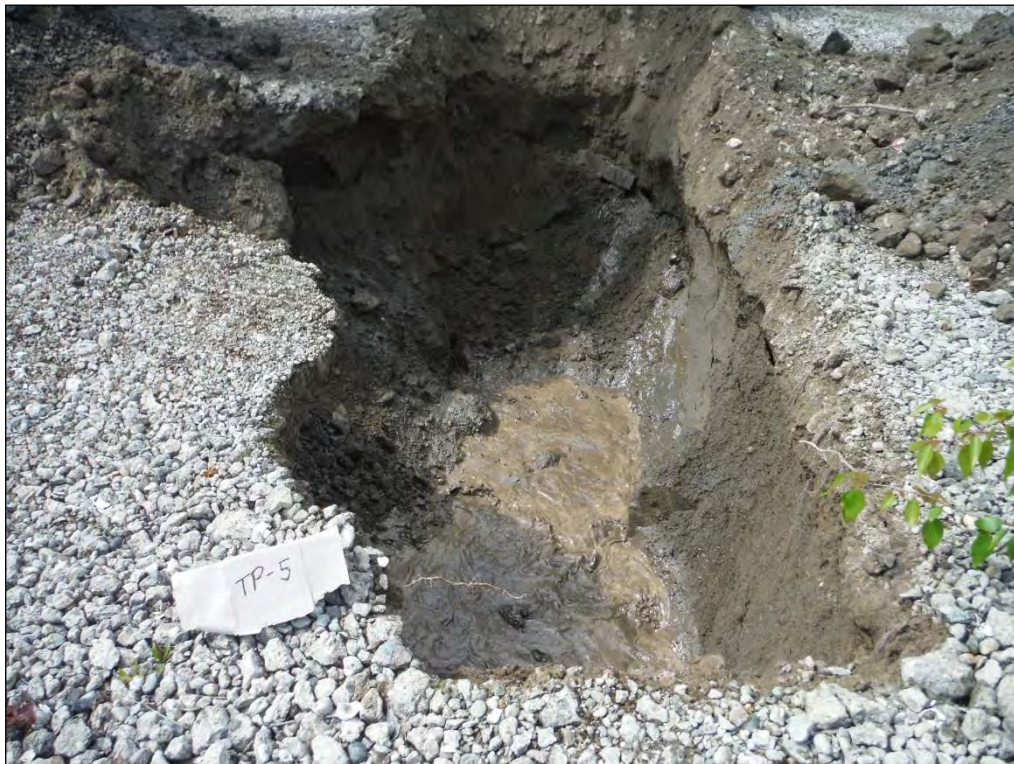
14. Test pit TP-5.

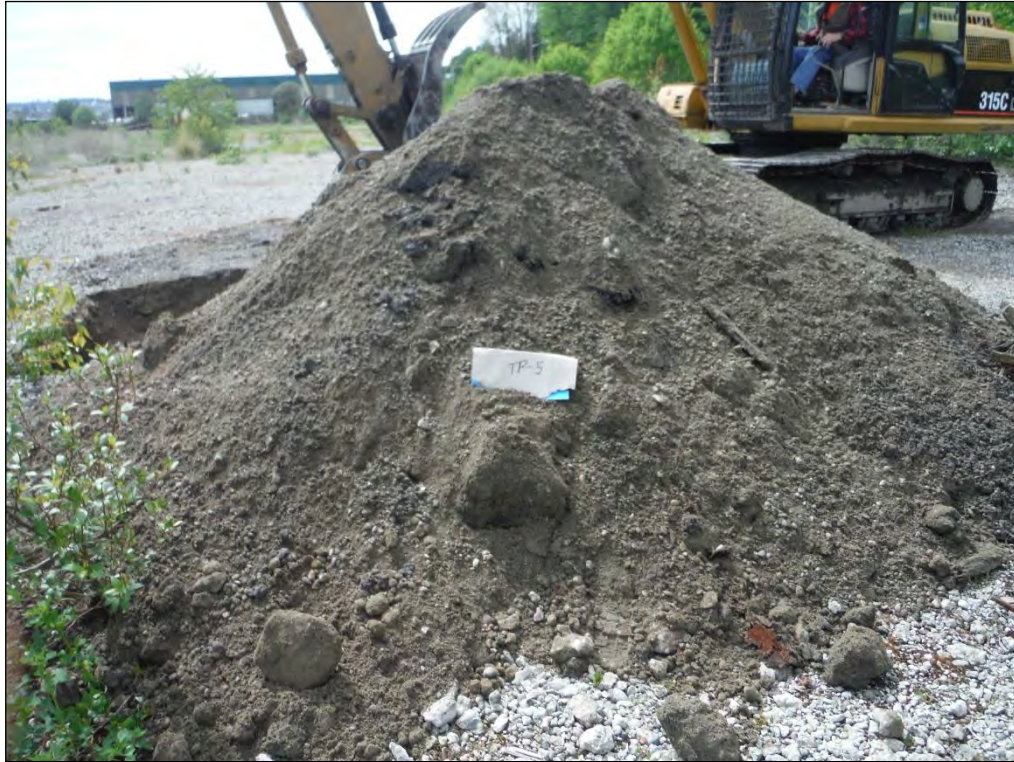
15. Test pit TP-5.

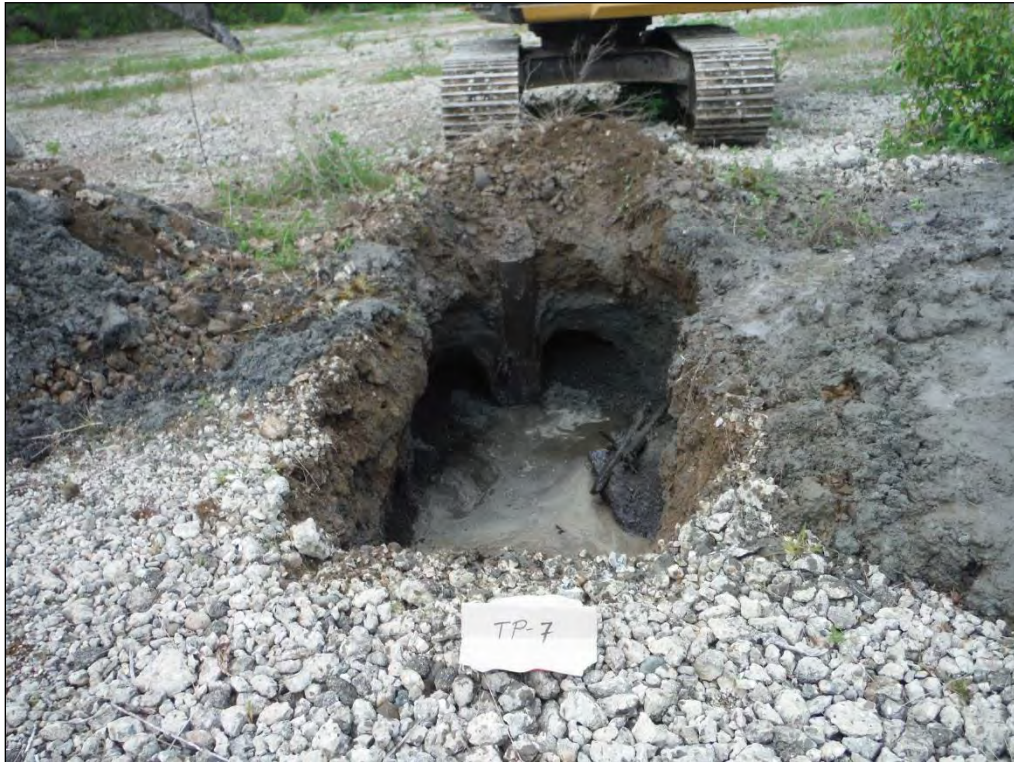
17. Test pit TP-7.

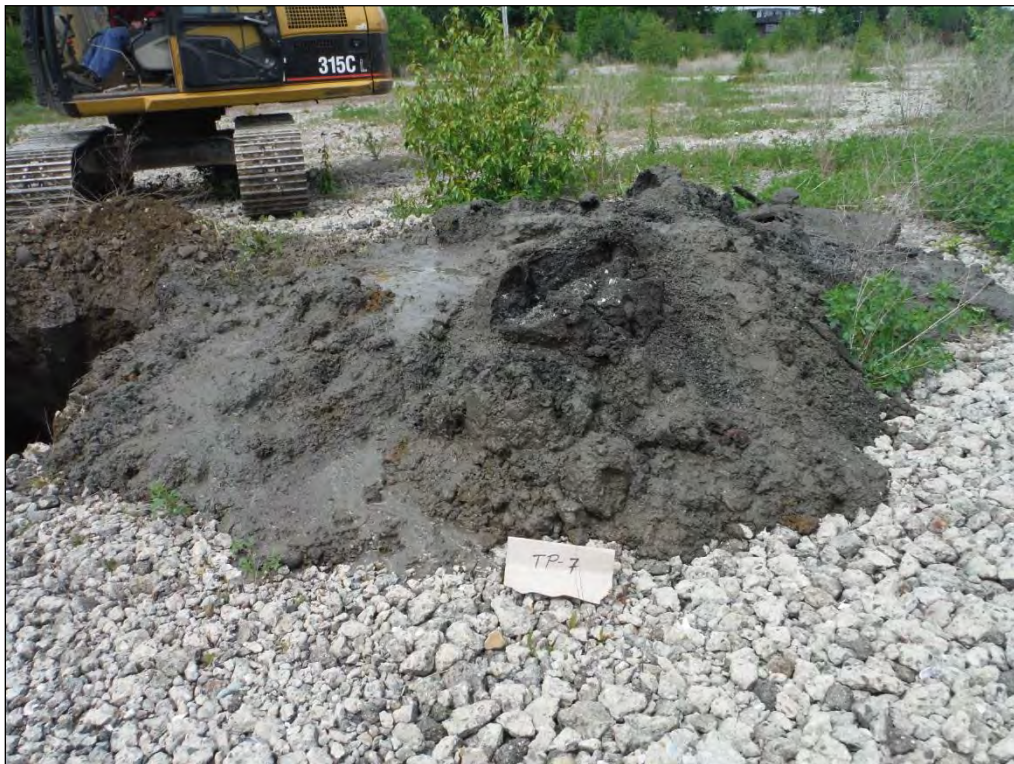
18. Test pit TP-7.

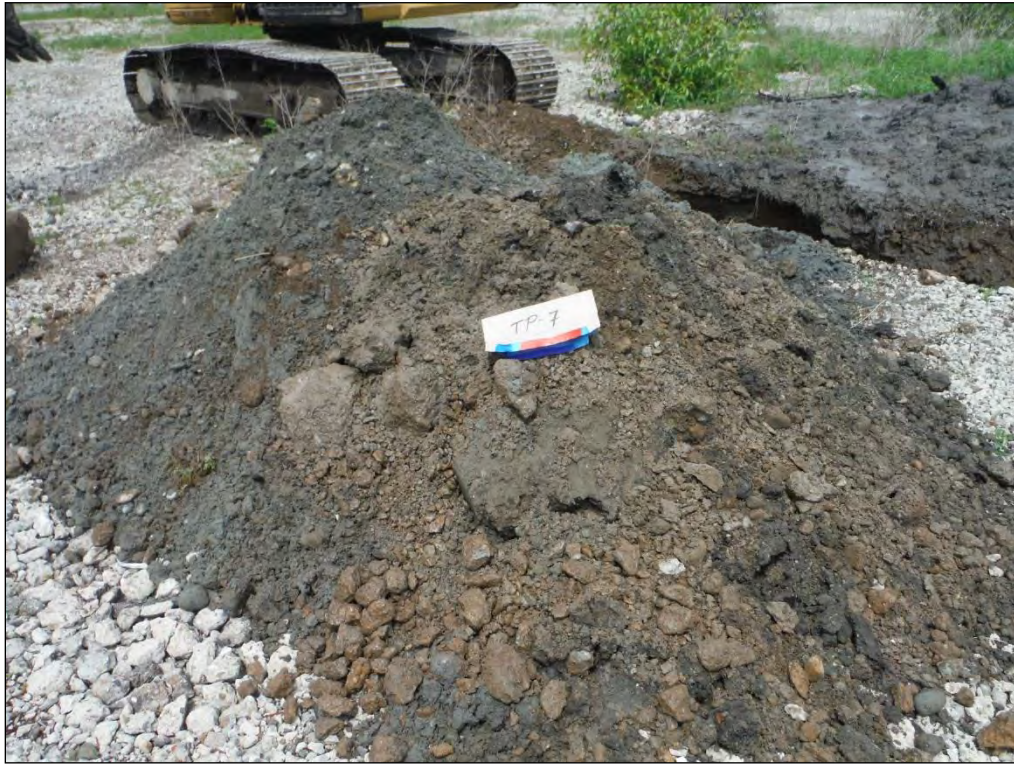
19. Test pit TP-7.

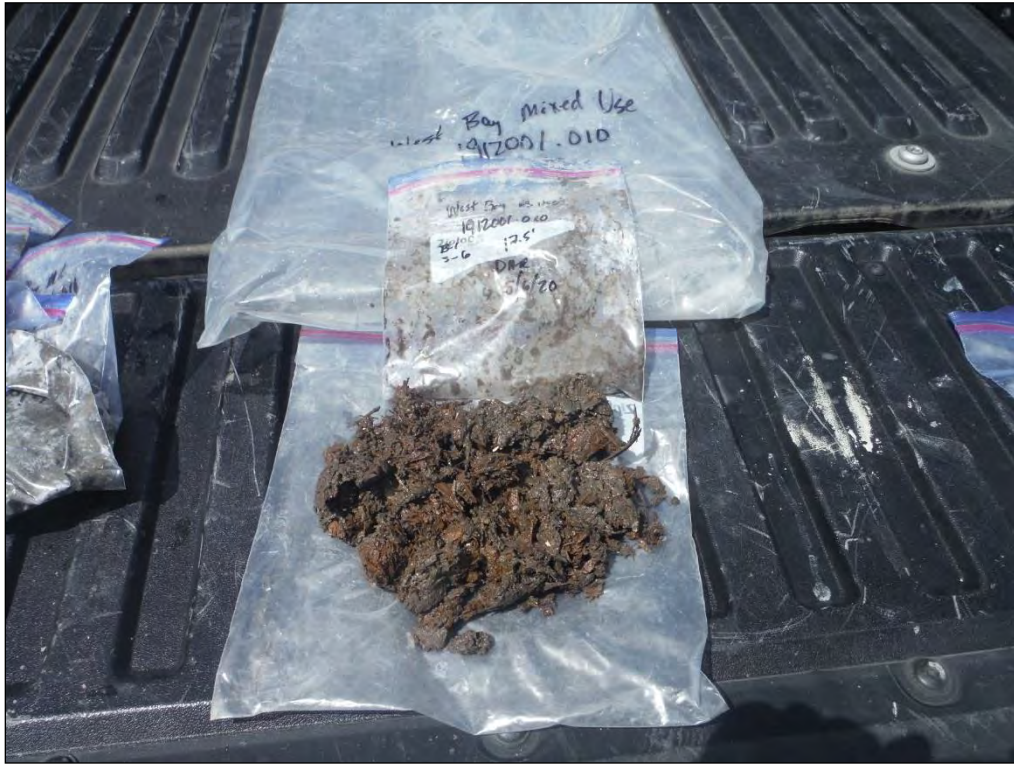
1. Wood debris from boring B-1.

ESU 2. An approximately 4- to 18-ft-thick layer of wood debris was encountered beneath ESU 1. This layer was encountered in all explorations that extended beyond the bottom of ESU 1. The wood debris generally consisted of sawdust- to wood chip-sized particles, mixed with mineral soil. Samples of ESU 2 typically could not be collected with a standard split-spoon sampler, but were recovered with a modified California sampler. Typical ESU 2 material is shown on Figures 5a and 5b.

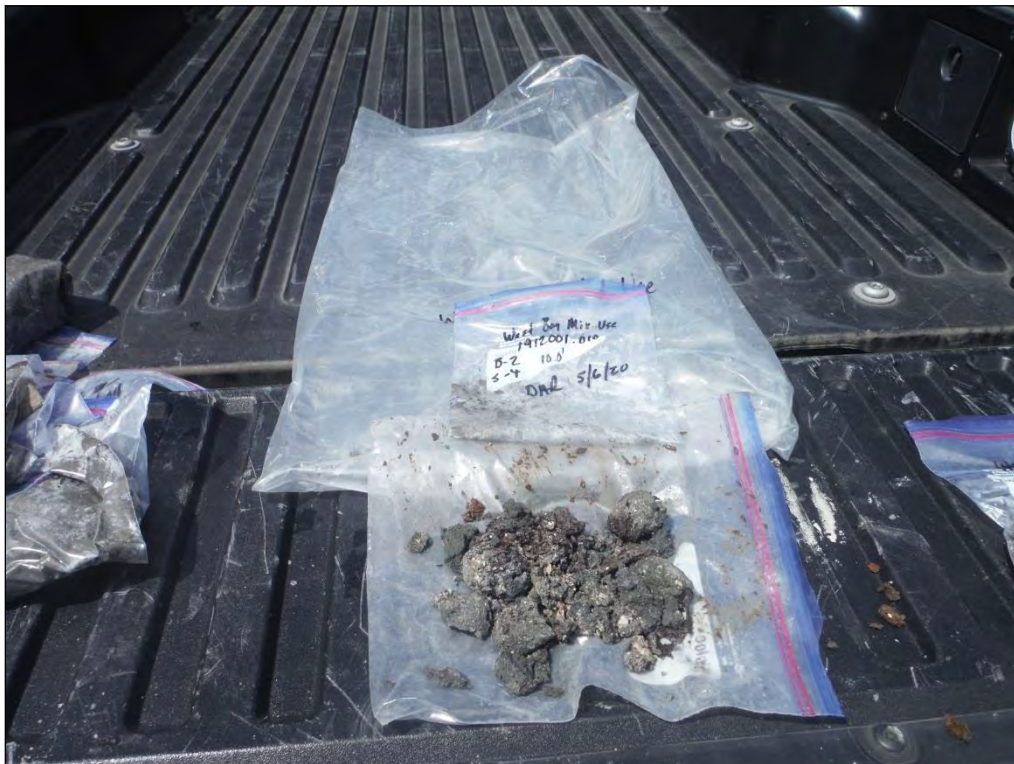
2. Wood debris from boring B-2.

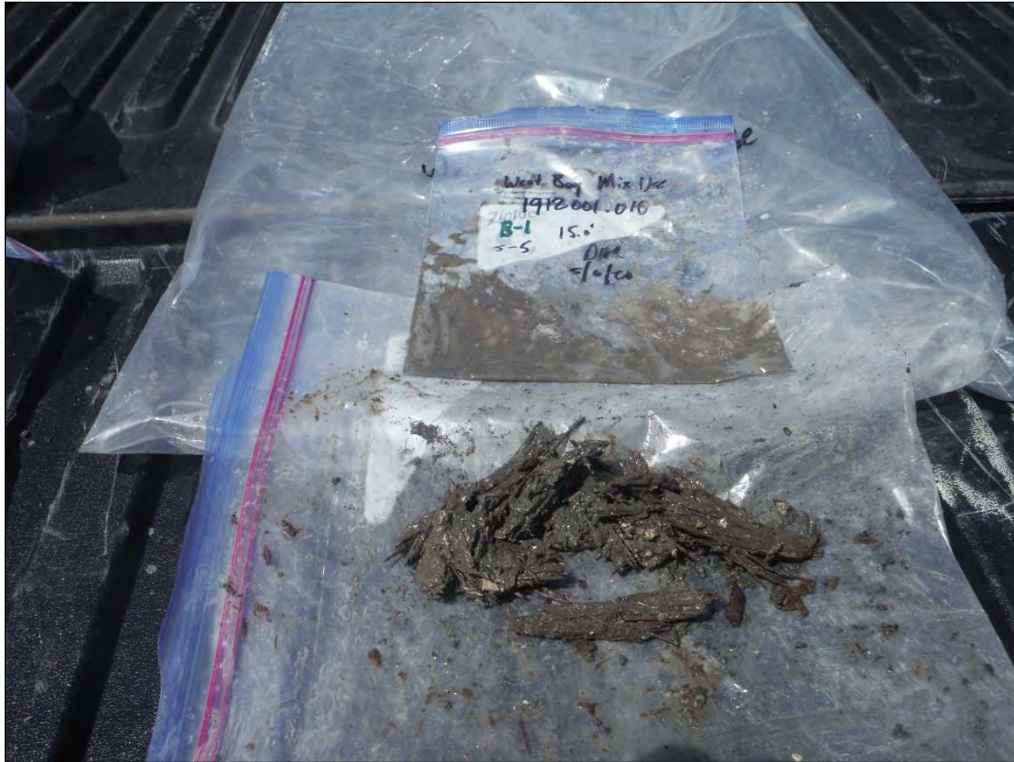
3. Wood debris from boring B-1.

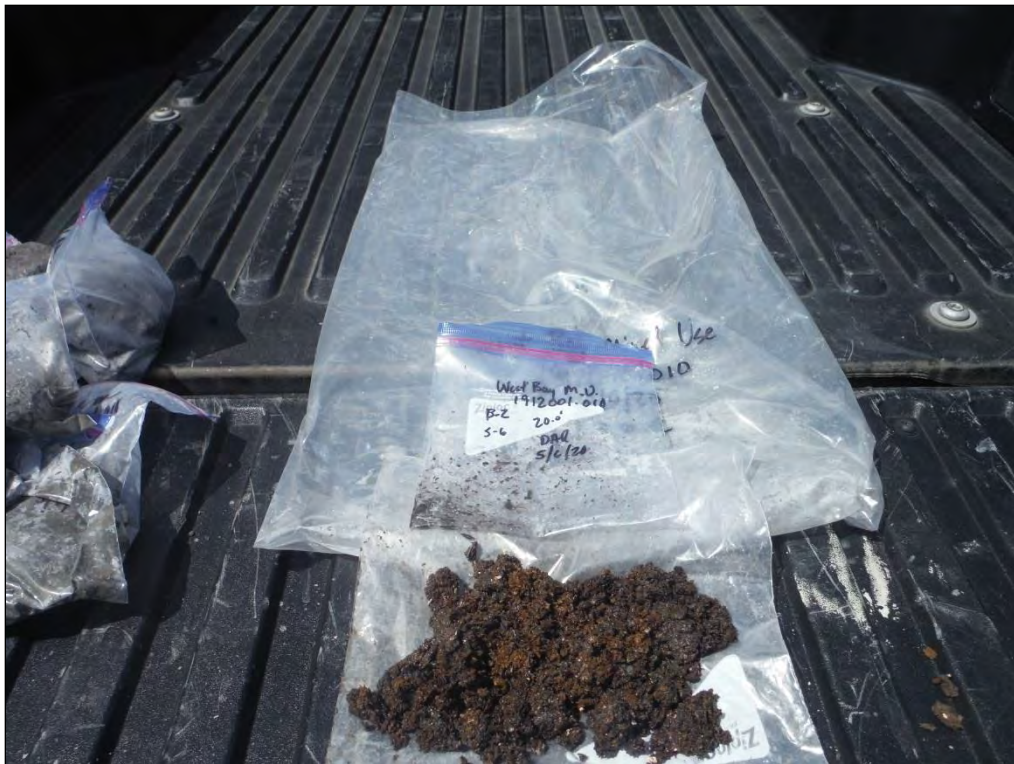
4. Wood debris from boring B-2.

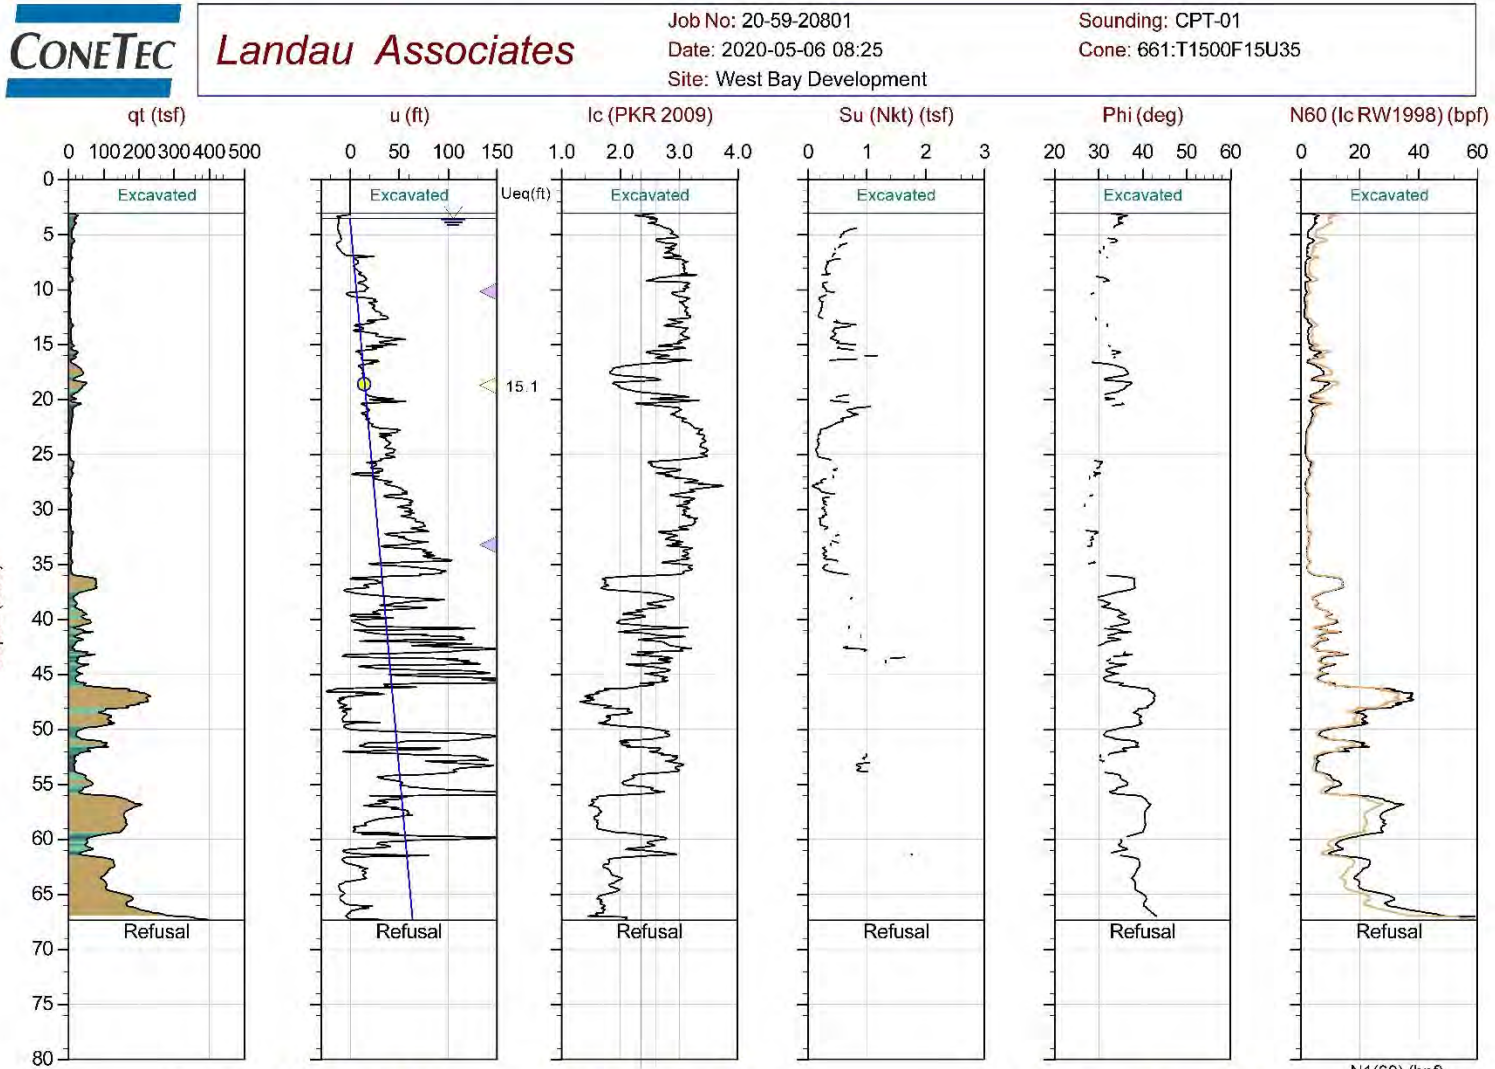
Max Depth: 20.525 m / 67.34 ft
 Depth Inc: 0.025 m / 0.082 ft
 Avg Int: Every Point

File: 20-59-20801_SP01.COR
 Unit Wt: SBTQtn (PKR2009)
 Su Nkt: 15.0
