Technical Memorandum

TO: Brandon Smith, Milestone Companies West Bay Development Group, LLC
FROM: Daniel Simpson, PE, and Calvin McCaughan, PE
DATE: August 27, 2020
RE: **Preliminary Geotechnical Engineering Recommendations
West Bay Yards
Olympia, Washington
Project No. 1912001.010.011**

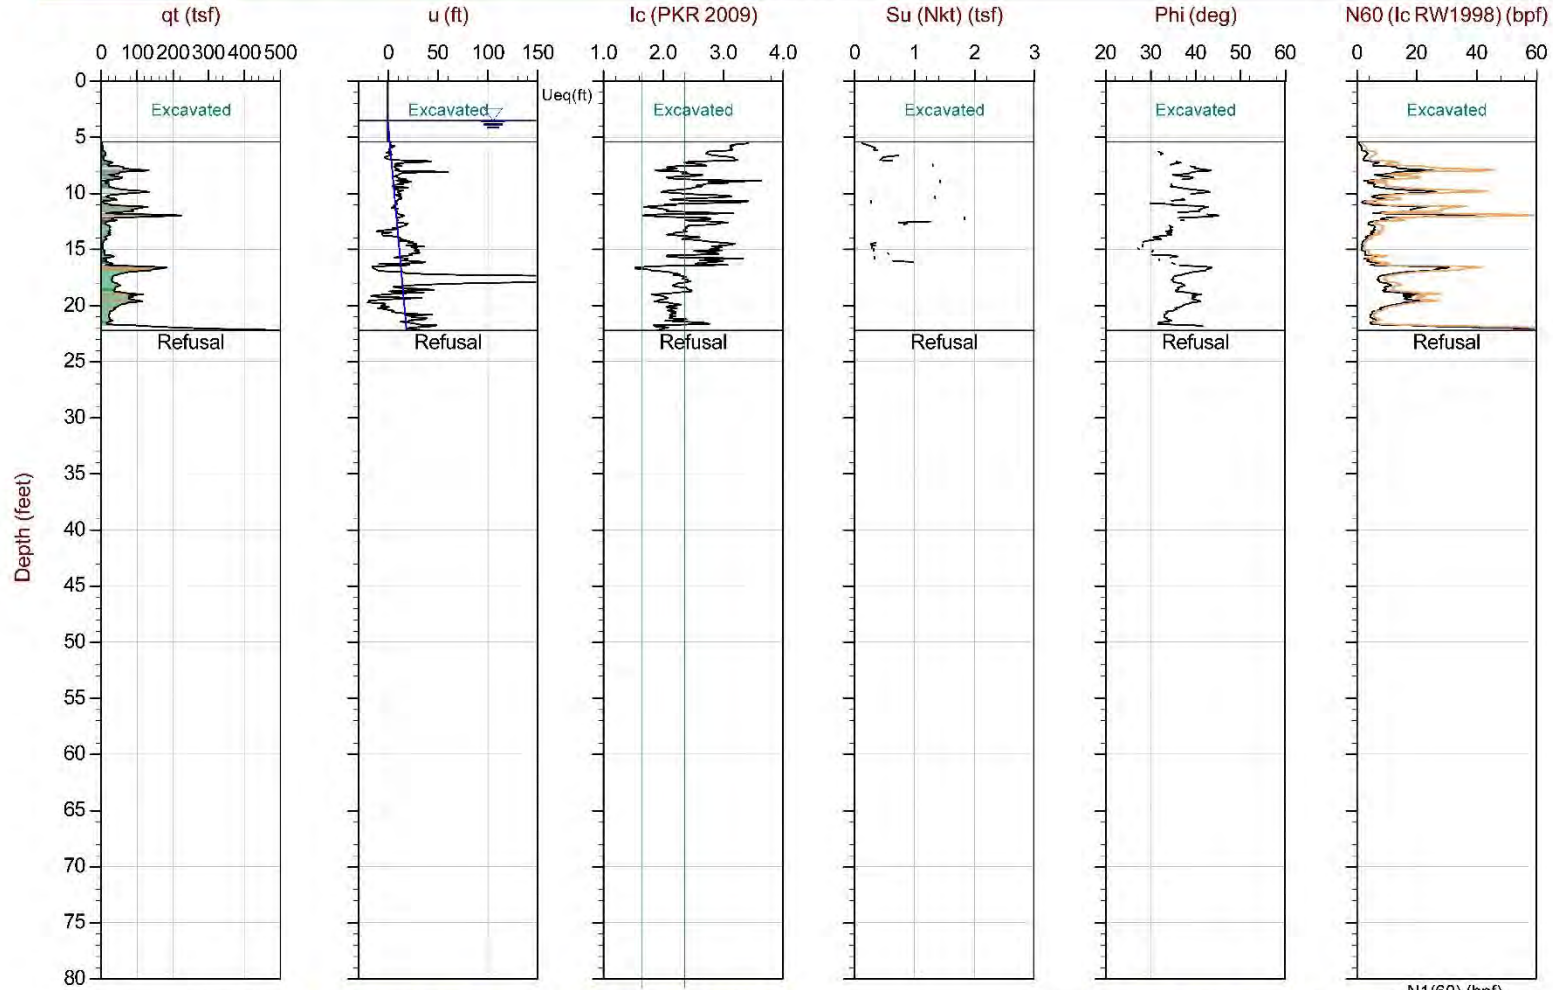
CONETEC *Landau Associates* Job No: 20-59-20801 Sounding: CPT-03
 Date: 2020-05-06 12:12 Cone: 661:T1500F15U35
 Site: West Bay Development

Max Depth: 6.775 m / 22.23 ft
 Depth Inc: 0.025 m / 0.082 ft
 Avg Int: Every Point

File: 20-59-20801_CP03.COR
 Unit Wt: SBTQtn (PKR2009)
 Su Nkt: 15.0

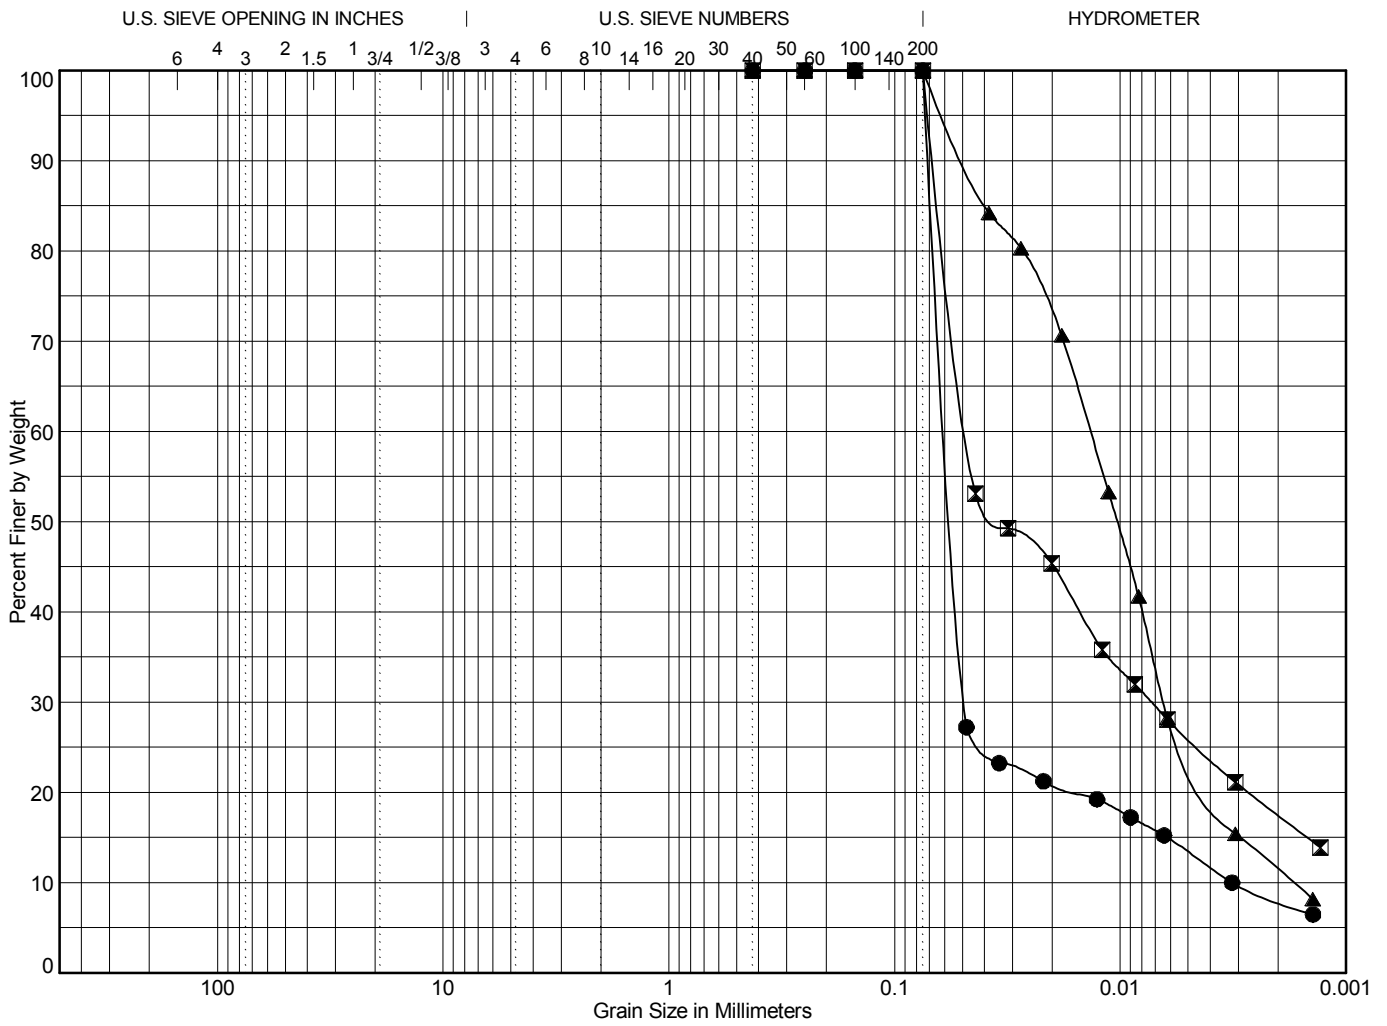
Figure
2-1

Point	Depth	Classification	LL	PL	PI	C _c	C _u
●	B-1 30.0	SILT (ML)	25	25	NP	12.76	18.41
☒	B-1 40.0	Clayey SILT (CL-ML)	21	17	4		
▲	B-2 35.0	SILT (ML)	29	27	2	1.79	7.95

Grain Size Test Data

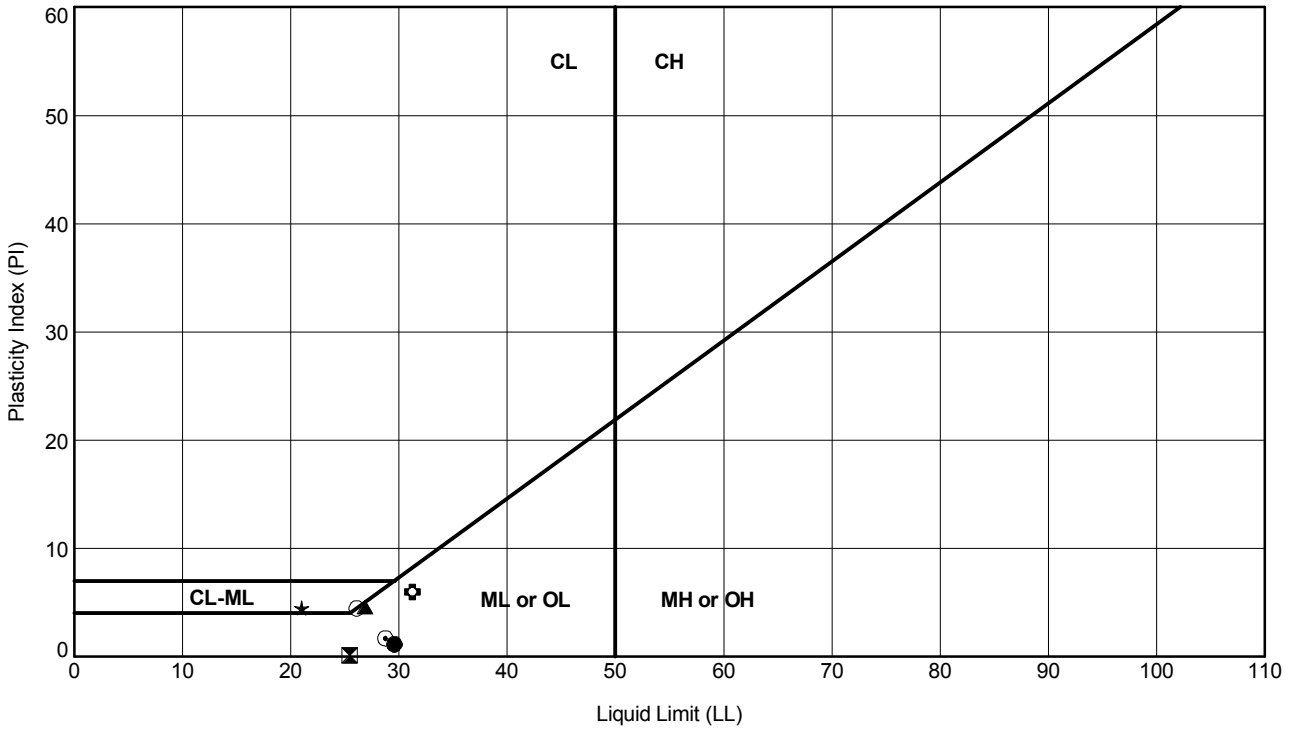
ATTERBERG LIMIT TEST RESULTS

Symbol	Exploration Number	Sample Number	Depth (ft)	Liquid Limit (%)	Plastic Limit (%)	Plasticity Index (%)	Natural Moisture (%)	Soil Description	Unified Soil Classification
●	B-1	S-9	25.0	30	28	2	43	SILT	ML
⊠	B-1	S-10	30.0	25	25	0	26	SILT	ML
▲	B-1	S-11	35.0	27	22	5	28	SILT	ML
★	B-1	S-12	40.0	21	17	4	75	Clayey SILT	CL-ML
⊙	B-2	S-9	35.0	29	27	2	35	SILT	ML
⊕	TP-1	S-4	13.0	31	25	6	37	SILT	ML
○	TP-2	S-3	11.0	26	22	4	19	Clayey SILT	CL-ML
