## WINDOWS

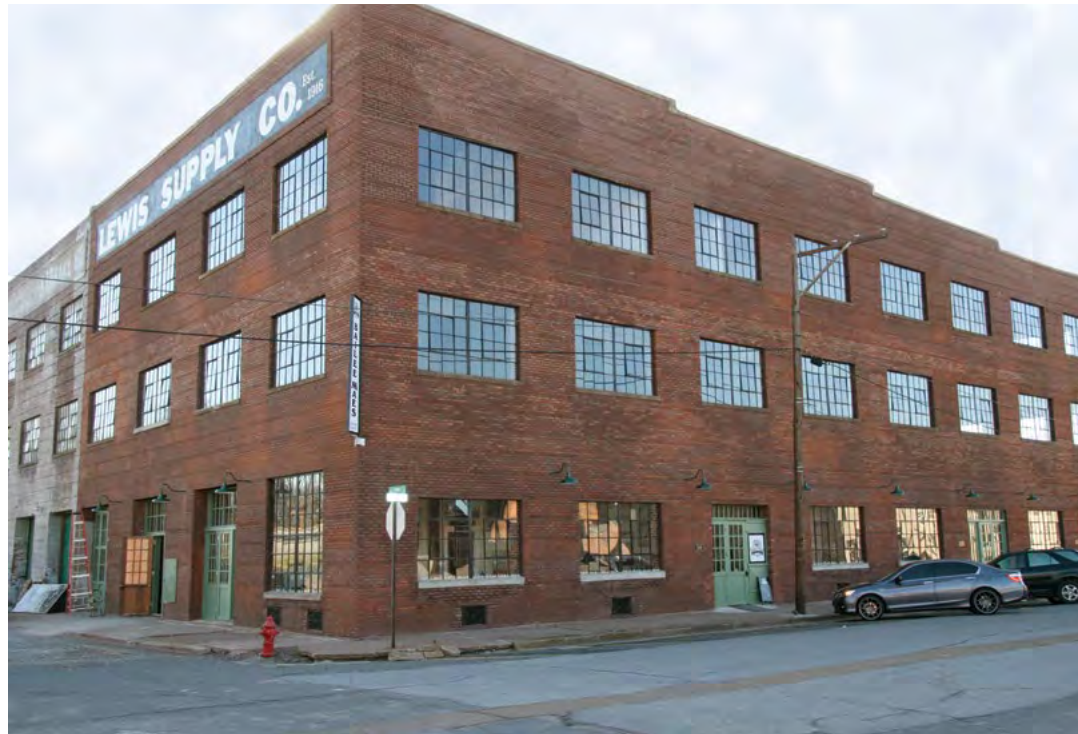
[20 a-d] The original steel windows in this industrial building were successfully repaired as part of the rehabilitation project (left).

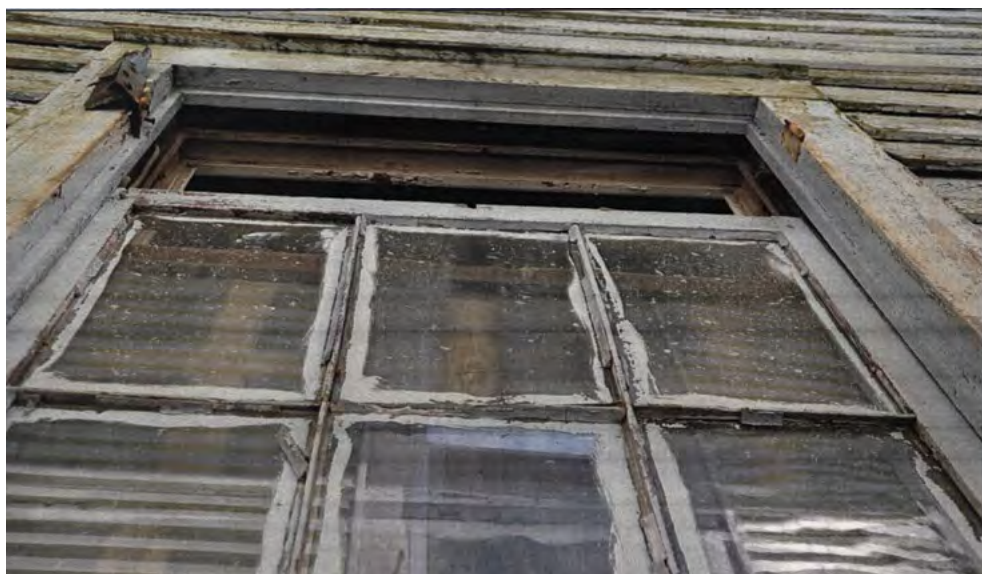
[23] (a) This deteriorated historic wood window was repaired and retained (b) in this rehabilitation project.
