# WEST BAY YARDS SHORELINE RESTORATION

## INTERTIDAL SHELLFISH AND SUBMERGED AQUATIC VEGETATION SURVEY REPORT

NOVEMBER 21, 2022

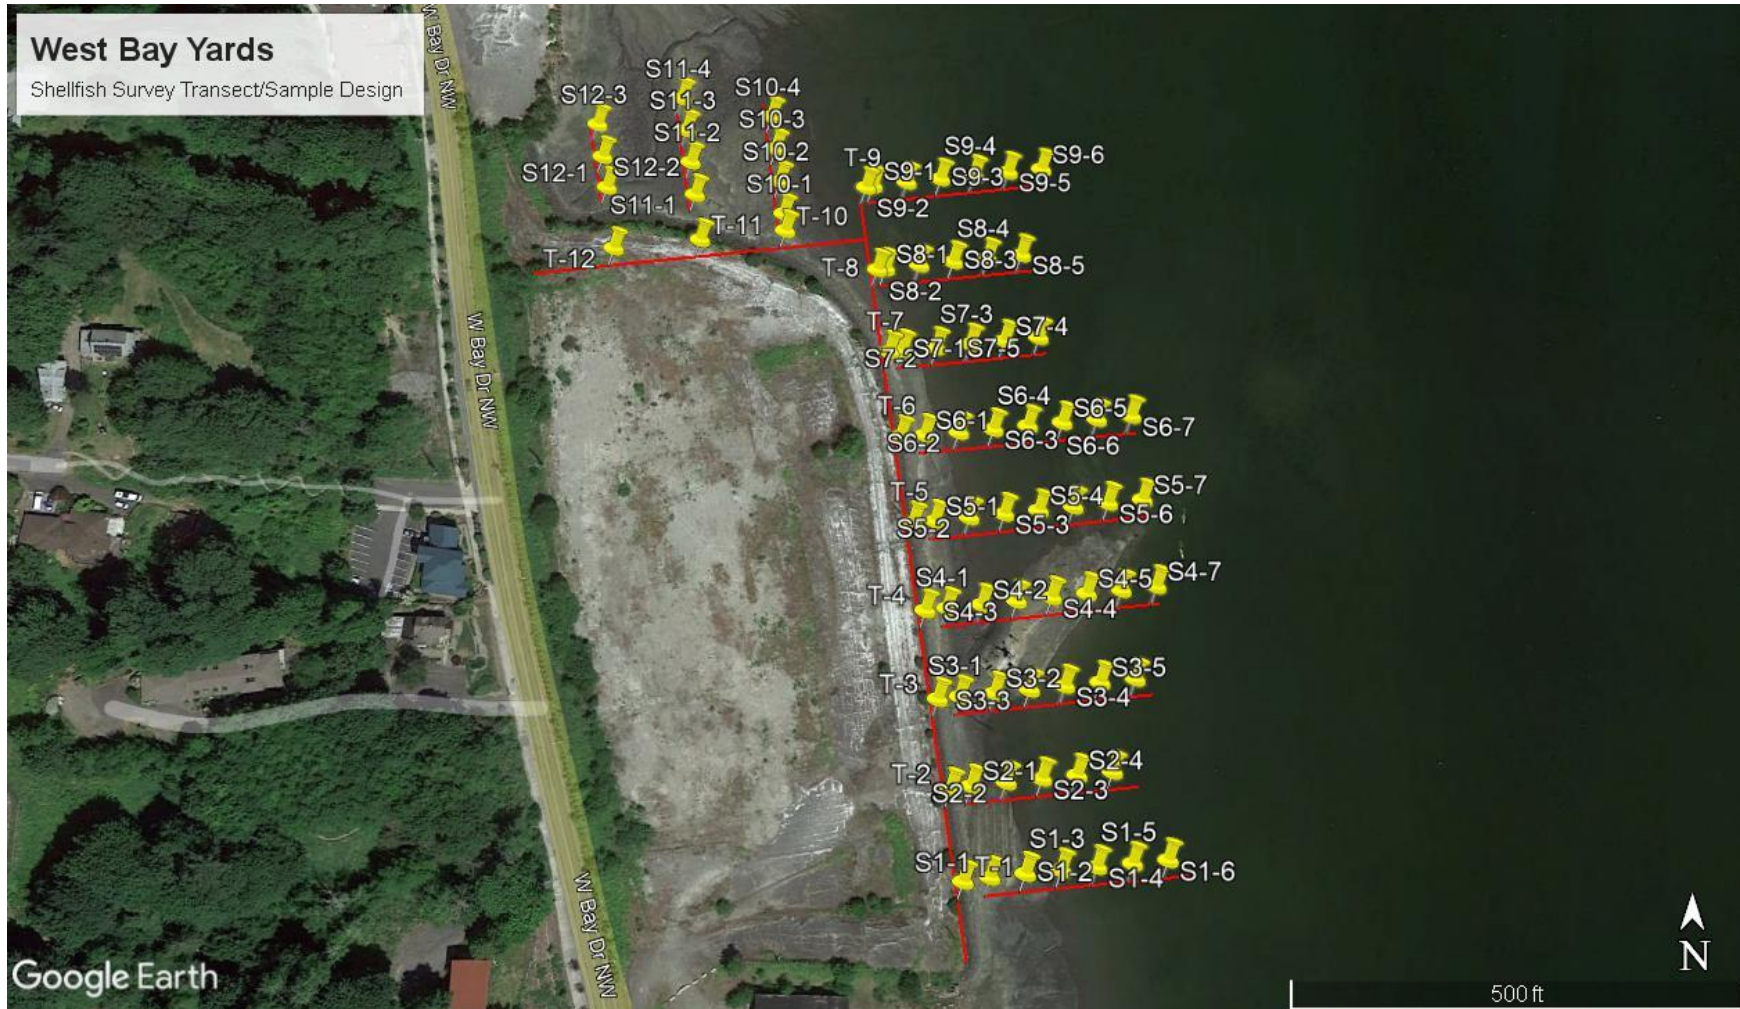
**Figure 3. Transects and sample plot locations** for the West Bay Intertidal Shellfish & SAV Survey in Olympia, WA. Transects (e.g., “T-1”) are represented by the red lines, with the sample plots (e.g., “S1-1”) locations noted by the yellow pins. Coordinates for sample plots are listed in Appendix B.

The location of the first transect (T-1) was determined using a random number generator in Excel. A random number between 0-100 was generated, and the first transect was placed 72 feet from the start of the baseline at the south end of the site. Each subsequent transect was spaced 100 feet apart. At the location where the two baselines intersect, the next transect was spaced 100 feet west of the intersection point (Figure 3).

Following this procedure, a total of 12 transects were established on the Site. Nine transects are located along the north/south baseline, and three transects are located along the east/west baseline (Figure 3).

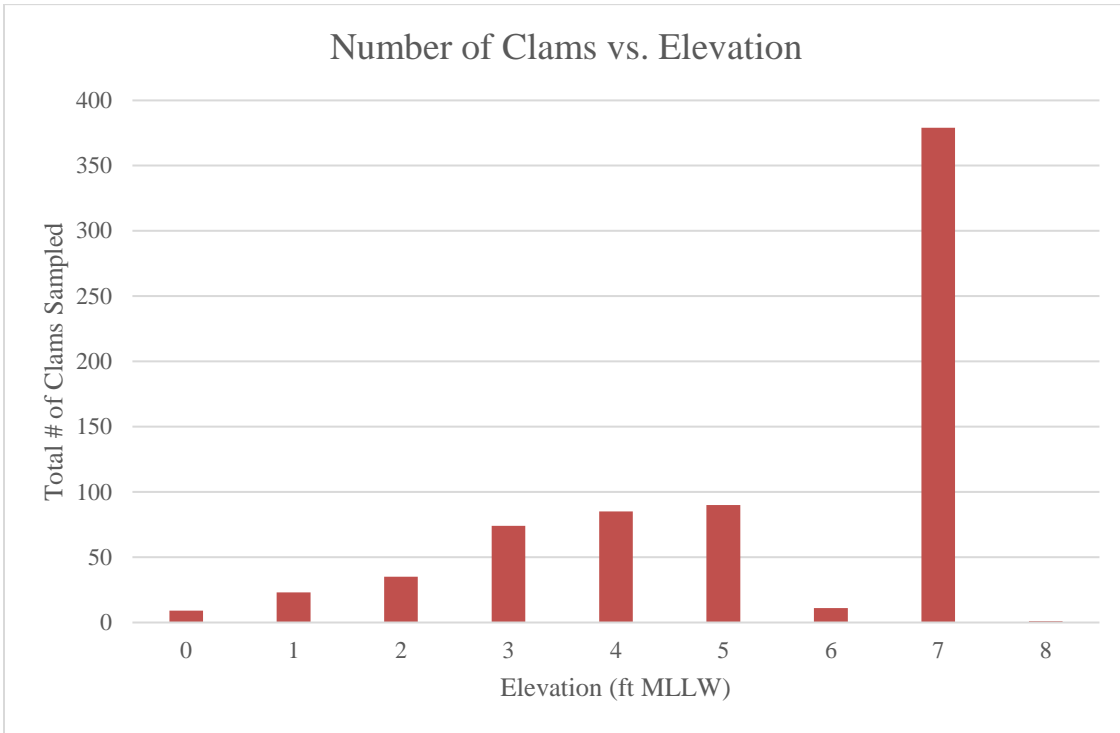
Overall, the shellfish on Site seemed to appear more frequently in sandy and gravelly sediments (from +5 ft to +8 ft MLLW), instead of the fine silty sediments (from 0 ft to +5 ft MLLW). The mean number of clams per square foot sampled (i.e., sample plot, n = 20) was 35.4 clams. From 0 ft to +5 ft MLLW, the total area was 140,352 ft<sup>2</sup>, with a mean of 20.5 clams per sample plot (n = 11), and an estimated population total of 2,877,216 clams. For estimates from +5 ft to +8 ft MLLW, the total area was 32,134 ft<sup>2</sup>, with a mean of 53.4 clams per sample plot (n = 9), and an estimated population of 1,715,956 clams. Figure 4 presents the total number of clams sampled (n = 20) at each foot of elevation.

**Figure 4. Total number of clams sampled and the approximate elevation of the corresponding sampling locations for the West Bay Intertidal Shellfish and SAV Survey in 2022.**

When looking at population estimates on Site, more clams appeared at higher elevations from +5 ft to +8 ft MLLW (Figure 4). The mean number of clams present in the samples at the +5 ft to +8 ft MLLW elevation band was 53.4 clams, compared with a mean number of clams at the 0 ft to +5 ft MLLW elevation band of 20.5 clams. One study suggests most hardshell clams (like those encountered during this survey) prefer sediments which are a mix of gravel and sand, whereas fine sediments increase the risk of filter feeder suffocation, and decrease the ability for larval settlement (Dethier 2006). The upper sections of the beach above +5 ft MLLW consisted of sediments that were a mix of gravel and sand much like that described by Dethier (2006), which could be one explanation as to why more clams were found at higher elevations below the riprap revetment during this survey.

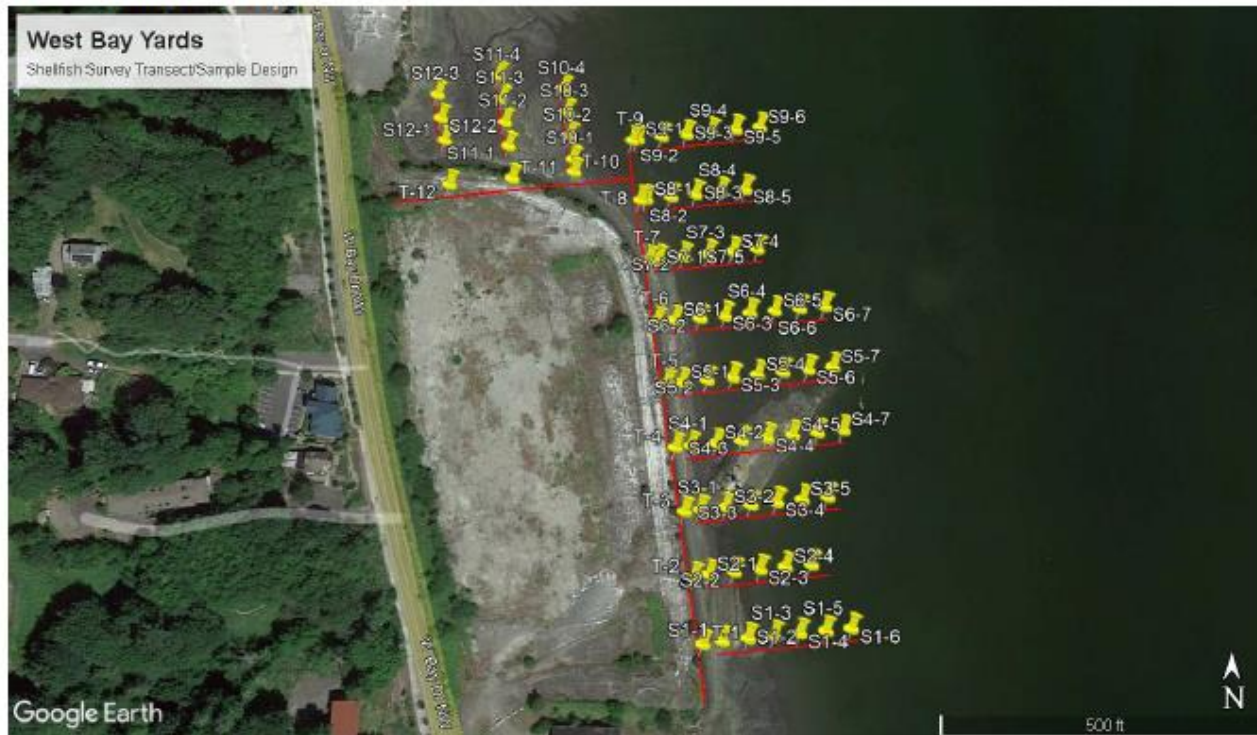
Figure 3. Transect and sample design

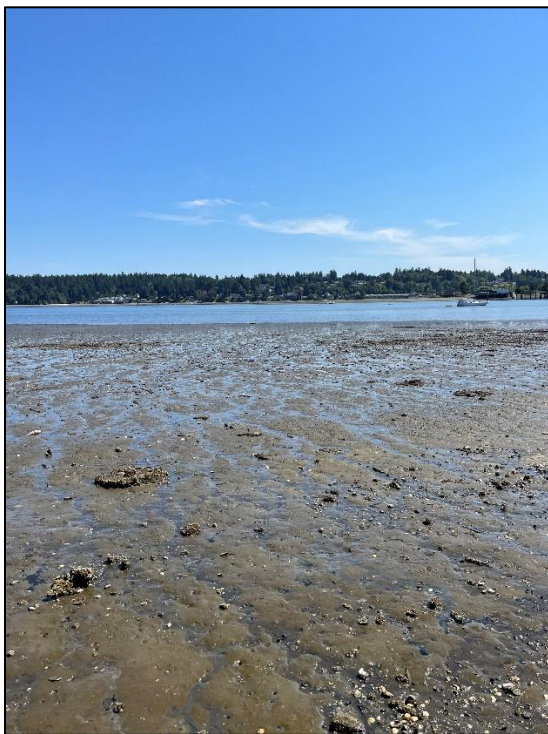
**Photograph 1. Site during low tide conditions**, looking east towards the exposed silty/sandy mud which was void of macroalgae and aquatic vegetation. Photo taken July 27, 2022.

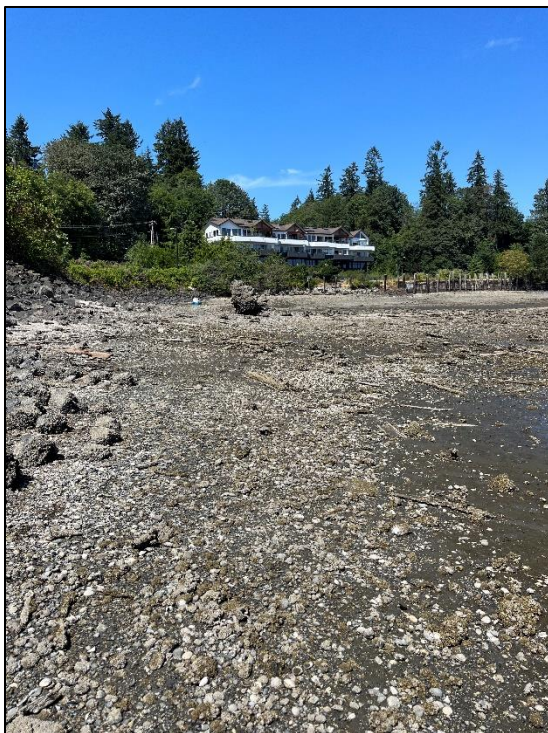
**Photograph 2. Upper shoreline conditions**, looking north during low tide. Photo taken July 27, 2022.

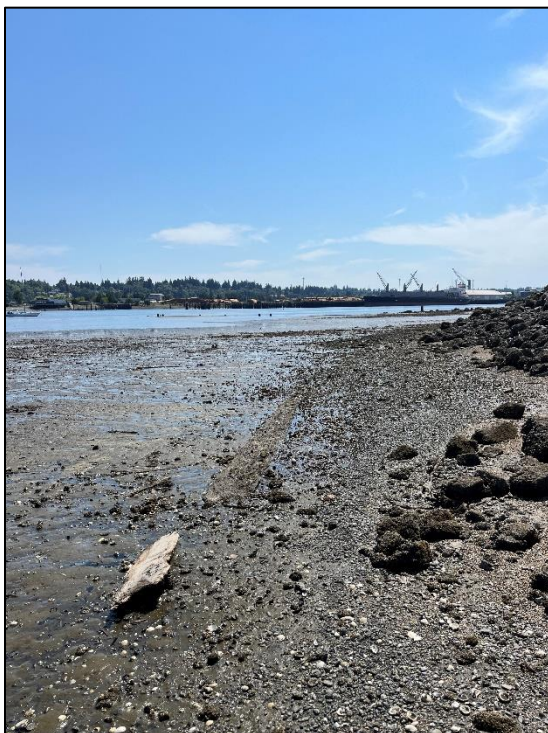
**Photograph 3. Upper shoreline conditions, looking south during low tide. Photo taken July 27, 2022.**

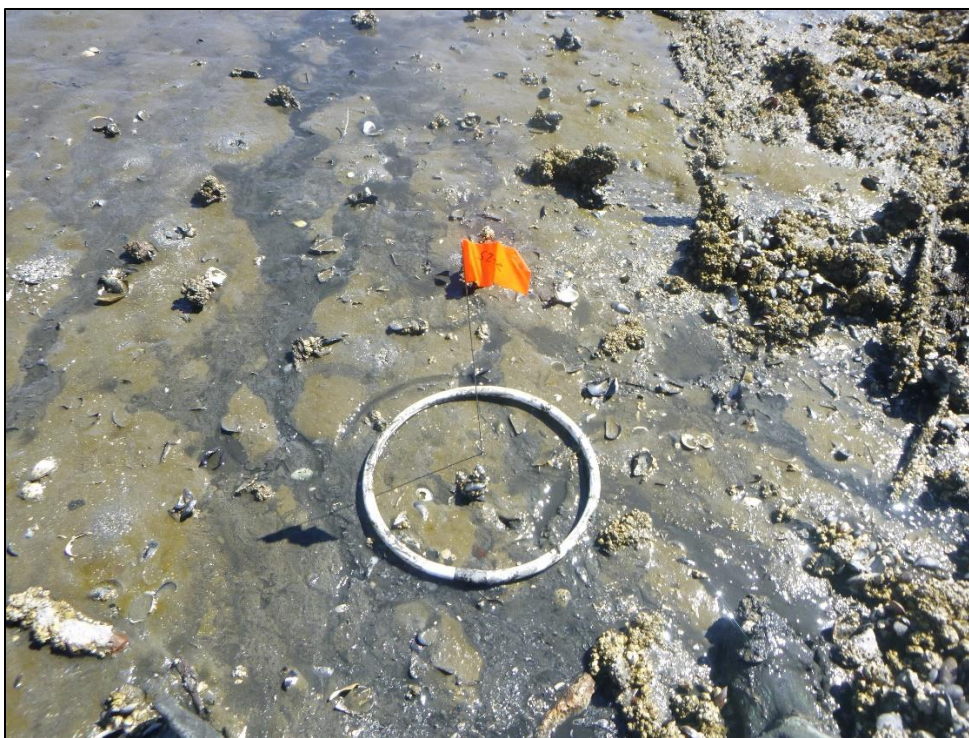
**Photograph 4. Example of a sample plot along a transect on Site during low tide. Photo taken July 27, 2022. The flag and ring indicate the location of the sample plot.**
