RE: VCP Application and Remedial Investigation Data Gap Report
Hardel Mutual Plywood Corporation Site (AO DE4108, Cleanup Site ID 3704)
1210 West Bay Drive NW, Olympia, Washington

Remedial Investigation Data Gap Report

Hardel Mutual Plywood Corporation Site
1210 West Bay Drive NW
Olympia, Washington

August 2021

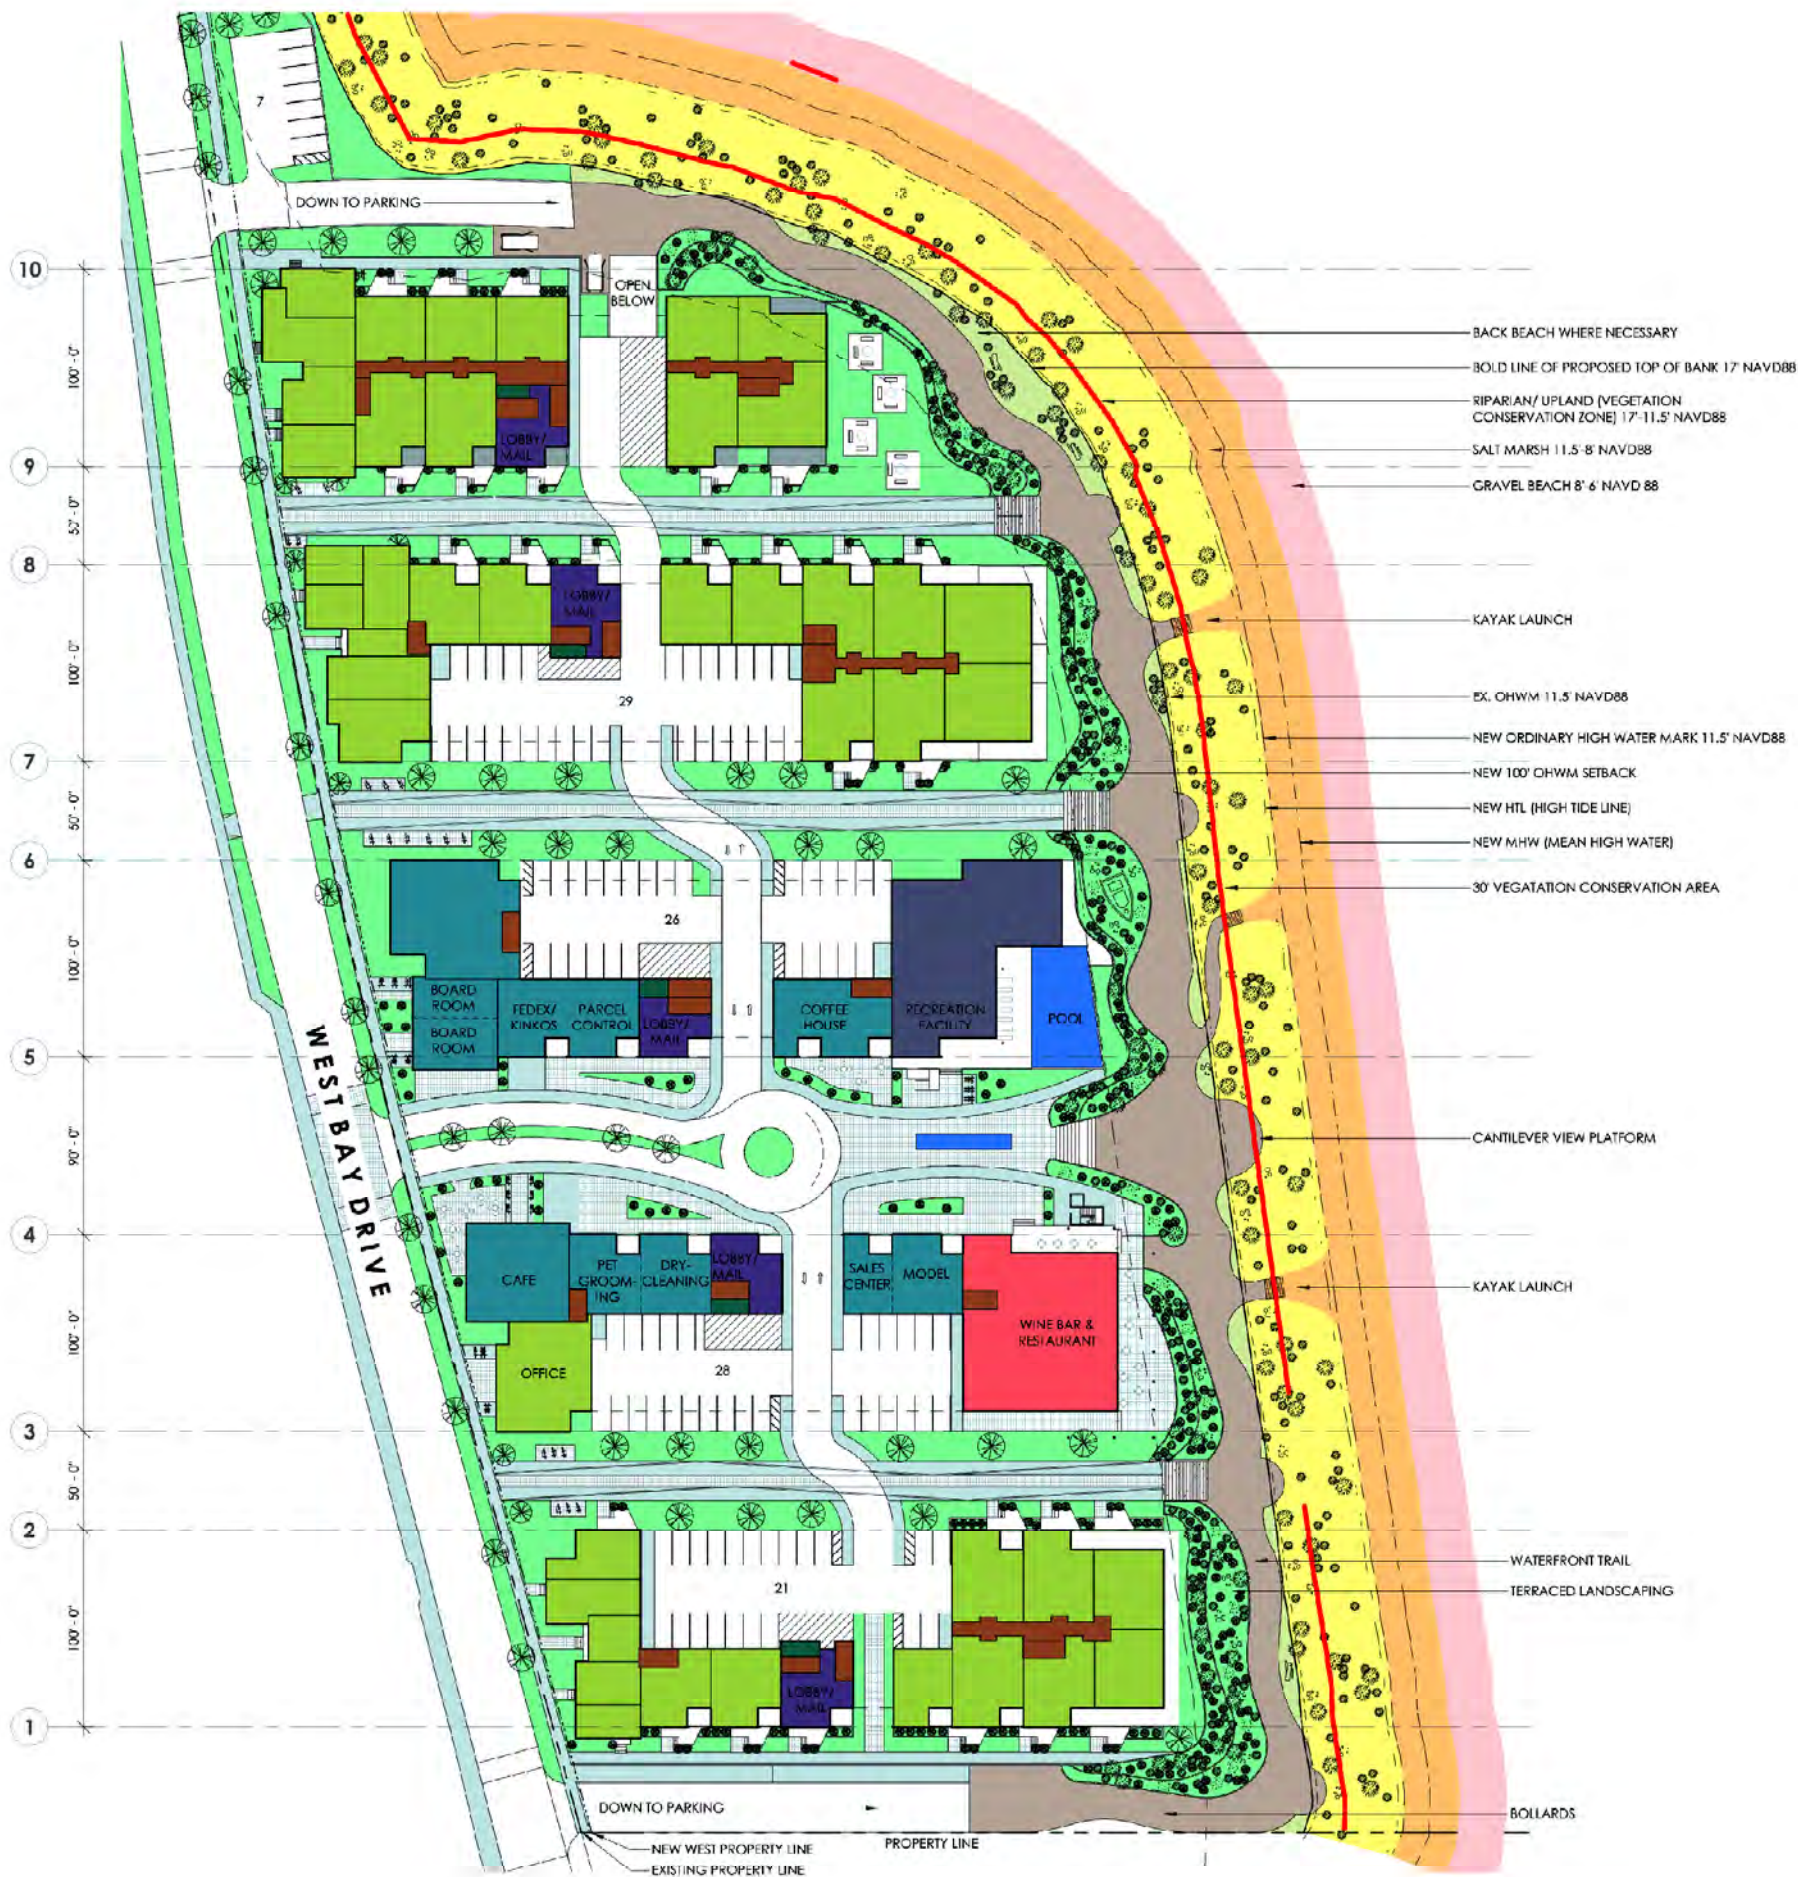
Redevelopment Overview
Remedial Investigation Data Gap Report
Hardel Mutual Plywood Corporation Site

West Bay Development Group, LLC purchased the property from Hardel in March 2021 and plans to construct a mixed-use development known as the West Bay Yards. This brownfield redevelopment project will transform a derelict industrial legacy property that has been unused for 25 years into a vibrant mixed-use development that provides urban housing, jobs, shoreline habitat restoration, and waterfront access. The redevelopment plans include (1) shoreline restoration, (2) outdoor public spaces (e.g., waterfront trail and kayak launches), (3) subsurface parking garages, (4) commercial retail, restaurants, and residential housing on the first floor of occupied spaces (i.e., “plaza level”) and (5) residential housing on the floors above the plaza level. The schematic design for the planned redevelopment is included in Appendix B, and the “site plan” from the schematic design is shown in Figure 2. Construction is currently scheduled to begin by 2023.

- The top of bank elevation for the proposed development will be 17 feet NAVD88 (see Figure 2 and Appendix B). As a result, up to four feet of clean fill soil will be added on top of the current ground surface prior to constructing any buildings. This also means that potentially contaminated subsurface soil will not be inadvertently brought to the surface during future construction activities.

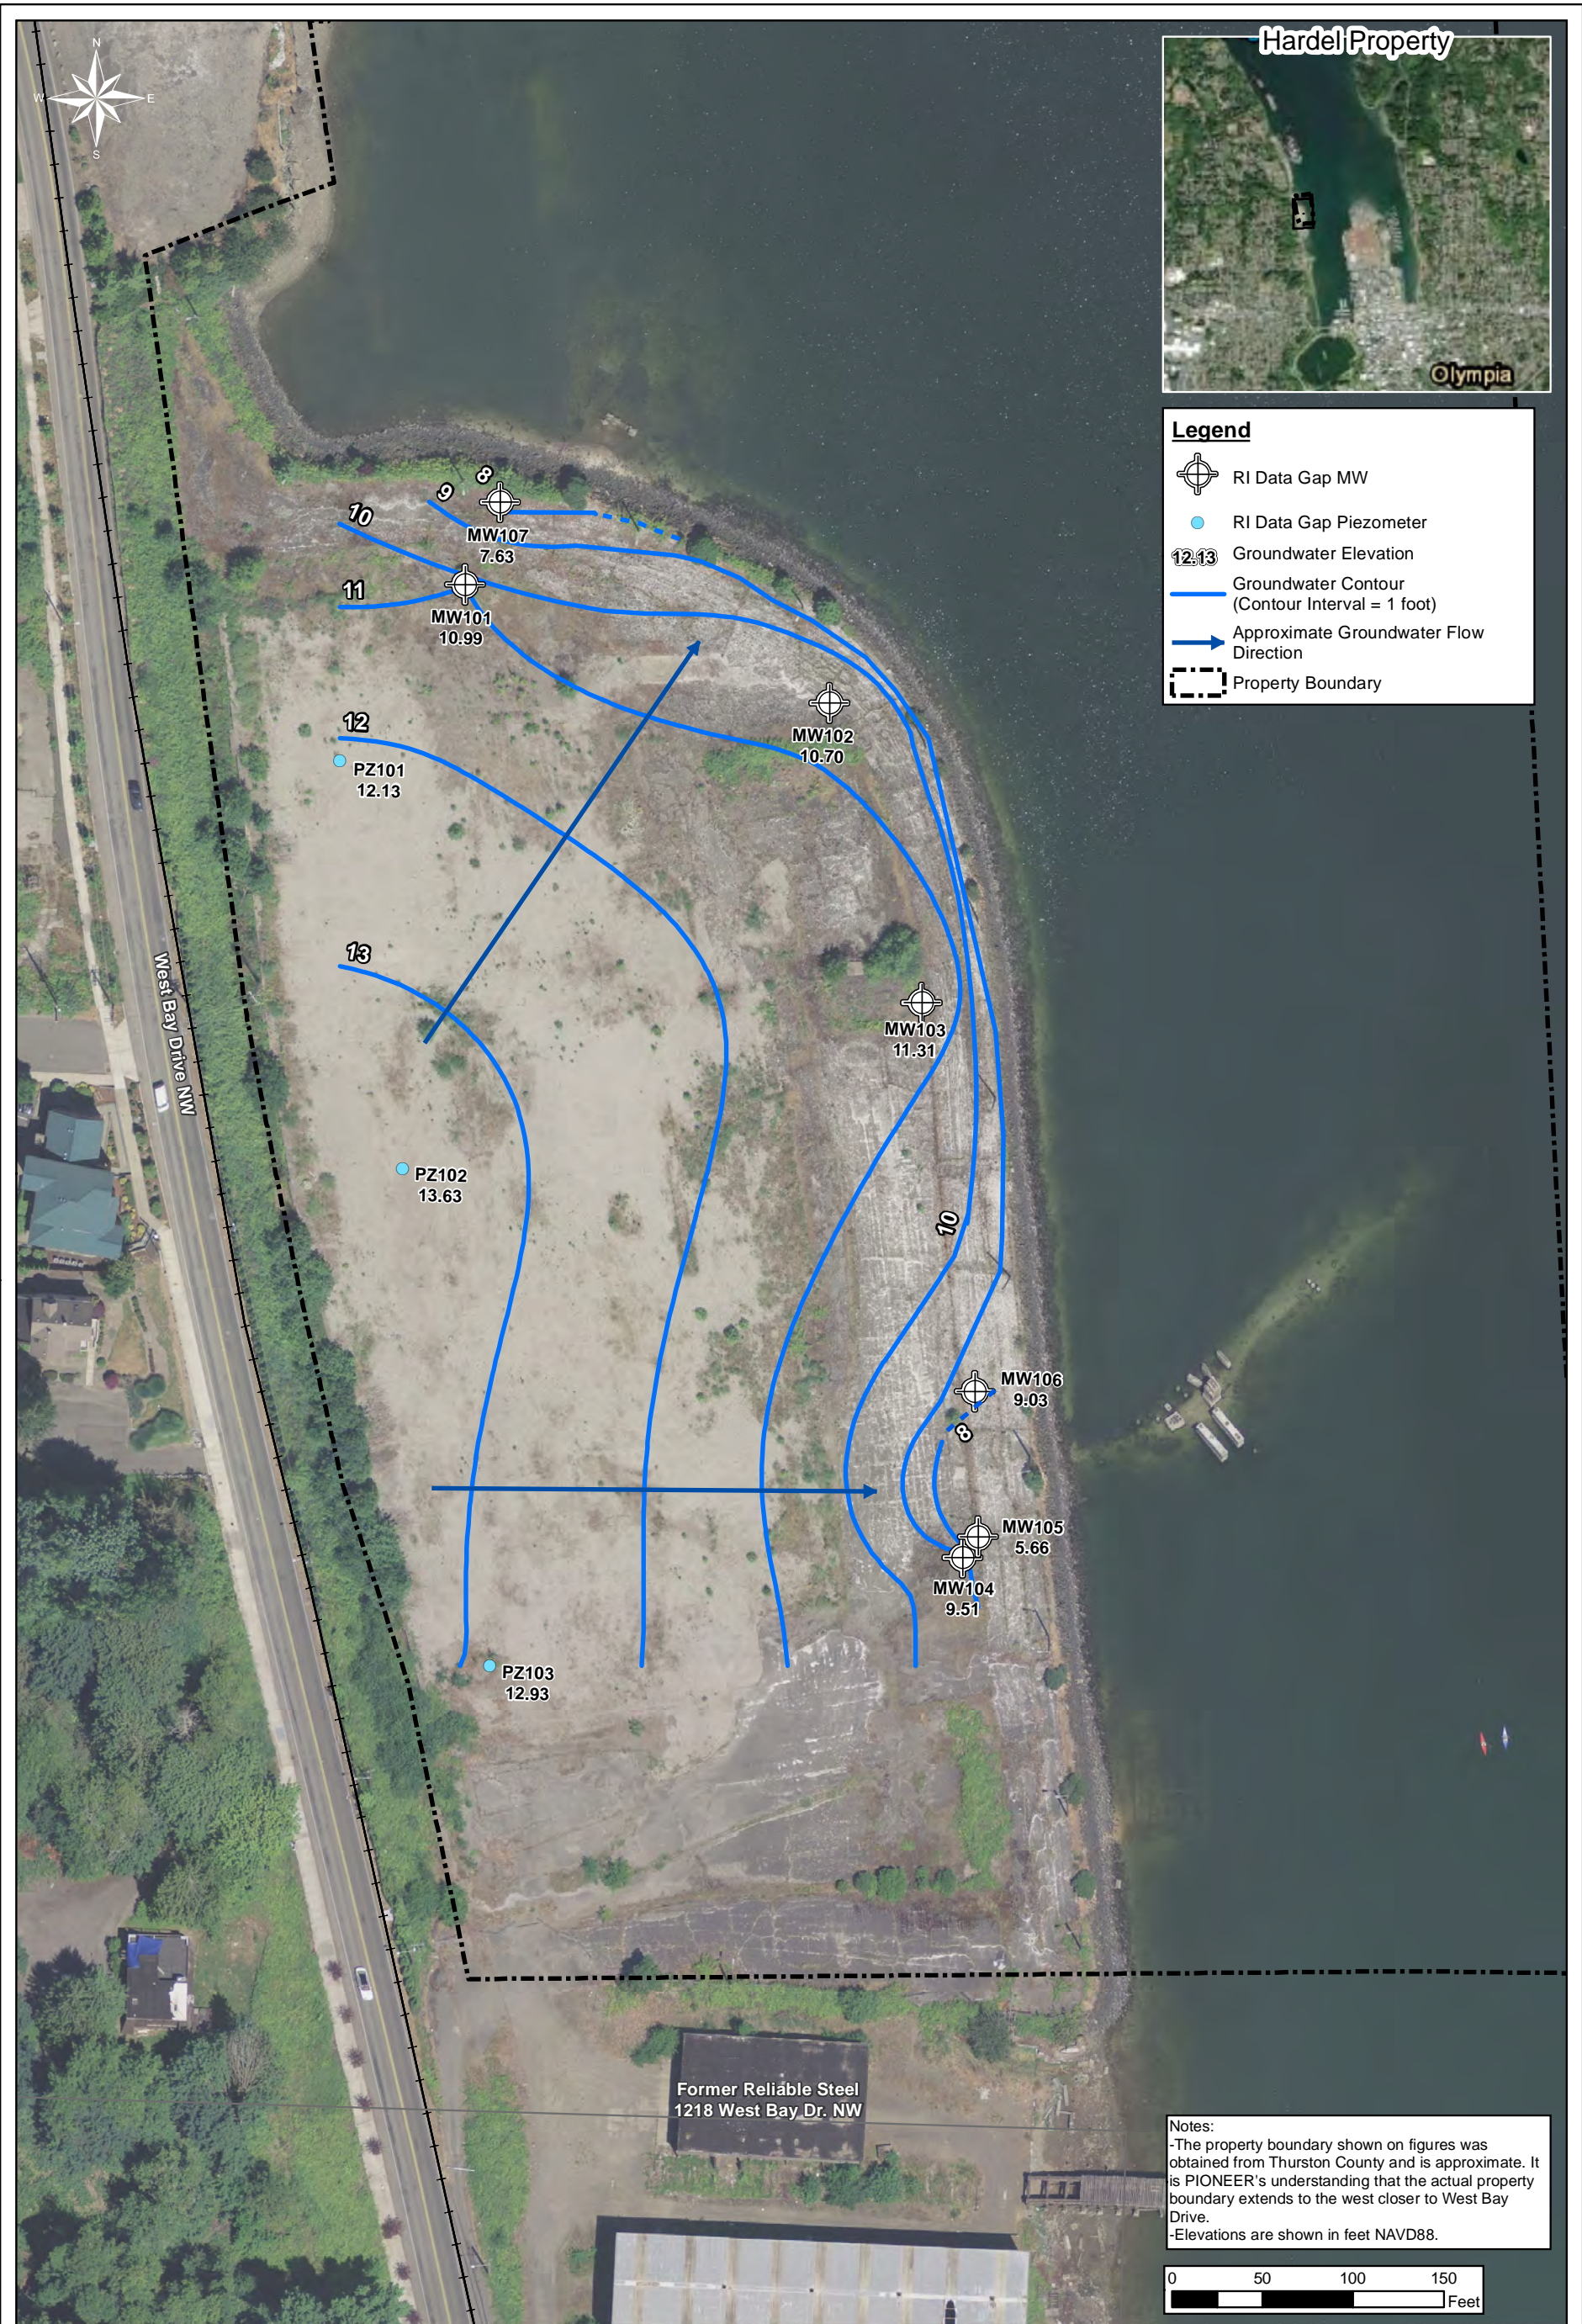
Figure 3

May 2021 Groundwater Flow Map
Remedial Investigation Data Gap Report
Hardel Mutual Plywood Corporation Site

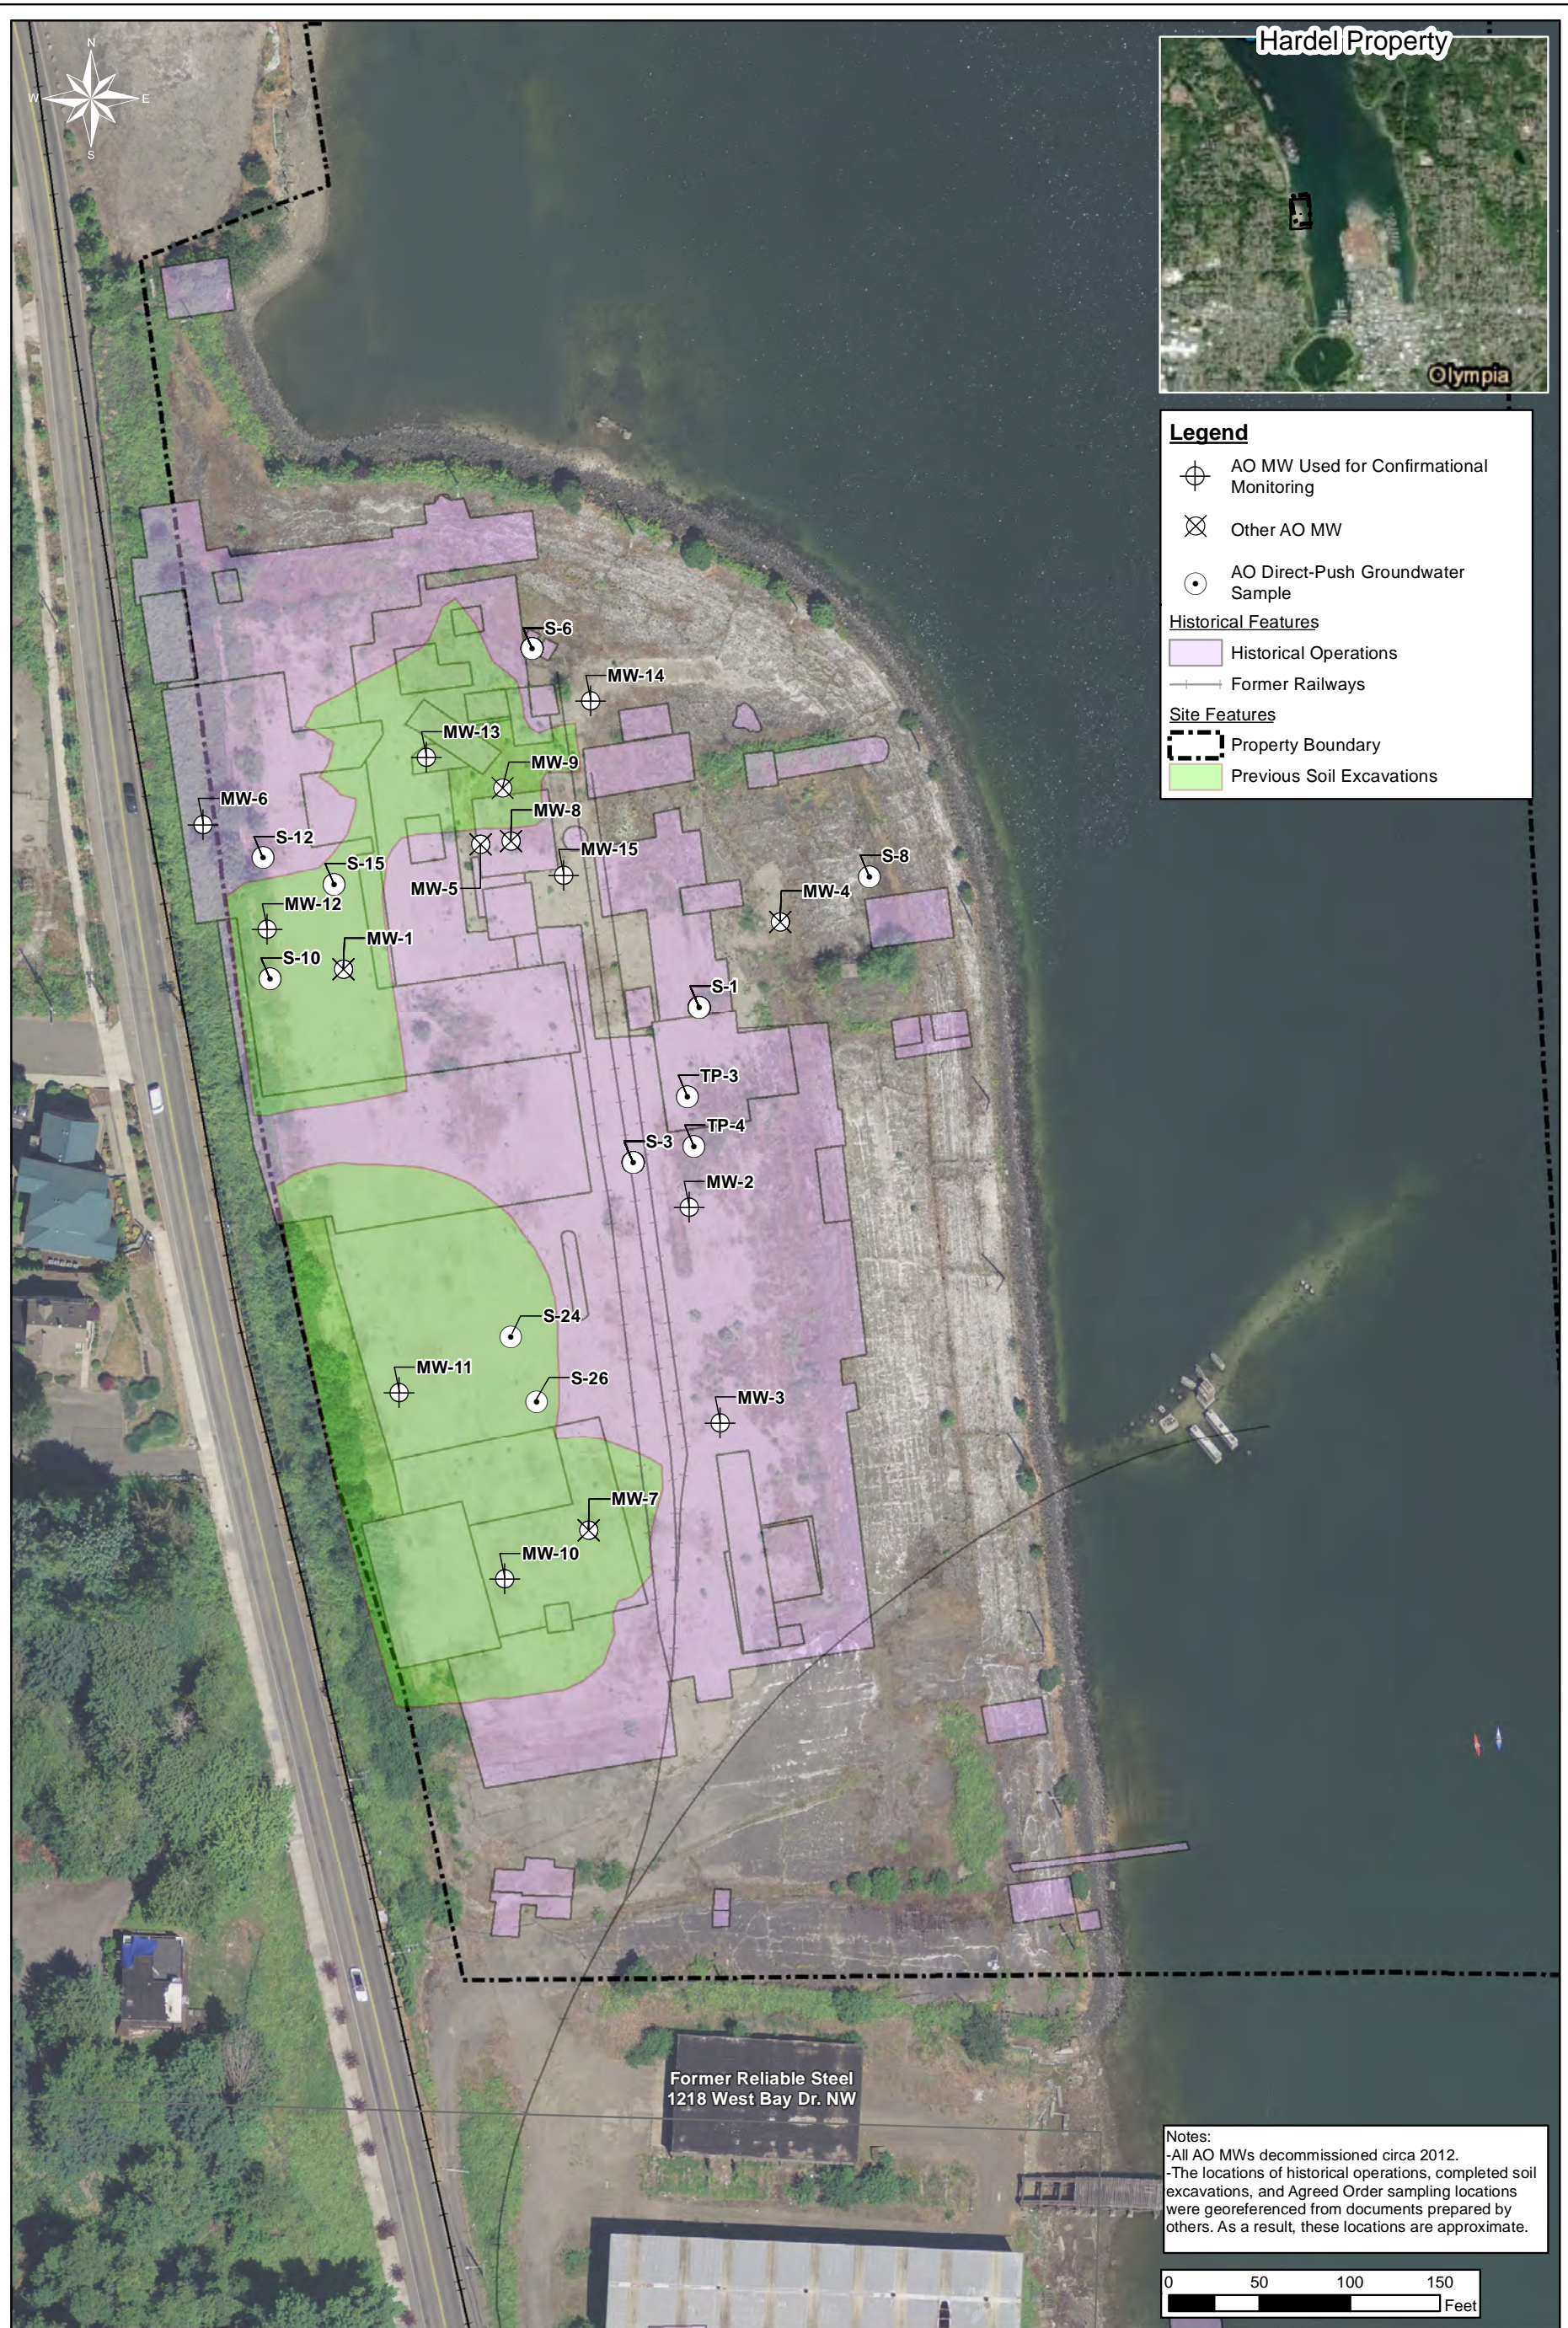
Figure 5

Historical Operational Features,
Completed Soil Excavations,
and AO Groundwater Sampling Locations
Remedial Investigation Data Gap Report
Hardel Mutual Plywood Corporation Site

- The 2010 IA (which included removal of contaminated soil and debris, stained concrete, and LNAPL) completely addressed all soil and groundwater contamination within and immediately downgradient of the IA excavation boundaries (see Figures 4 and 5).

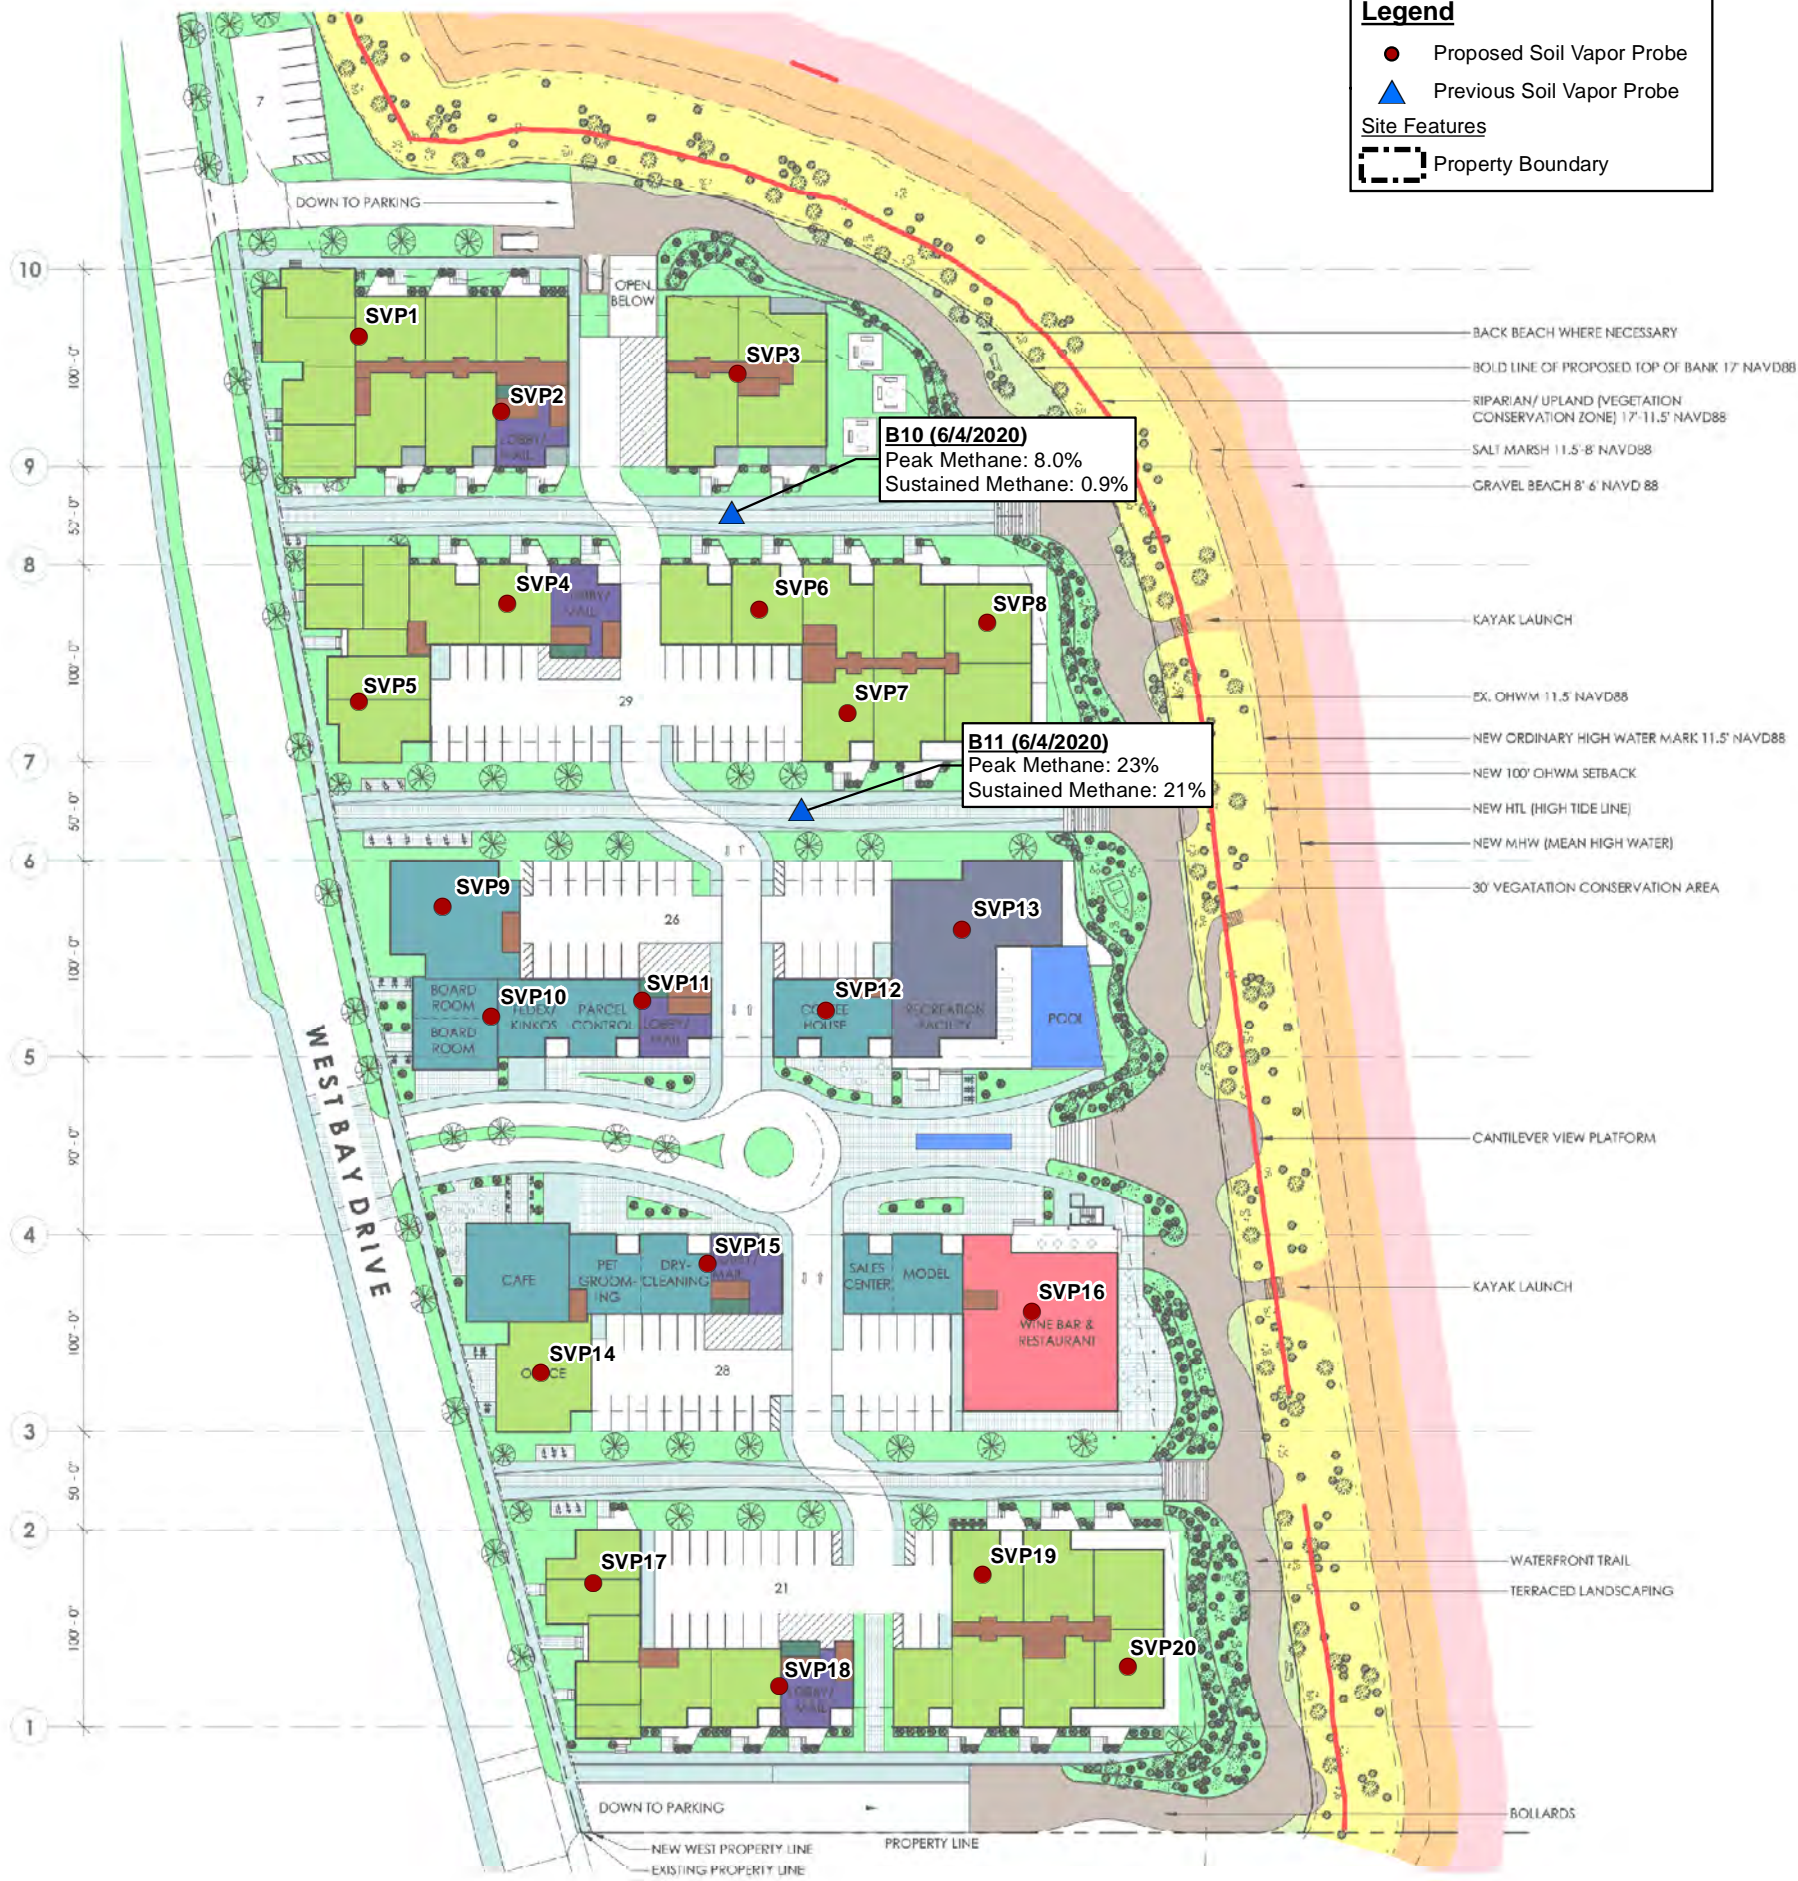
Notes:
 -%: percent by volume
 -Peak methane readings are those recorded at the beginning of SVP purging on June 4, 2020 and represent built up gasses within the capped SVP.
 -Sustained methane readings are those recorded after 15 minutes of SVP purging on June 4, 2020.

Based on the measured results in B10 and B11 SVPs (i.e., methane soil gas concentrations were less than 30% and differential pressures were less than 500 Pascals), no further action is recommended in ASTM Designation E2993-16 with respect to a potential methane hazard for future buildings (see decision matrix in Section 4.1.5). However, given the amount of wood debris in the subsurface, the relatively high methane concentration in B11, and the limited nature of the methane investigation activities to date, additional field methane investigations are planned now that the redevelopment schematic design has been prepared. Proposed SVPs locations for field methane soil gas measurements are shown on Figure 12. As part of the evaluation of these additional field methane measurements, it should be considered that potential methane gas transport to the air within subsurface parking garages in the planned redevelopment will likely be decreased by (1) the additional fill material that will raise the top of bank elevation to 17 feet NAVD88, and (2) the code-required air exchange requirements for an enclosed structure that will apply to the parking garages.
