**Drainage Evaluation**  
**for**  
**Bruce Titus, Chrysler Jeep**

Skillings Connolly, Inc.  
Thomas E. Skillings, PE

Bruce Titus Drainage Evaluation  
January 10, 2019

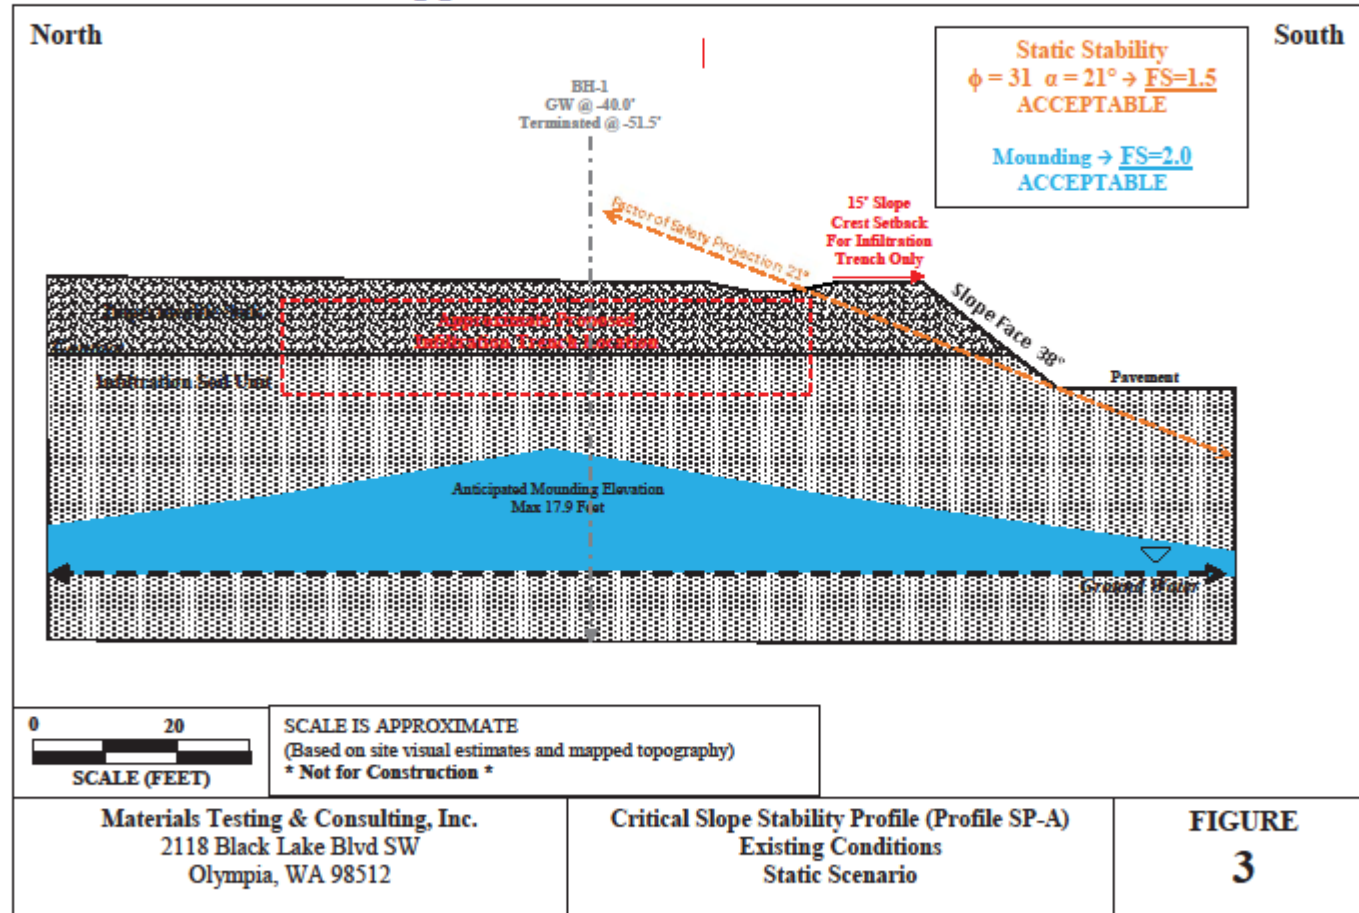
## Appendix C. SLOPE PROFILES

Mr. Titus has indicated he has observed a large amount of water seeping out of the bank on the north property line during high rainfall events. I believe this is most likely the result of the rain infiltrating the upper soils layer, hitting the till layer, flowing in a southerly direction and exiting out of the bank at the Dealership’s north property line. The developer is proposing to continue to infiltrate rainwater from roof drains, pervious pavement, rain gardens, yards and landscaping. Stormwater will also continue to infiltrate from the ponds in Wellington West development. Therefore, it can be anticipated stormwater induced groundwater seepage will continue to occur along the Dealership’s north property line and will impact the Dealership property.

There is a potential for the project’s infiltration pond to create seepage on the bank below the infiltration site. (See discussion on groundwater mounding.)

- I would recommend a “French drain” cutoff be constructed at the top of slope to intercept the seepage that can be anticipated to be generated from the Wellington Heights project. This will *“protect the downstream properties from stormwater impacts”, to facilitate compliance with mitigation measure No. 3.*
