**Re: Portadam® Feasibility Assessment
West Bay Yards Shoreline Restoration
Olympia, Washington
Sage Project No. 033001**

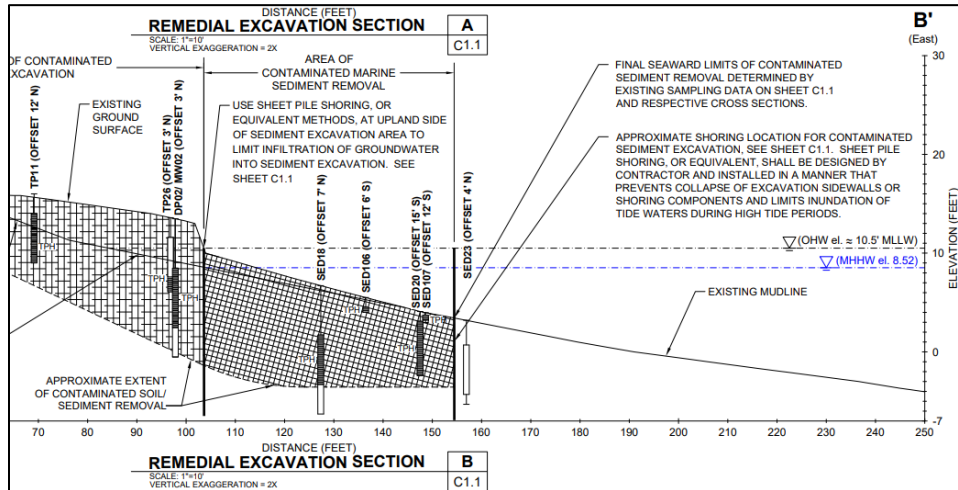
The Portadam described above replaced a contractor-designed sheet pile wall cofferdam. The excerpted plan sheet below shows topographic similarities between the West Bay Yards Shoreline Restoration project and the Irondale Iron and Steel Plant project. Both projects were designed to limit groundwater infiltration into shoreline construction excavations.

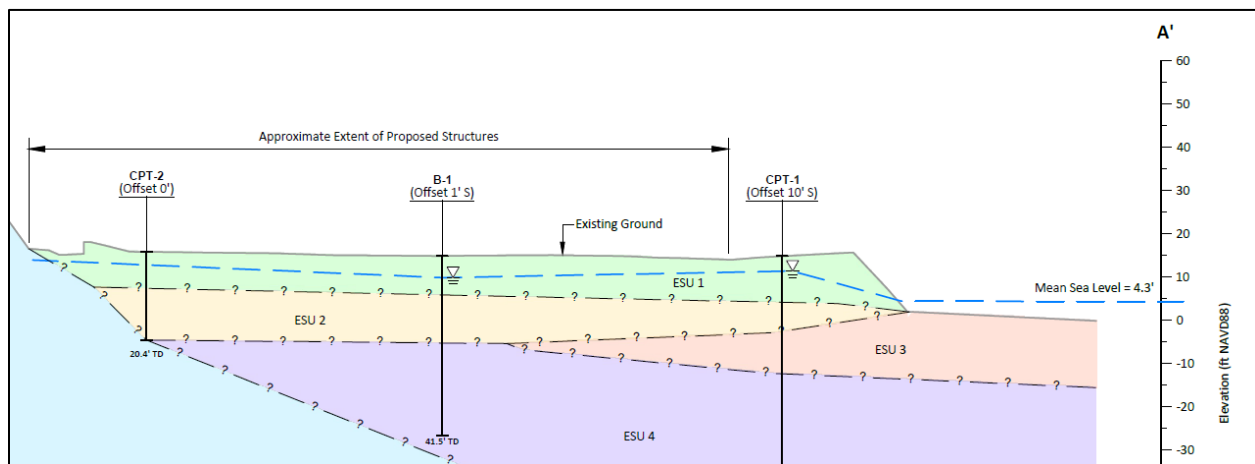
Sage concludes that Portadam construction is not feasible at West Bay Yards due to the presence of soft plastic/cohesive, fine-grained site soils (Engineering Stratigraphic Unit [ESU] 3). The approximate extent of ESU 3 soil is shown below (Landau 2020). The location of ESU 3 soils align with the location of where a Portadam would be constructed.

The estimated shear strength of the ESU 3 soils is as low as 0.2 tons per square foot. Additional loads, such as those contributed by a Portadam, are likely to exceed the bearing capacity of ESU 3 soils. As a result, the Portadam foundation could experience instability and failure. Additionally, excavation and dewatering inside the Portadam present a risk for piping and excavation instability.
