City of Olympia

West Bay Environmental Restoration Assessment

Final Report

Coast & Harbor Engineering, a Division of Hatch Mott MacDonald

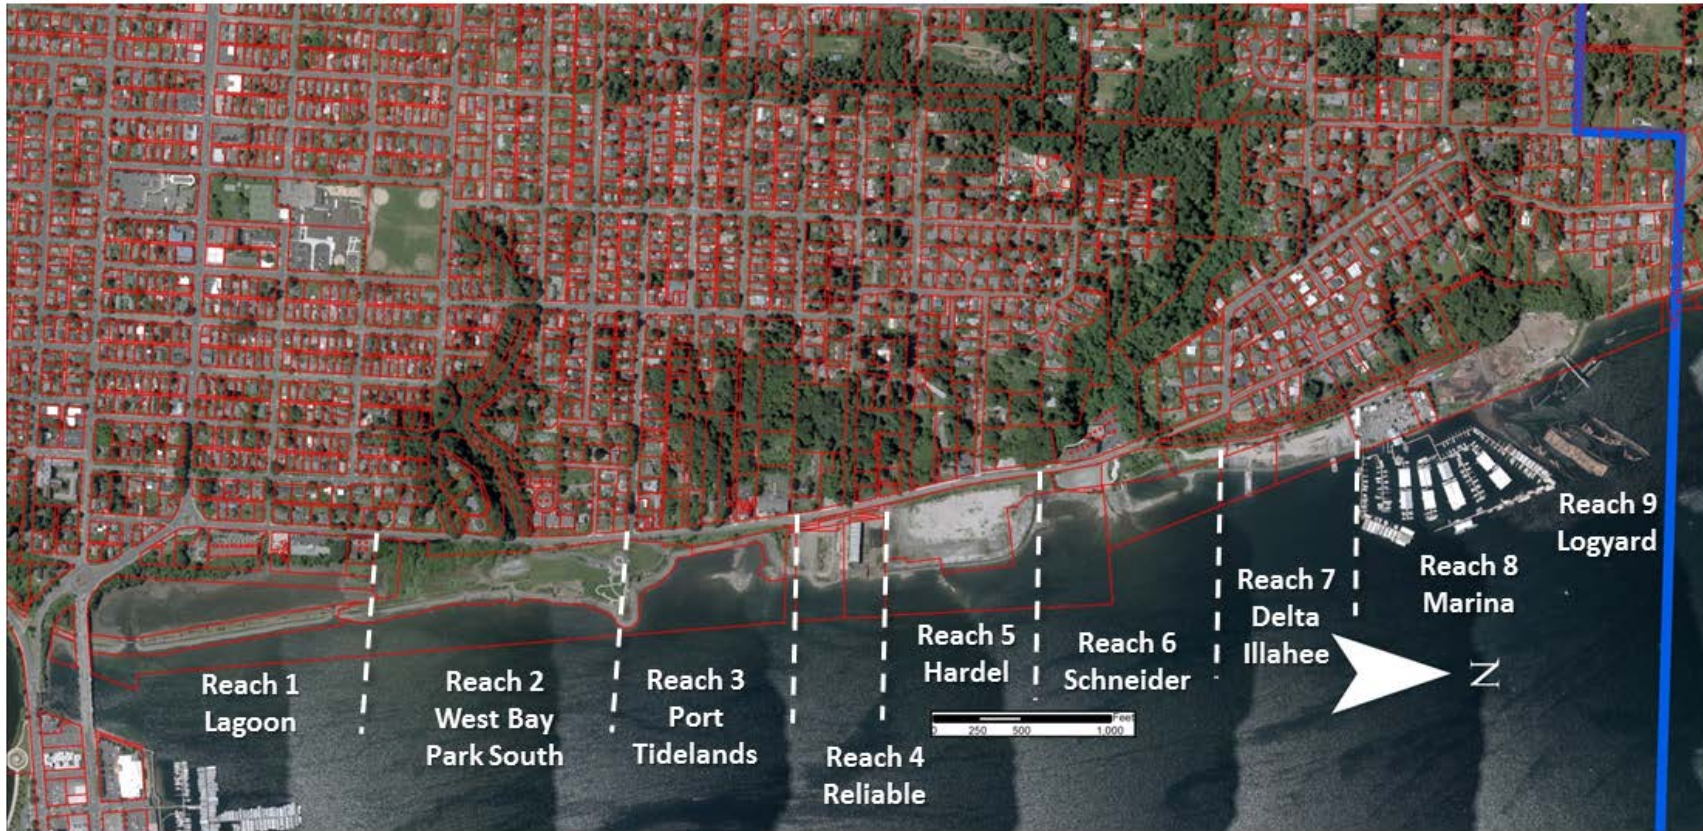
Figure 1. Project reaches, parcel boundaries, and aerial photograph from 2015.

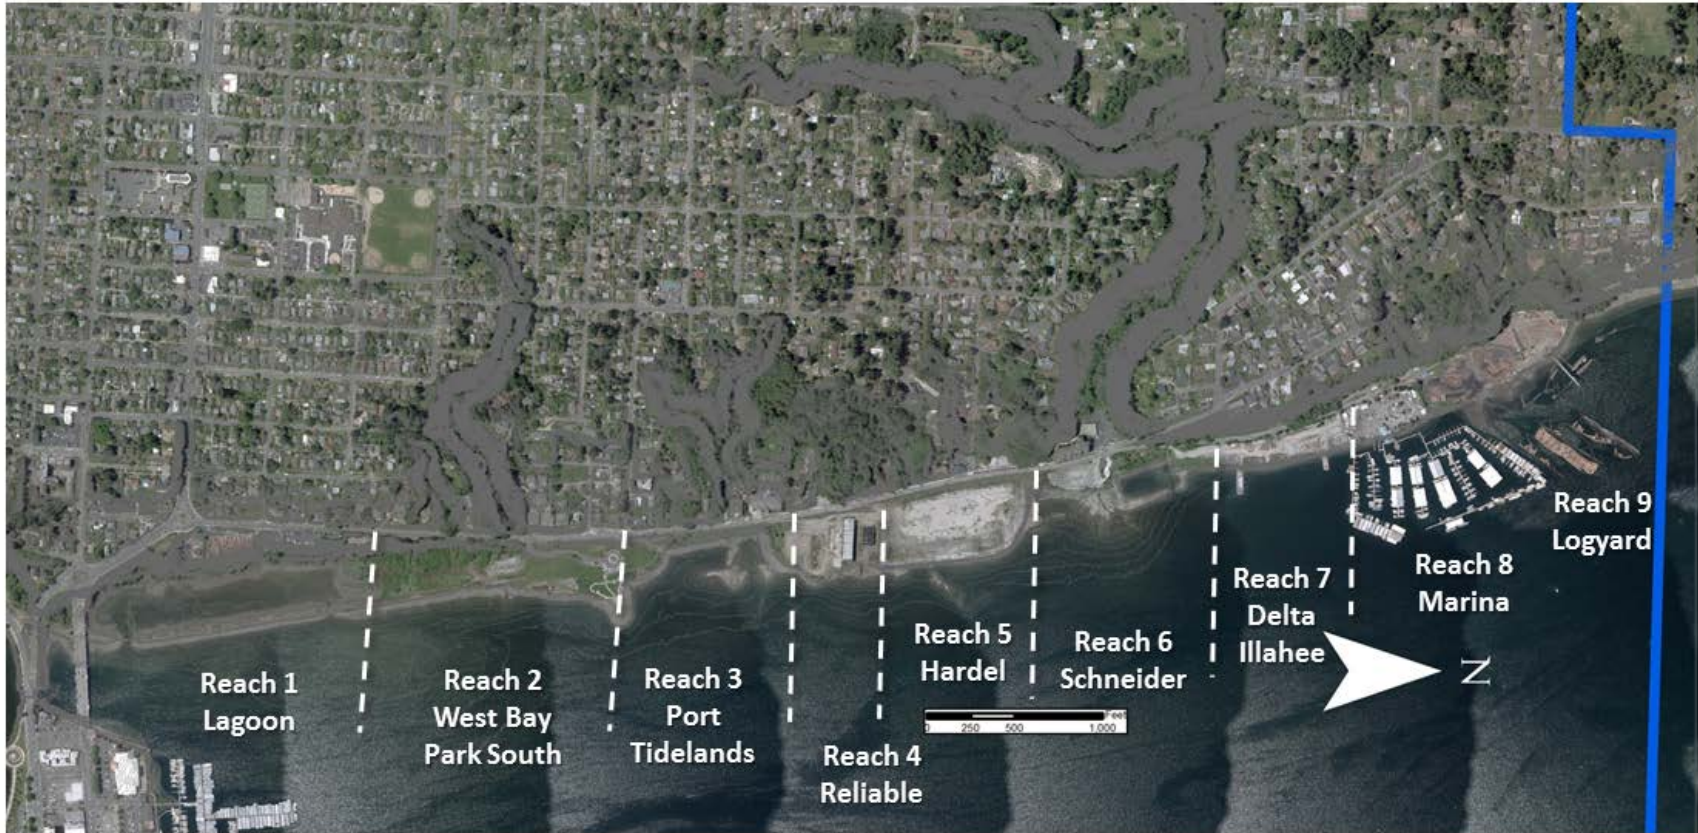
Figure 2. Project base map showing project reaches, 1-ft topographic contours, and aerial photograph from 2015.

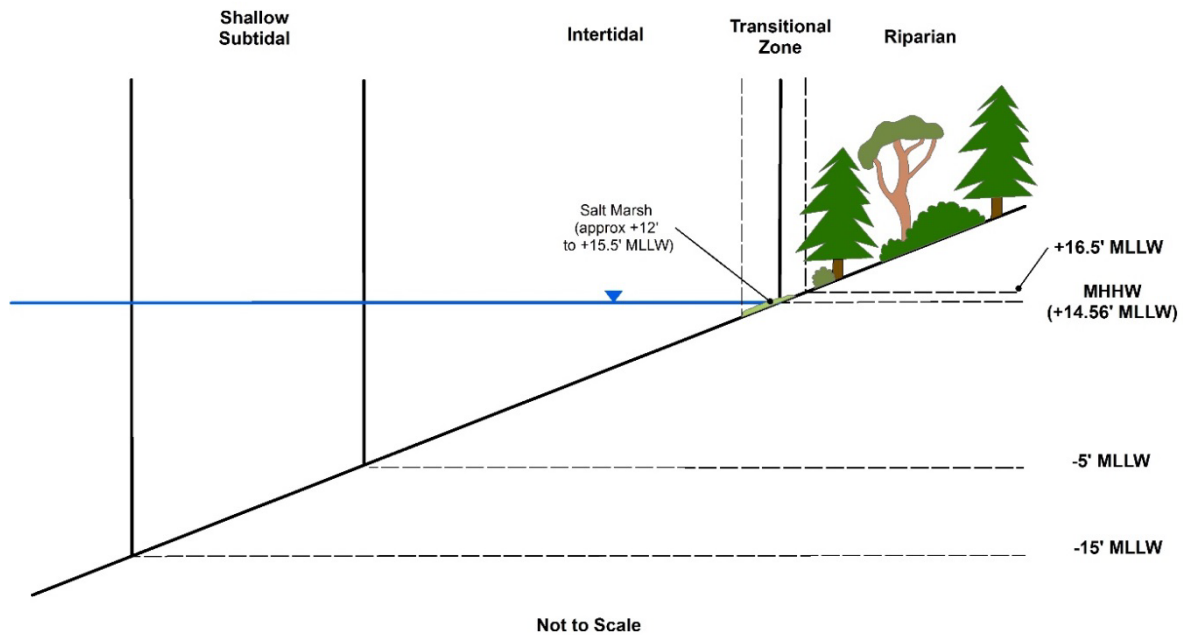
Figure 4. West Bay Habitat types cross section.

The West Bay habitat valuation model uses four primary inputs; 1) existing habitat type value, 2) proposed habitat type value, 3) size, and 4) year to maturity. Habitat types obtained from existing models include estuarine marsh, intertidal, and shallow subtidal from Iadanza (2001) Riparian habitat type was obtained from unpublished draft guidelines. Figure 4 shows a typical profile of the habitat types used in the assessment.

Upper and lower habitat values established for each habitat type reflect fully functioning and degraded conditions, respectively. Habitat value ranged from 0.0 for developed land to 1.0 for estuarine marsh and freshwater/brackish wetlands. Baseline adjusted habitat values are also included to discount the value of functioning habitat adjacent to degraded habitat. The number of years required for habitat types to mature to fully functioning conditions is also defined in existing models and used in habitat improvement calculations. This value is incorporated into the model to reflect the specific amount of time each restored habitat type takes to achieve the level of function that would occur naturally and the respective increase in value of each habitat type over time as it matures. Modifications made for the West Bay assessment include the addition of freshwater/brackish wetlands habitat type, partially functioning conditions, and reduced habitat function under elevated structures as shown in Table 4.

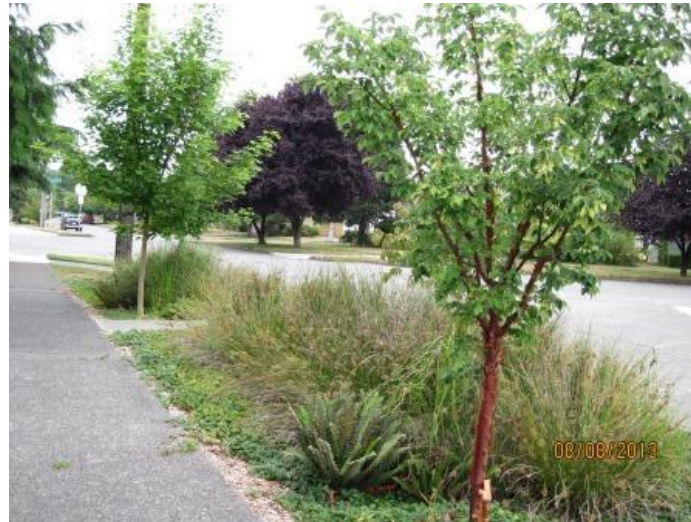
Figure 1 - Bioretention Area installed on existing landscape strip to treat roadway runoff

Low Impact Development stormwater techniques such as bioretention (rain gardens) and other techniques such as treatment wetlands are designed to mimic the benefits of the natural environment to achieve stormwater treatment and other benefits. These approaches generally use more real-estate than the emerging technologies which are mostly underground facilities. Therefore, LID type approaches are generally better suited for sites that will be redeveloped, or where the LID feature can be incorporated into the landscaping of a development or habitat restoration project. Bioretention areas can also be retrofitted in the shoulder or planting area adjacent to existing roads, as shown in Figure 1.

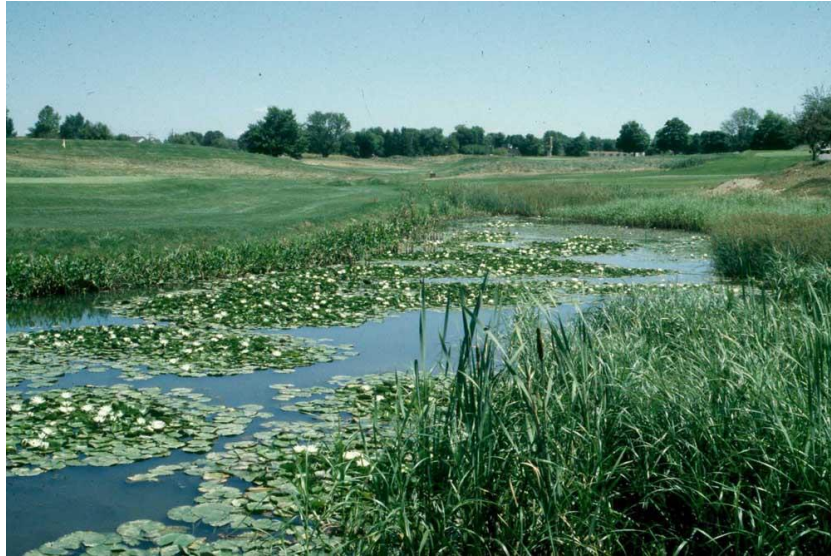
Figure 2 - Treatment Wetland

A stormwater treatment wetland is a conventional stormwater treatment BMP that is designed to mimic the benefits of natural wetlands, by treating stormwater through the biological processes associated with emergent aquatic plants. These type of wetlands consist of shallow man-made ponds that typically consist of a pre-settling cell and a wetland cell which is planted with emergent wetland plants. An image of a stormwater wetland is shown in Figure 2. Stormwater wetlands perform well to remove sediment, metals, and pollutants that bind to humic or organic acids. Phosphorus removal in stormwater wetlands is highly variable.

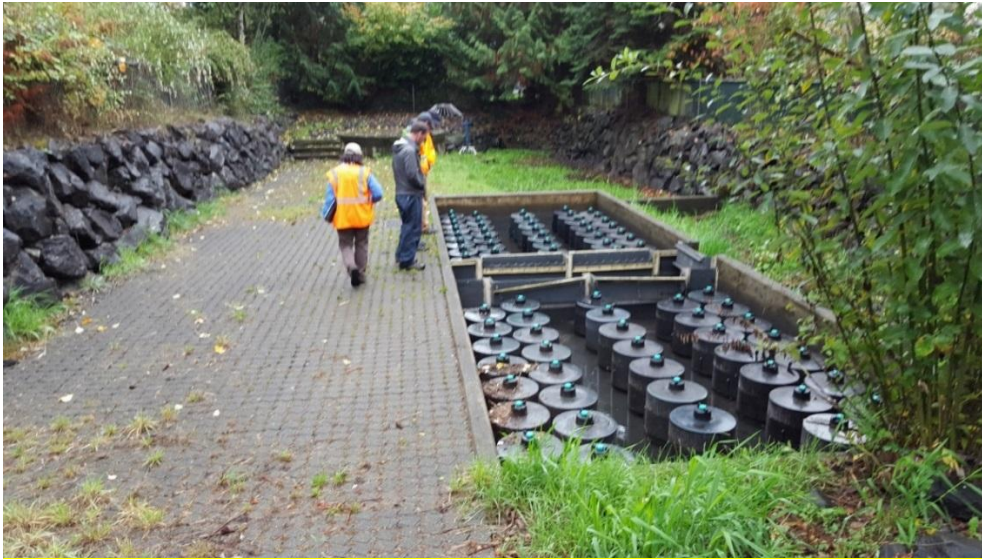
Figure 3 - Stormwater Filtration at the City of Olympia's Giles Avenue Facility

The City of Olympia has an existing StormFilter® facility with pretreatment (CDS) at the Giles Avenue treatment facility, which is in the Schneider Creek basin. That facility, as shown in Figure 3, is installed without the concrete lid, allowing a view of the cartridges within.

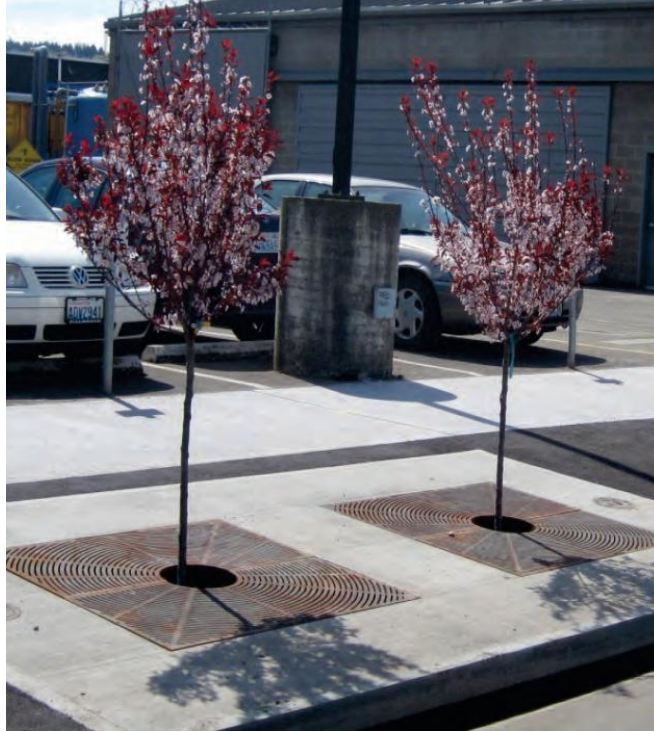
Figure 5 - Filterra® Bioretention System installed adjacent to sidewalk

Manufactured biological filtration devices are Media filtration devices that support plants or bacterial biofilms. Examples that have been approved by Ecology for use in Washington include Filterra® tree box units and Modular Wetland System®. Filterra® tree box units have been used in Olympia and throughout western Washington, and are GULD approved for oil treatment in addition to enhanced and phosphorous. Therefore, the Filterra® system has been used for cost estimating the conceptual opportunities in this study. A diagram of the Filterra® tree box components is shown in Figure 4. An image of a Filterra® tree box installed adjacent to a sidewalk is shown in Figure 5.

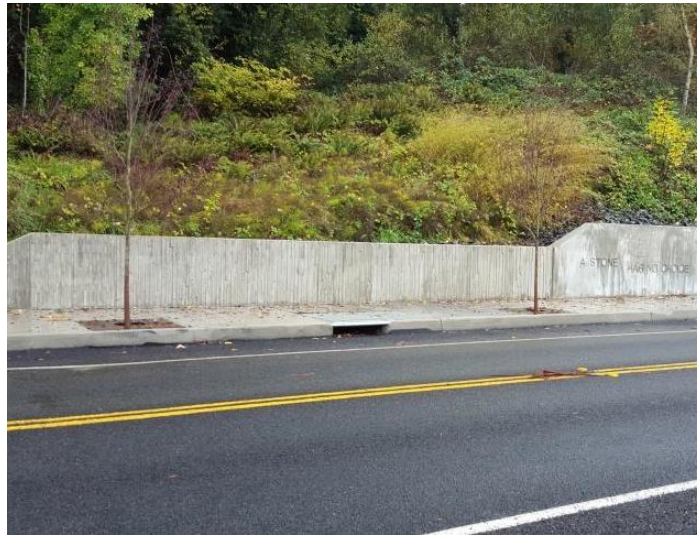
Figure 6 - Modular Wetland System (MWS)® installed on West Bay Drive

An existing outfall is located on the former Reliable Steel site, and drains an area of approximately 13 acres, much of which is forested and undeveloped. A portion of West Bay Drive in this area does have existing stormwater treatment for the roadway runoff. This treatment was installed by the City of Olympia with a roadway and sidewalk project that was completed in 2015 (see also Figure 6).

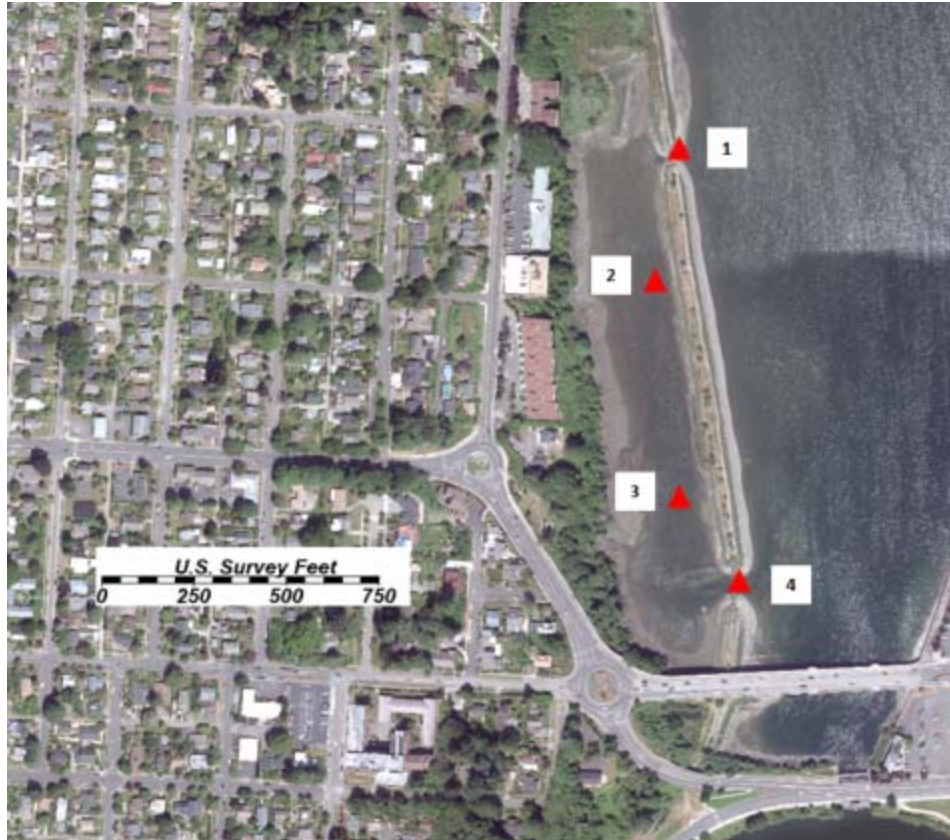
Figure 11. Location of model stations used for stationary analysis.

The output from local scale numerical model simulations included water surface elevations, depth-averaged flow velocities. Results were evaluated by analysis of changes in velocities throughout the lagoon and numerical dye tracer propagation in response to changes in the lagoon configuration. The flow velocity analysis included extraction and comparison analysis of modeling results at controlling stations. For all modeling scenarios, model stations were specified in the modeling domain at locations that are considered representative for analysis of potential changes and for evaluation of the conceptual design alternatives. The locations of the representative stations are shown and labeled in Figure .

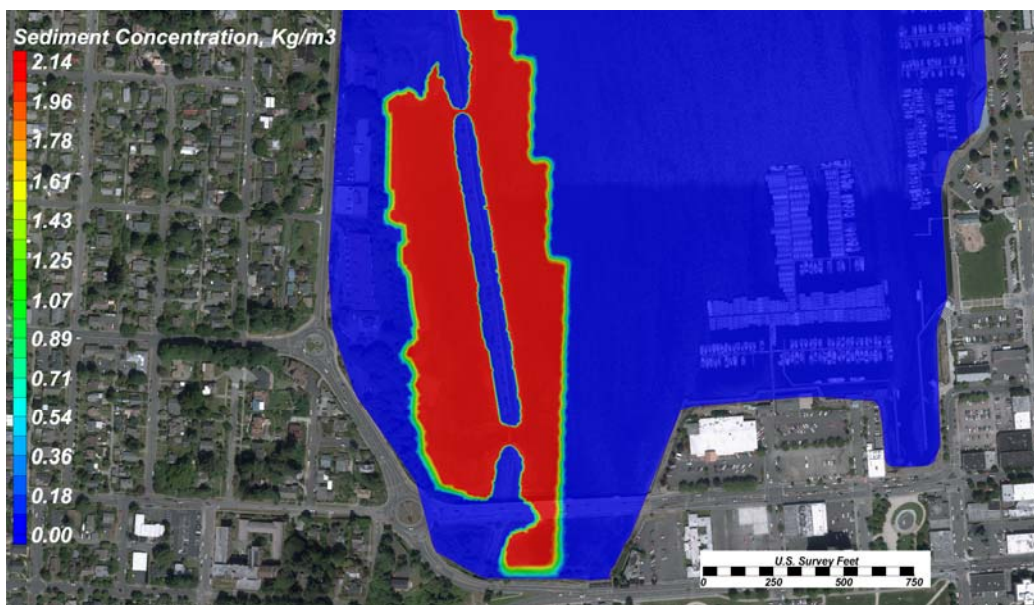
Figure 14. Initial concentration around the lagoon for evaluation of residence time in the lagoon for existing conditions.

Numerical dye as a concentration tracer modeling was conducted to determine the residence time for each of the alternative lagoon design options. Residence time was used as a proxy for circulation and flushing of each of the alternative designs. The residence time in a body of water is typically defined as the amount of time required for the concentration of some suspended material – non-settling dye in this case – to drop down to 37% of its initial concentration. The faster that it takes to decrease the initial concentration to the reference concentration, the more circulation is taking place in the body of water. A non-settling constituent (e.g. numerical dye) was integrated into the modeling grid around the alternative lagoon designs. Circulation models were run for existing conditions and each of the alternatives. The initial concentration conditions within the lagoon was set to 2.14 kg/m^3 and residence time was determined when the average concentration in the lagoon reduced to 0.79 kg/m^3 . Figure 14 shows the modeling grid for existing conditions with the initial concentration of the lagoon at 2.14 kg/m^3 . As the models run, tidal flow through the lagoon and flow from the dam results in the dispersal of the initial concentration condition prior to dispersal.
