From: Michelle Sadlier
Sent: Friday, July 10, 2015 3:12 PM
To: Todd Stamm
Cc: Michelle Sadlier; Nancy Lenzi
Subject: Medela Rezone - Review of Historical-Period Resources
Attachments: 1 - Aerial of Cemetery Labeled w Concentration of Historical-Period Markers.jpg; 2 - Historical-Period Buildings Labeled.jpg; 3 - Table of Properties Surveyed.docx

Informal Reconnaissance-Level Survey for Medela Rezone
Buildings Aged 45 Years Old & Older

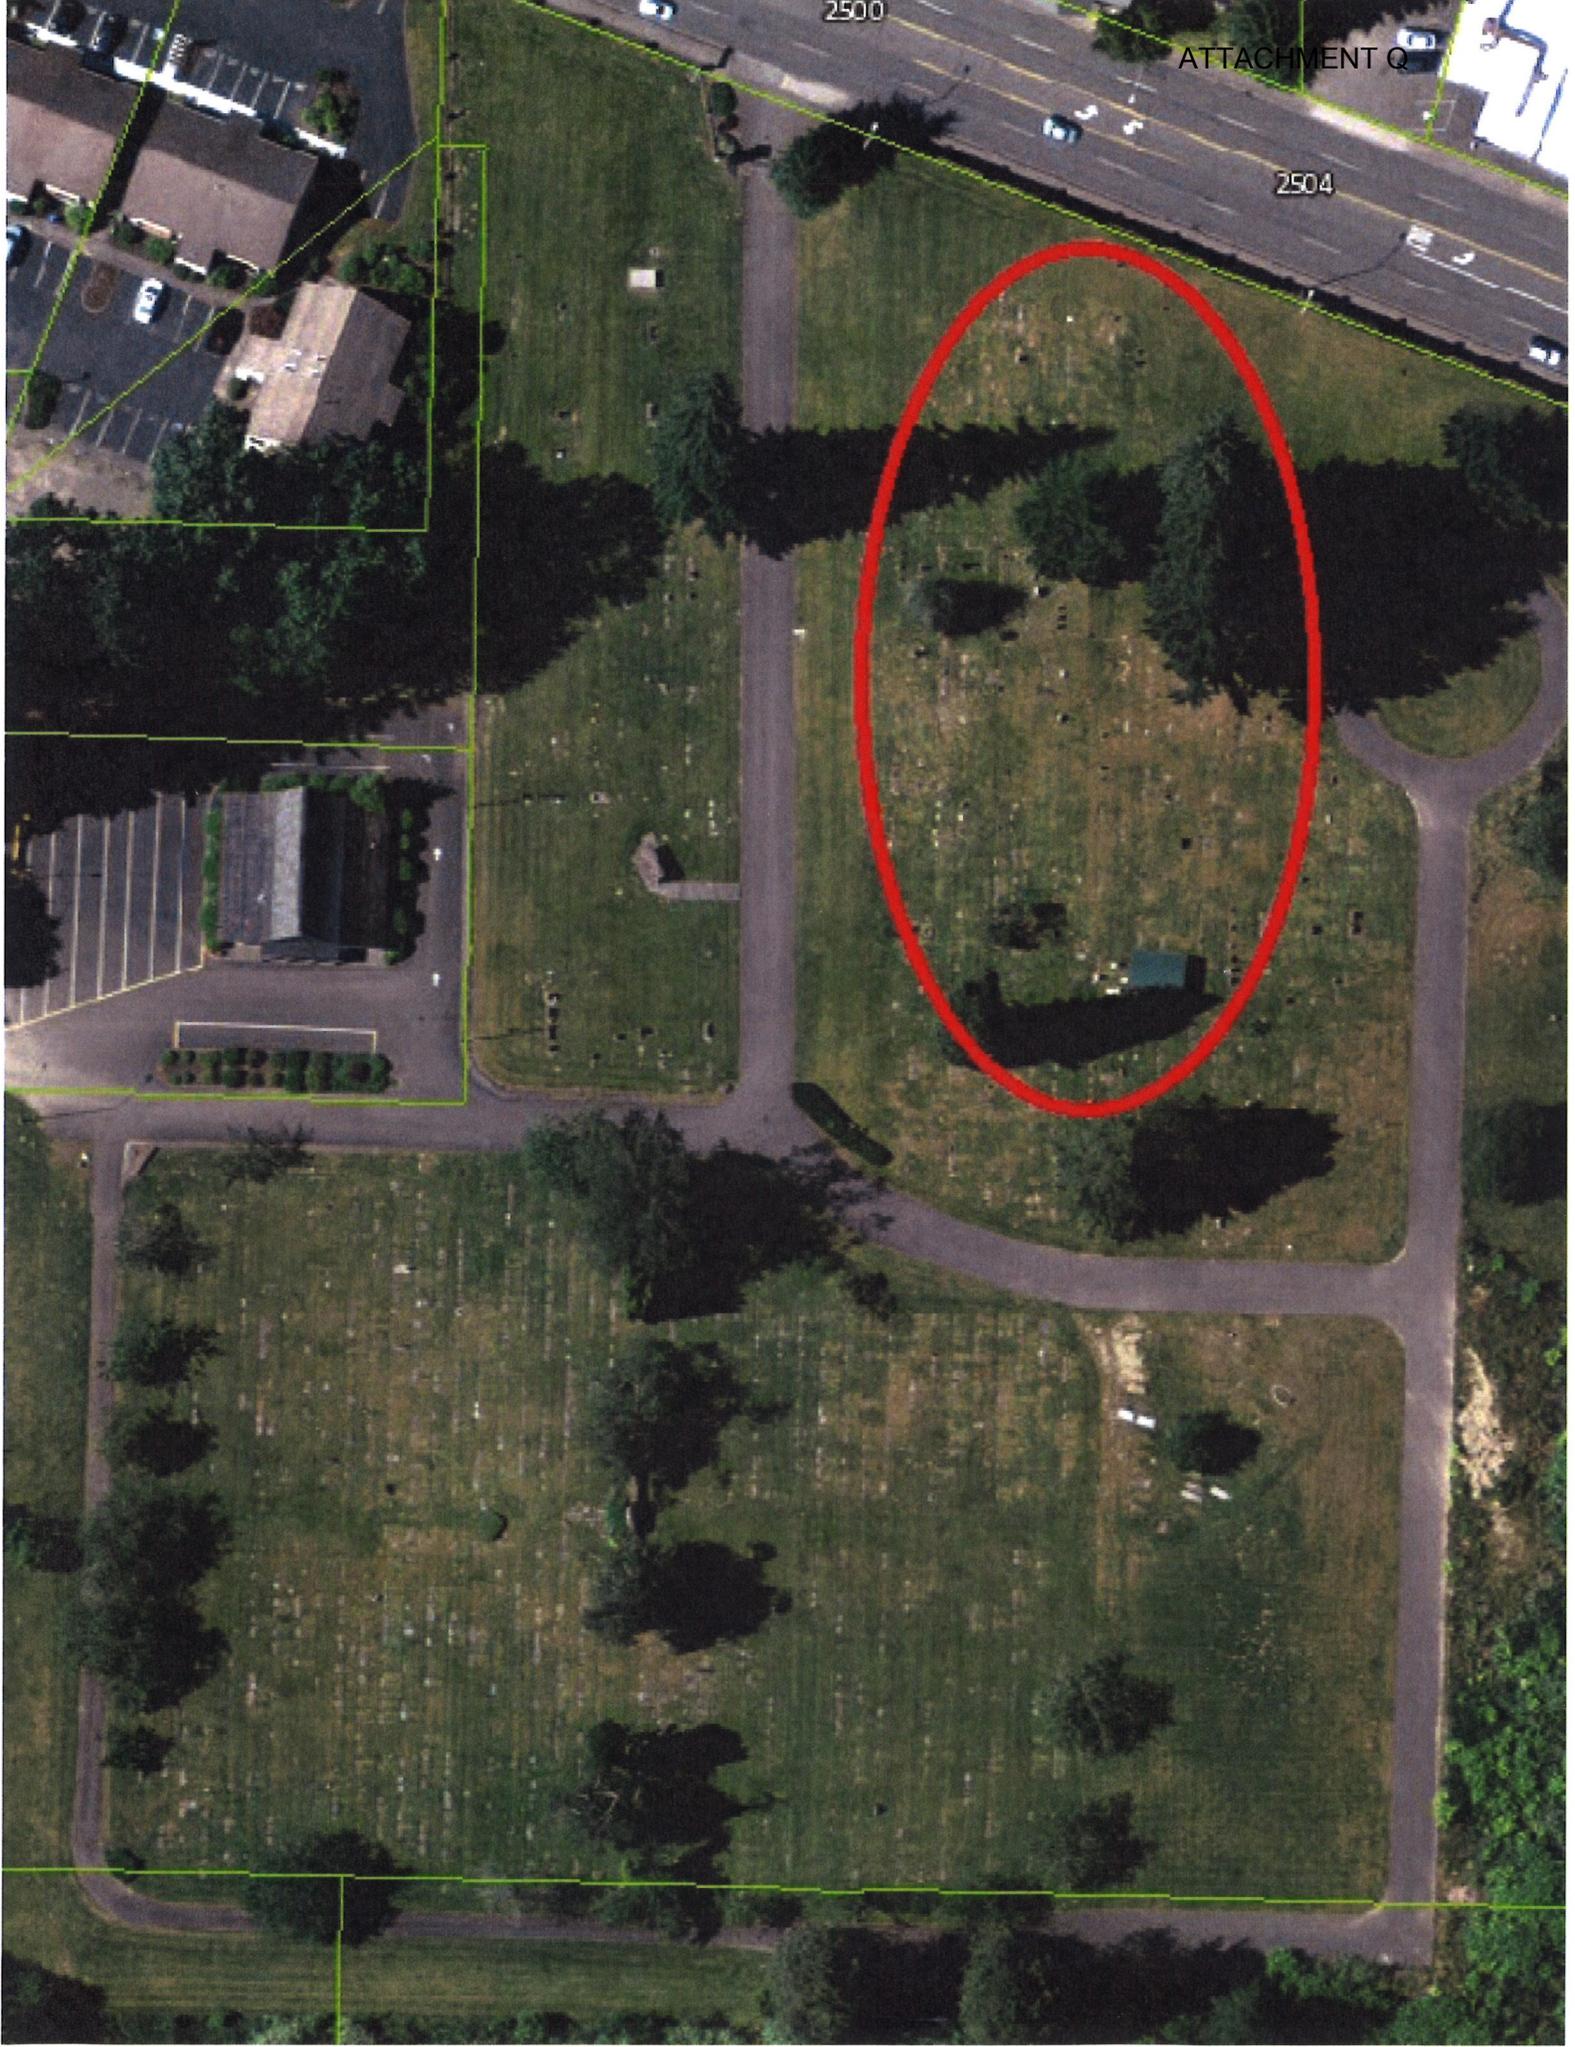
I identified where the core of the historic-period grave markers is located (see map in Attachment 1). I have photographs of the cemetery survey if you need them.

Most of the oldest grave markers are located at the center and northern end of the core grouping. The southern boundary of the core grouping is a minimum of 250' from the northern boundary of the proposed rezone area. In the cemetery area located between the historical grouping and the site of the proposed rezone, a review of the grave markers and mausoleum plates indicates that they date only as far back as the late 1960s.

In my opinion, with the distance between the historical core and the proposed rezone site and the intervening, modern-period burials in between, it is unlikely that there would be historic-period spillover burials on the site of the rezone.

These observations are unlikely to have direct bearing on the rezoning process but if the area is rezoned for multifamily and a proposal is submitted that requires SEPA review, an assessment of the known and anticipated nearby archaeological resources should be performed. I recommend that the project proponent consult with Department of Archaeology and Historic Preservation (DAHP) and the Tribes of record to help in the archaeological assessment and identification of any appropriate mitigation as needed.

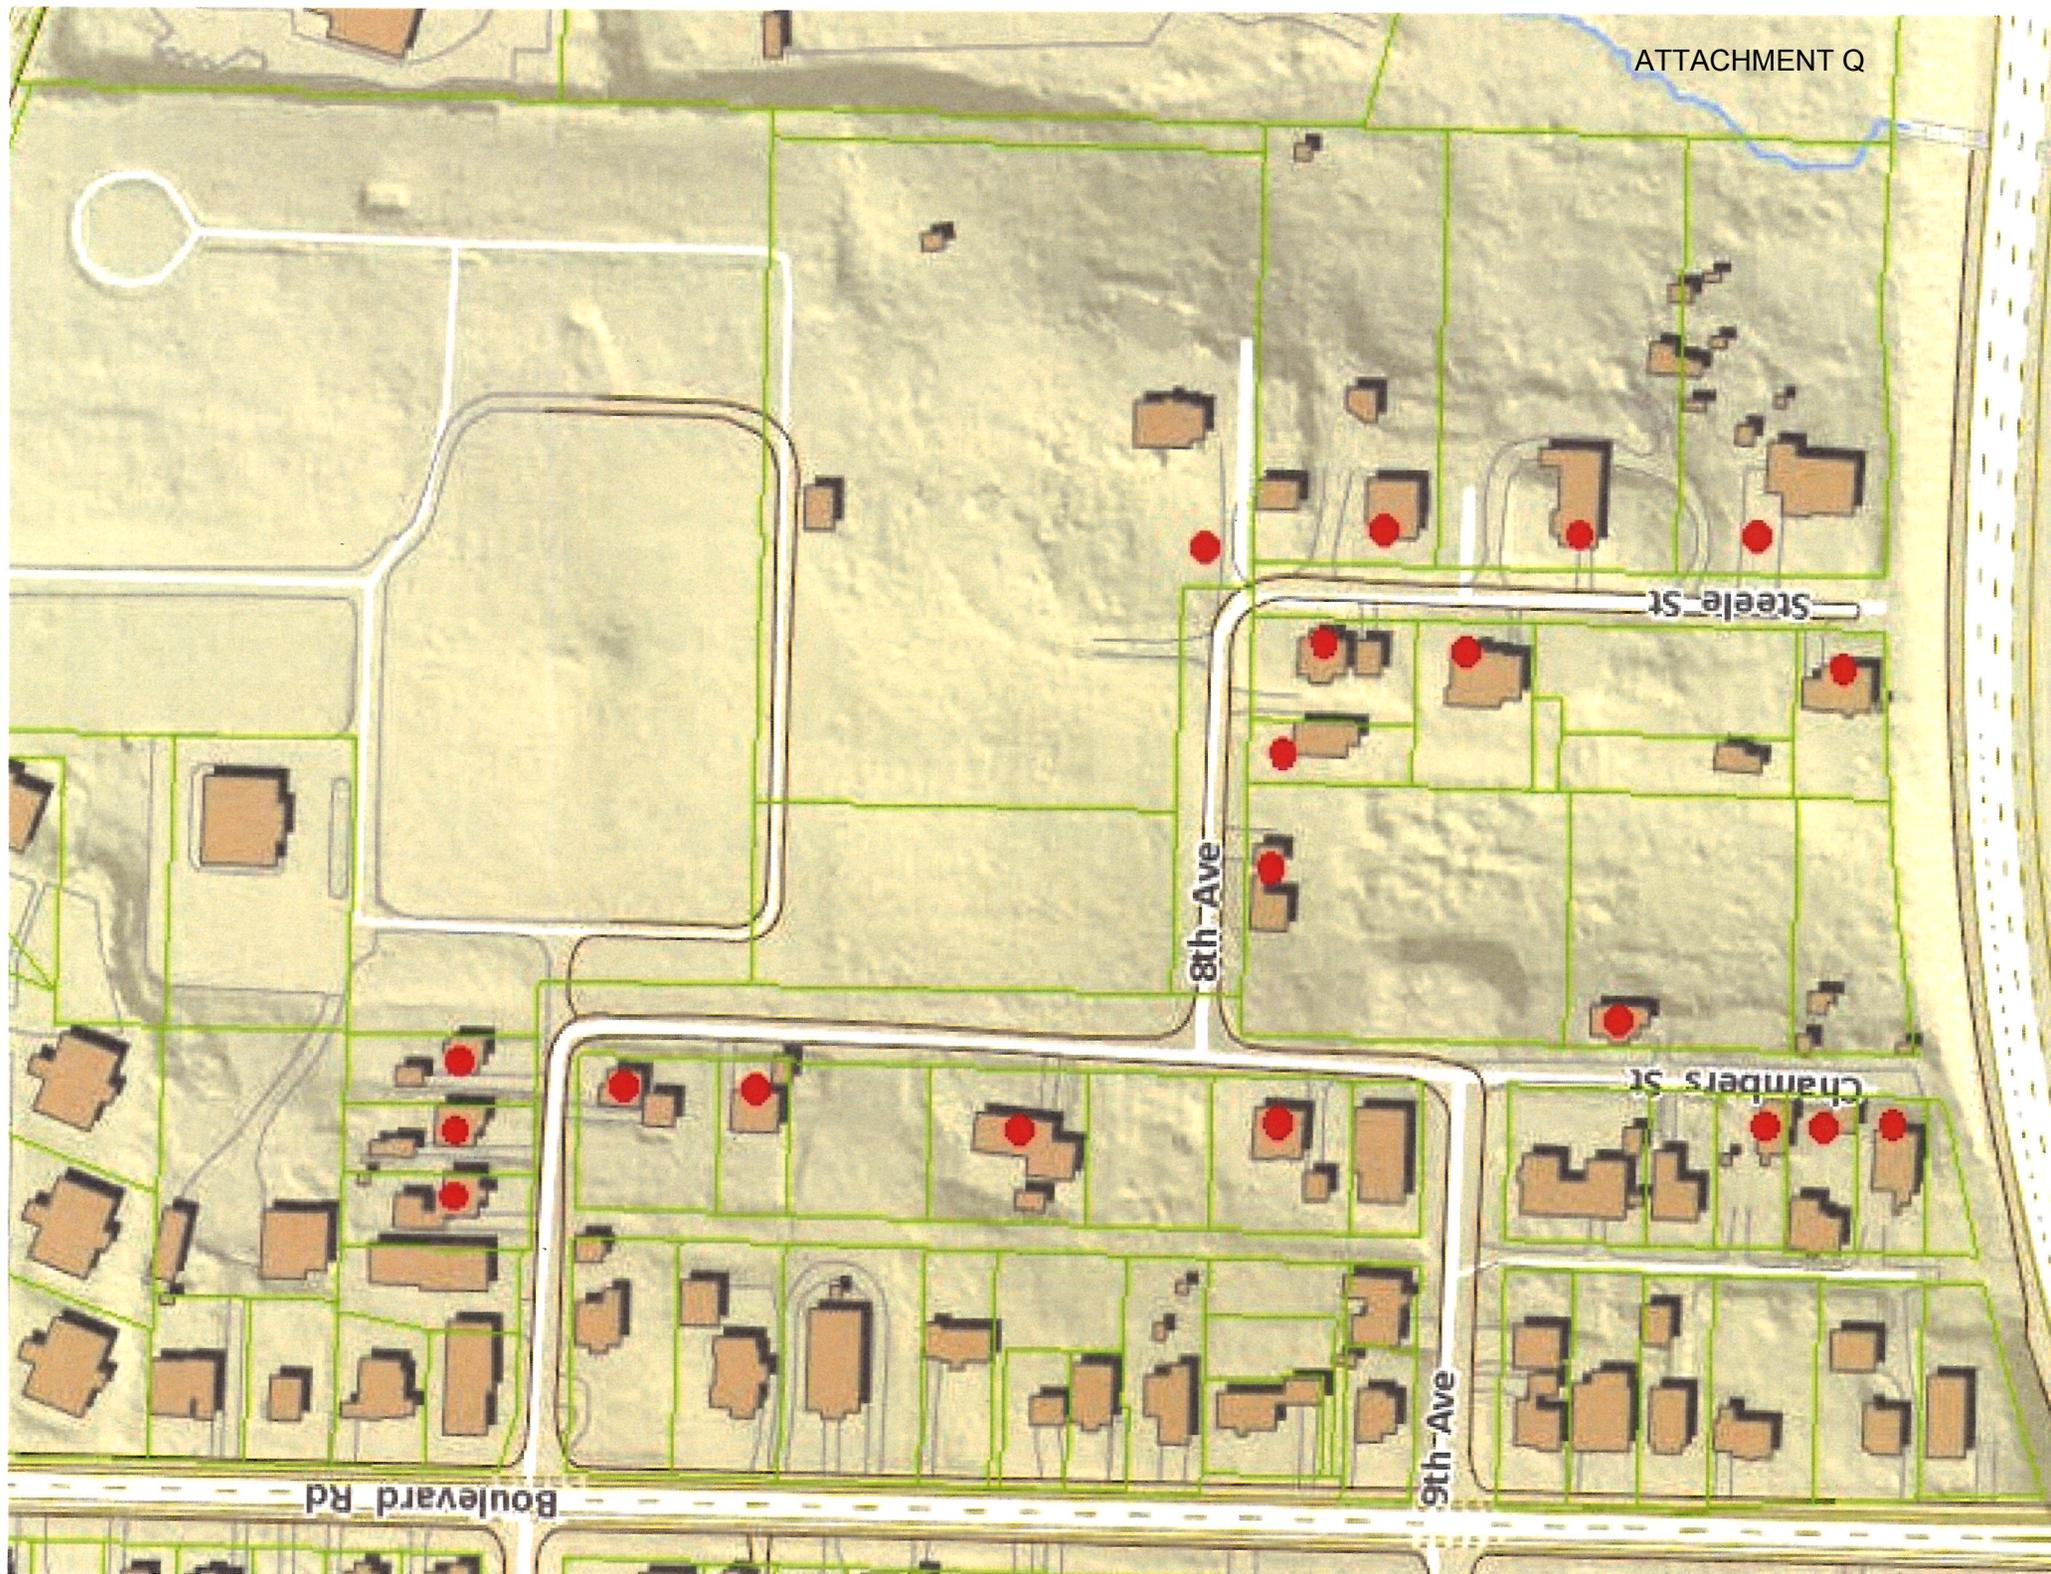
I did a reconnaissance-level inspection of the twenty (20) buildings adjacent to or in the proposed rezone area that appeared to be 45 years old or older (labeled with red dot in map in Attachment 2). Where a building was either in good condition or had at least reasonable integrity or both, I took a photograph. The table which summarizes my observations is attached (Attachment 3). Dates come from the County Assessor. This area contains a significant proportion of historical-period buildings of various levels of historical integrity. From this brief survey, I have noted three (3) particularly good examples of historic properties with high integrity. They are:

- 2324 7th Ave SE – NOTE: on Register
- 815 Chambers St SE
- 825 Steele St SE – NOTE: inside proposed rezone area

There is also a number of properties with a reasonable level of integrity that are likely to be fairly easily restored.

These observations are unlikely to have direct bearing on the rezoning process but if the area is rezoned for multifamily and a proposal is submitted that requires SEPA review, these properties should be further researched by a professional architectural historian to formally determine if any are eligible for the Olympia, Washington, or Federal Registers. If so, I would recommend that the consultant work with DAHP to propose mitigation measures for any such property which would be demolished or otherwise adversely affected by the development.

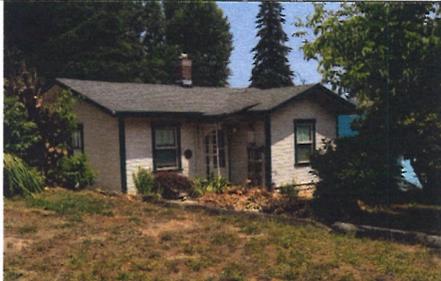
Address	Date of Construction (Assessor)	Notes	Identification Photo
2318 7 th Ave SE	1925	Poor integrity – significantly altered	N/A
2324 7 th Ave SE	1924	On Register

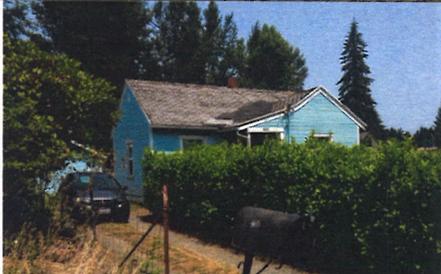
2326 7 th Ave SE	1924	Reasonable integrity; condition issues

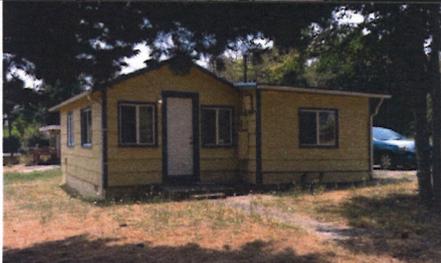
2327 7 th Ave SE	1946	Reasonable integrity; windows altered

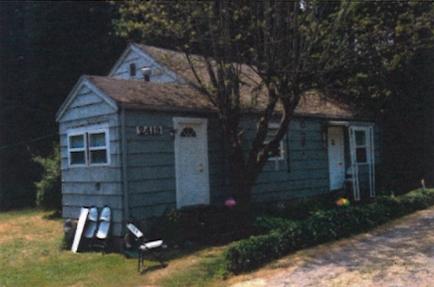
Address	Date of Construction (Assessor)	Notes	Identification Photo
2419 8 th Ave SE	1938	Reasonable integrity; windows and doors altered

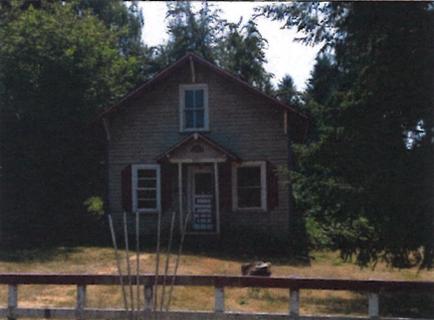
2421 8 th Ave SE	1920	Reasonable integrity; some windows altered; porch alterations likely

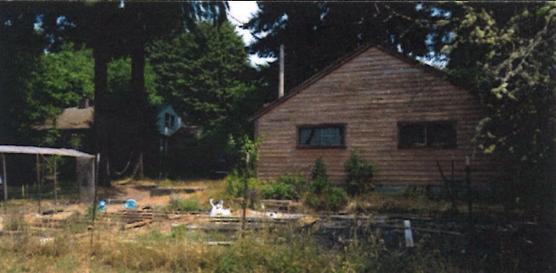
2504 8 th Ave SE	1940	Poor integrity – siding & windows replaced	N/A
2502 8 th Ave SE	1937	Integrity unknown – limited access with distant views

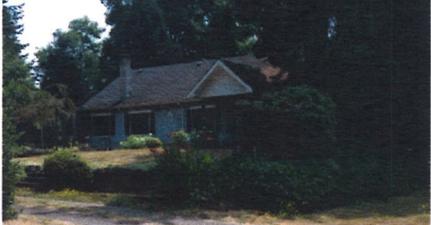
Address	Date of Construction (Assessor)	Notes	Identification Photo
2525 9 th Ave SE	1935	Building style appears to be out of period – sign of significant alteration?

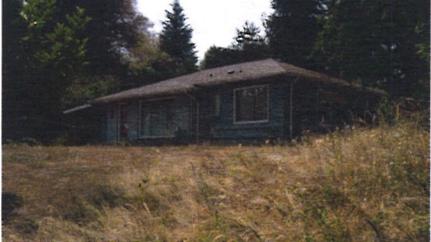
715 Chambers St SE	1956	Poor quality construction; poor integrity	N/A
729 Chambers St SE	1951	Reasonable integrity; door replaced, windows possibly altered

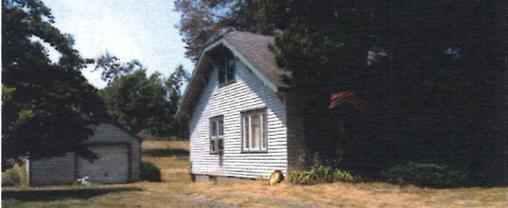
815 Chambers St SE	1929	High integrity – one window replacement visible; very good example of its type

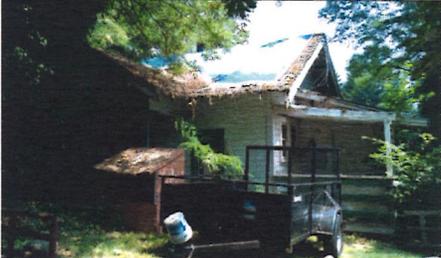
908 Chambers St SE	1930	Integrity impacted by poor condition; some unsympathetic alterations

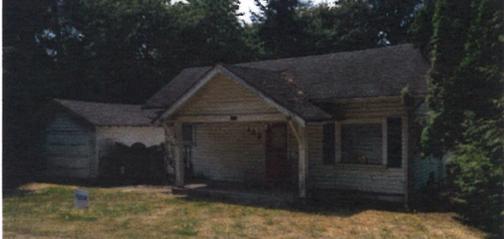
Address	Date of Construction (Assessor)	Notes	Identification Photo
915 Chambers St SE	1959	Poor integrity	N/A
923 Chambers St SE	1939	Not accessible (safety)	N/A
927 Chambers St SE	1941	Not accessible (safety)	N/A
823 Steele St SE	1910	Good condition but style does not reflect its date of construction – significantly altered?

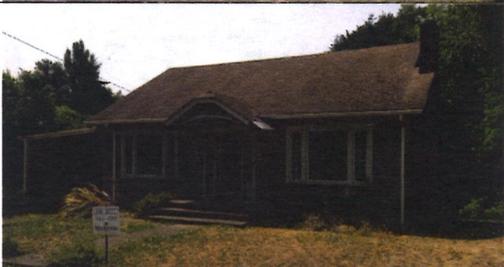
825 Steele St SE	1924	Very high integrity – no alterations to house visible; very good example of its type

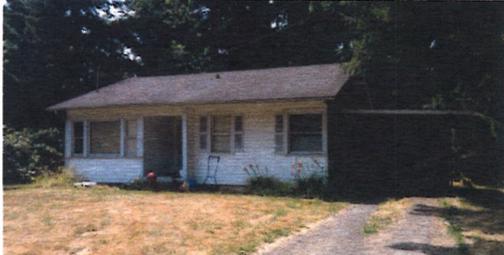
Address	Date of Construction (Assessor)	Notes	Identification Photo
919 Steele St SE	1901	Building style appears to be out of period – sign of significant alteration?

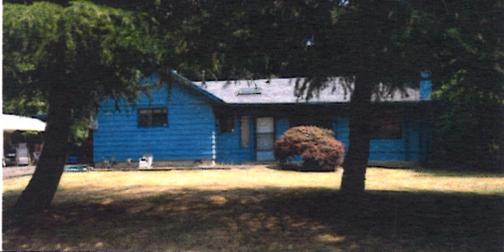
922 Steele St SE	1940	Reasonable integrity; fenestration likely replaced
