Bayan Trails Site

Olympia, Washington

Wetland and Soils Report and Mitigation Proposal April 2015

Project: Bayan Trails Wetland and Soils Report

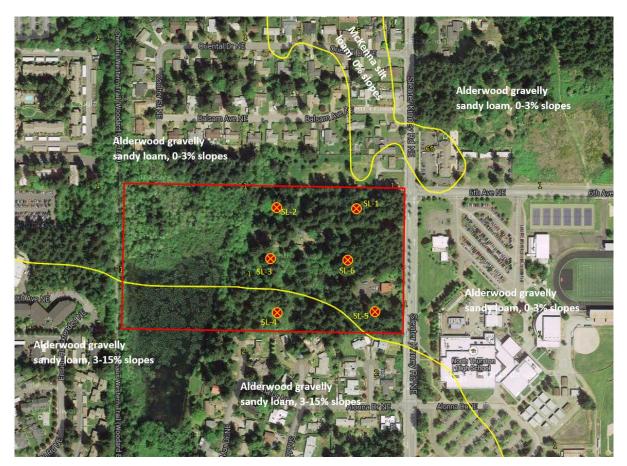
Figure 4. Thurston County Soil Survey map: whole site is mapped as the Alderwood gravelly sandy loam soil, 0-3% slopes.

Baseline soil depth and texture conditions were evaluated at 6 locations across the upland areas outside of wetlands and buffers for purposes of stormwater facility design (Figure 4). The onsite soils are mapped as the Alderwood soil series, which are expected to have gravelly sandy loam surface soils overlying cemented and impermeable glacial till at 3-4 feet depth. Stormwater infiltration facility design is difficult in Alderwood soil types due to limited soil depth, and shallow seasonal groundwater tables perching on top of the glacial till at 3-4 feet depth.
