City of Olympia

West Bay Environmental Restoration Assessment

Final Report

Coast & Harbor Engineering, a Division of Hatch Mott MacDonald

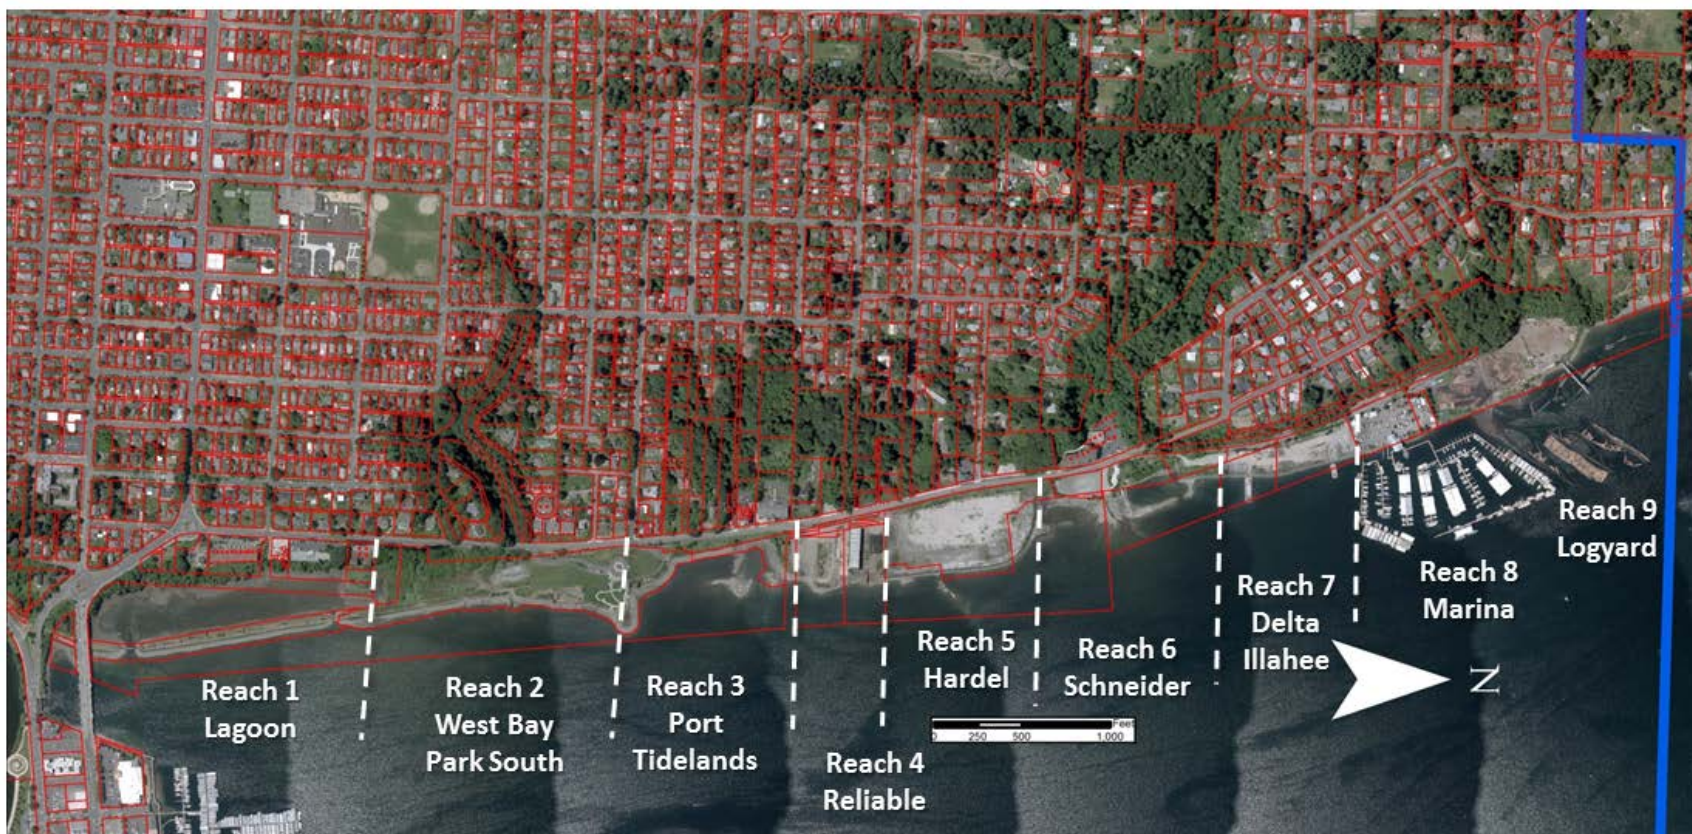
Figure 1. Project reaches, parcel boundaries, and aerial photograph from 2015.

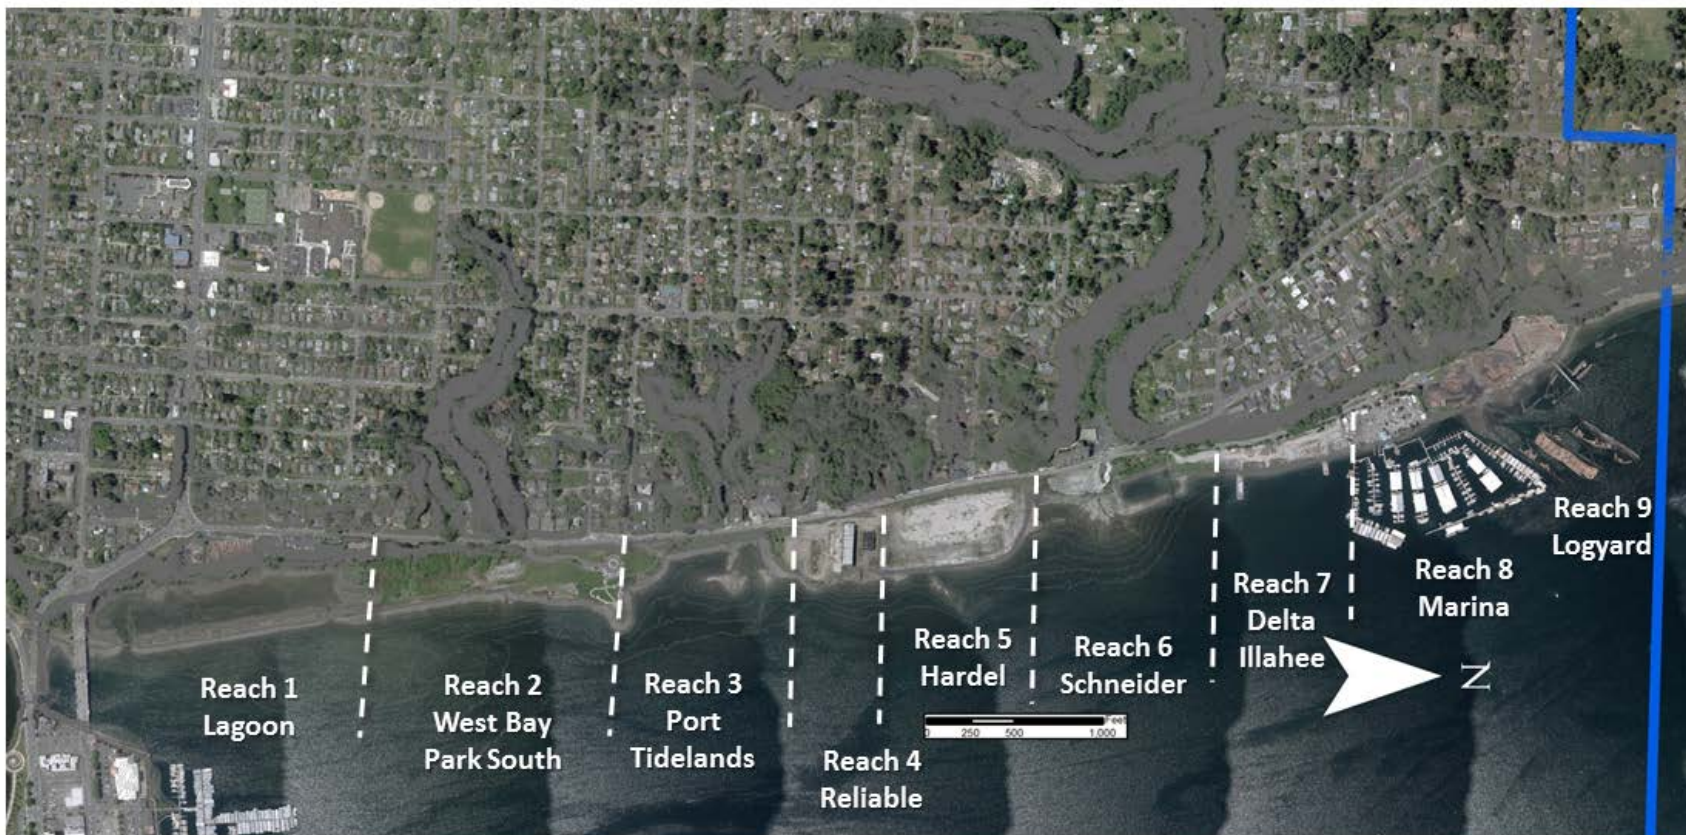
Figure 2. Project base map showing project reaches, 1-ft topographic contours, and aerial photograph from 2015.

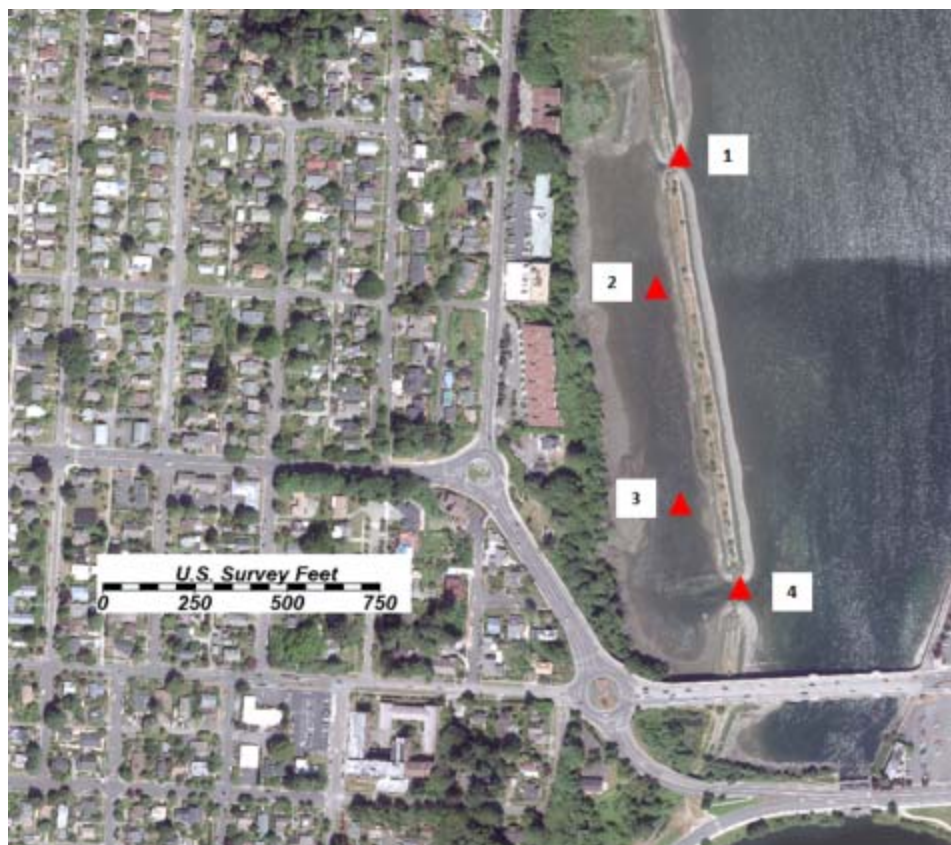
The output from local scale numerical model simulations included water surface elevations, depth-averaged flow velocities. Results were evaluated by analysis of changes in velocities throughout the lagoon and numerical dye tracer propagation in response to changes in the lagoon configuration. The flow velocity analysis included extraction and comparison analysis of modeling results at controlling stations. For all modeling scenarios, model stations were specified in the modeling domain at locations that are considered representative for analysis of potential changes and for evaluation of the conceptual design alternatives. The locations of the representative stations are shown and labeled in Figure .

Figure 11. Location of model stations used for stationary analysis.

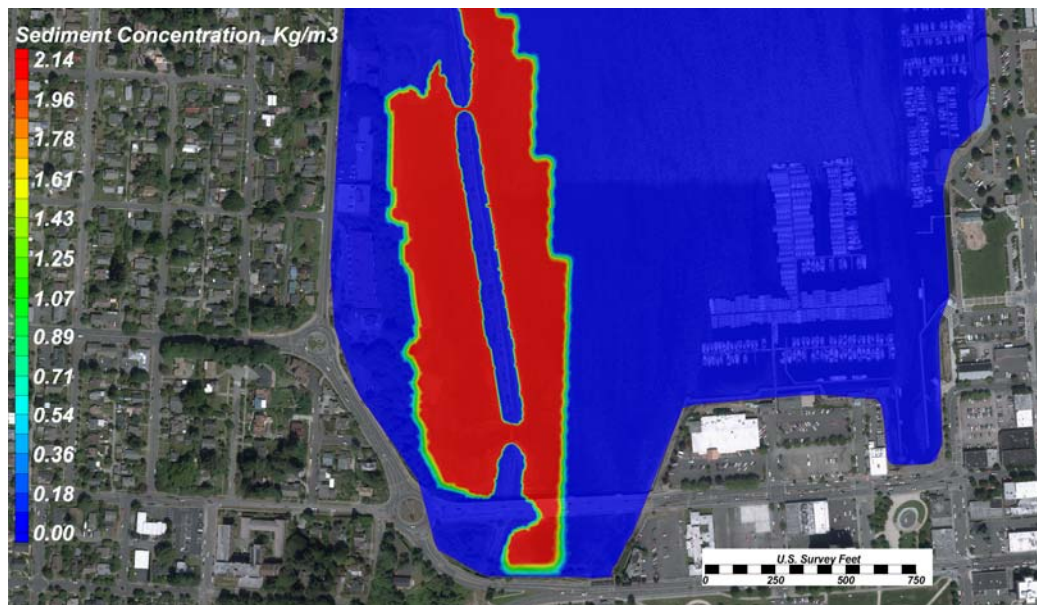
Numerical dye as a concentration tracer modeling was conducted to determine the residence time for each of the alternative lagoon design options. Residence time was used as a proxy for circulation and flushing of each of the alternative designs. The residence time in a body of water is typically defined as the amount of time required for the concentration of some suspended material – non-settling dye in this case – to drop down to 37% of its initial concentration. The faster that it takes to decrease the initial concentration to the reference concentration, the more circulation is taking place in the body of water. A non-settling constituent (e.g. numerical dye) was integrated into the modeling grid around the alternative lagoon designs. Circulation models were run for existing conditions and each of the alternatives. The initial concentration conditions within the lagoon was set to 2.14 kg/m^3 and residence time was determined when the average concentration in the lagoon reduced to 0.79 kg/m^3 . Figure 14 shows the modeling grid for existing conditions with the initial concentration of the lagoon at 2.14 kg/m^3 . As the models run, tidal flow through the lagoon and flow from the dam results in the dispersal of the initial concentration condition prior to dispersal.

Figure 14. Initial concentration around the lagoon for evaluation of residence time in the lagoon for existing conditions.
