## TECHNICAL MEMORANDUM

Date: November 22, 2024

Re: West Bay Yards: No Net Loss and Mitigation Sequencing Narrative

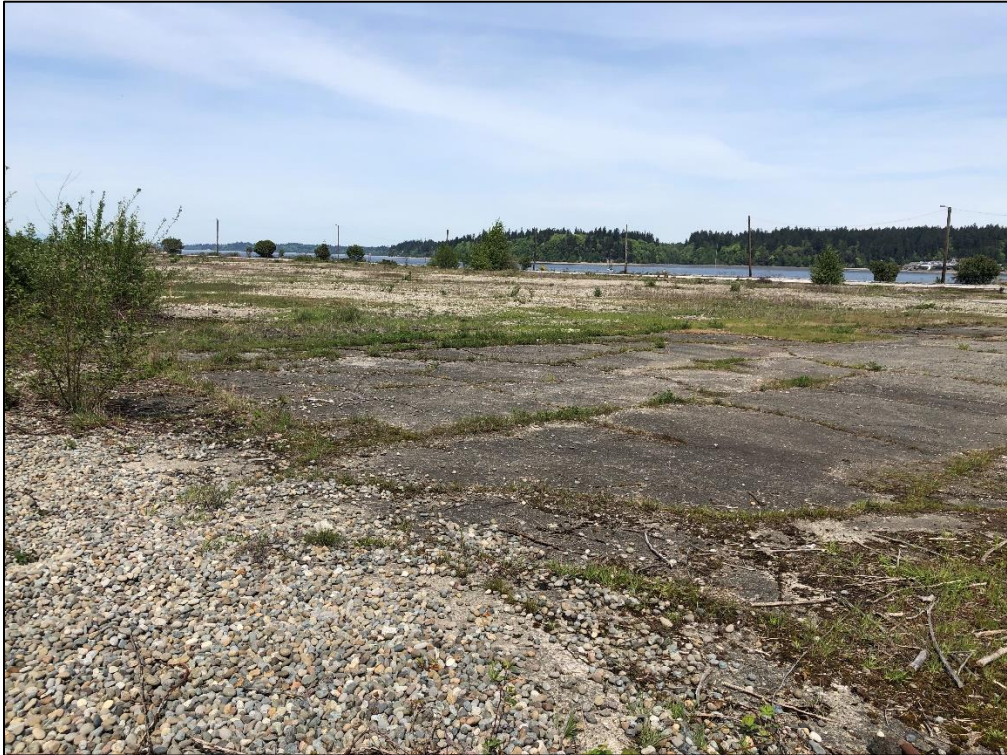
**Photograph 1. Typical upland site habitat, looking to north.**

The subject property was first developed in in the early 1900's and was used as a sawmill. Various other industrial uses occurred on the site over the years until 1980, when the subject property was occupied by the Hardel Mutual Plywood Corp. plywood manufacturing facility. The facility stopped operations in 1996 and the buildings were demolished in the late 1990's. The site then underwent various remediation actions until 2010, when much of the site was backfilled with crushed concrete surfacing. Since that time the site has been vacant. The site is set below the grade of West Bay Drive and is primarily flat. A long, linear depression associated with two rail spur lines runs along the length of the west parcel boundary, parallel to West Bay Drive. Within and along this depression shrub and herbaceous vegetation has established, including willows, Himalayan blackberry, and butterfly bush. The central portions of the site are primarily unvegetated, with much of this area consisting of asphalt and crushed concrete. Shrubby vegetation that is present consists of occasional birch saplings, blackberry, butterfly bush, yellow sweet clover, and low grasses and forbs. Shell hash is also prevalent, likely the result of sea gulls and crows dropping shellfish from height during foraging. The upland riparian habitat along the top of the shoreline slope consists of small, sparse trees and shrubs growing up through the crushed concrete and asphalt surfacing.

Habitat quality on the upland portions of the site is low. While the site does contain dense vegetation along the west property line associated with the linear rail spur depression, invasive blackberry has reduced the habitat potential in this area. There is very little foraging opportunity within the remainder of the site due to the crushed concrete and asphalt surfacing. Sparse non-native grasses and forbs are present, though they represent low quality browse for terrestrial species such as deer, which would likely prefer foraging opportunities along the hillside west of the site. Terrestrial species likely to use the site include those species associated with disturbed urban sites, including raccoon and opossum.

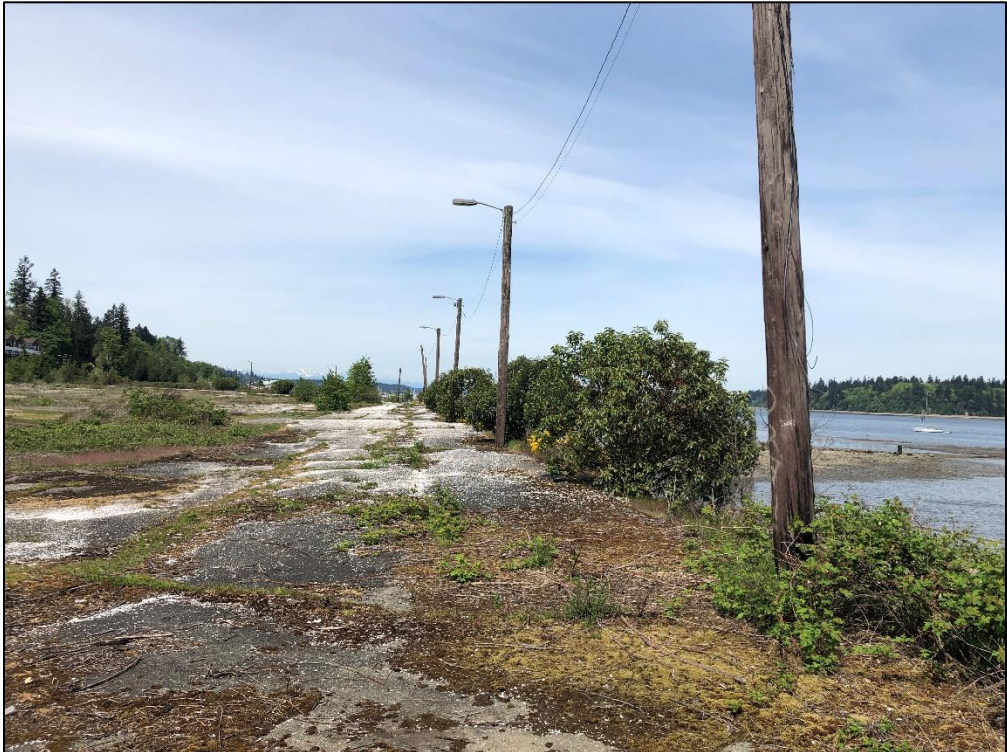
**Photograph 2. Typical riparian conditions along top of shoreline slope.**

The existing shoreline is composed primarily of an upland fill area and approximately 1,100 ft of steep riprap armored shoreline that abruptly transitions to intertidal mudflats and deeper subtidal areas. The shoreline of the subject property is degraded and is entirely stabilized by riprap. The top portion of the bank is characterized by sparse invasive plant species growing through asphalt, fill and riprap. Invasive shrubs such as Himalayan blackberry and scotch broom are present along portions of the top of the slope, with occasional larger shrubs such as red elderberry also present. Small trees including Pacific madrone and big leaf maple are also present in places. In addition, various invasive and non-native forbs occur along the top of the slope above the riprap.

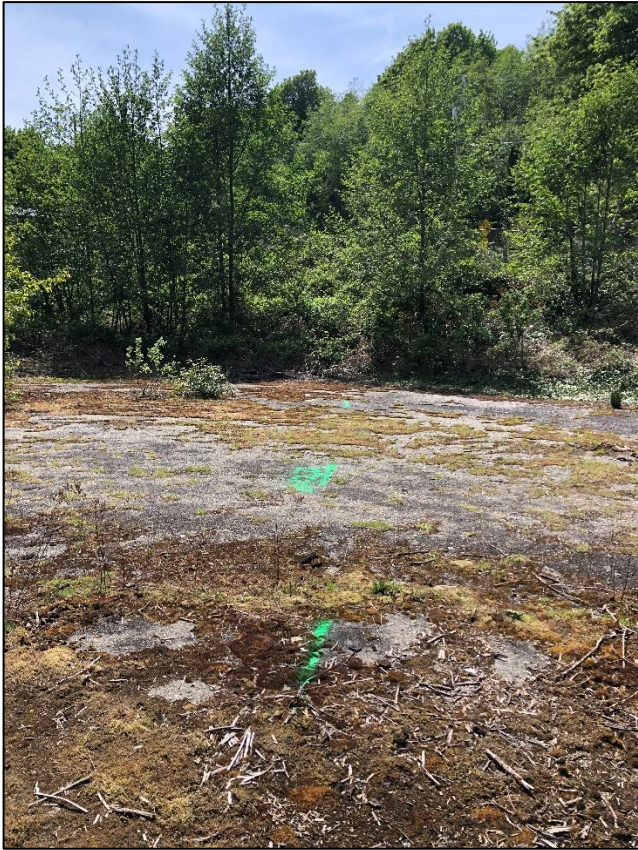
**Photograph 3. Vegetated area along rail spur adjacent to West Bay Drive.**

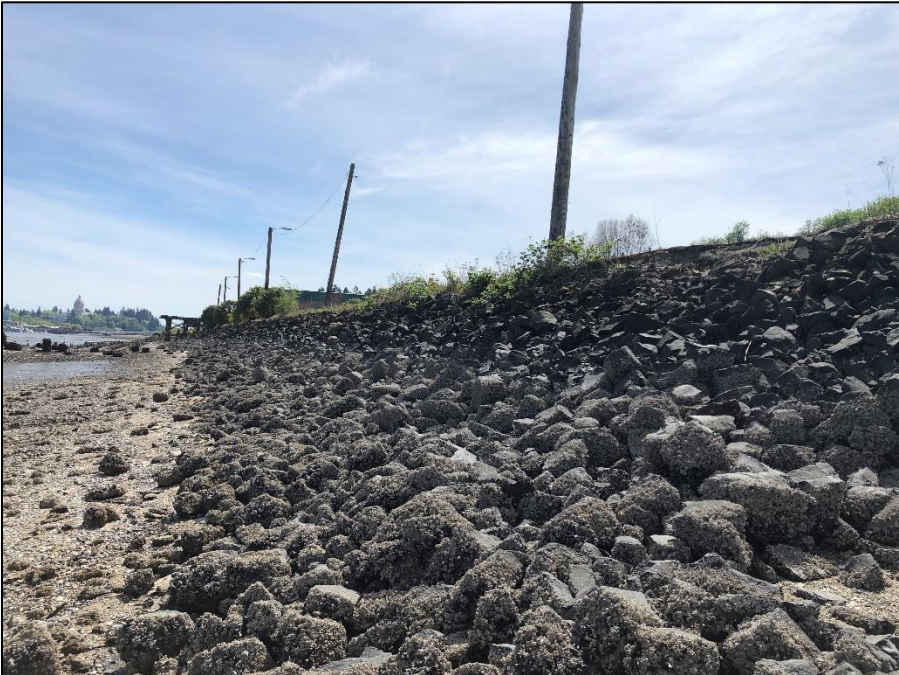
**Photograph 4. Typical steeply sloping shoreline armoring along shoreline slope.**

Below the top of the slope, the upper shoreline consists entirely of riprap and is almost entirely unvegetated. The slope is fairly steep, approximately 1:1. At the base of the riprap slope (approximately +5 feet MLLW), the lower shoreline flattens to a gentler slope. The substrate immediately below the riprap slope consists of gravel and shell hash intermixed with timber pile stubs and metal debris down to approximately 0 feet MLLW. Below, the lower intertidal substrate consists of unconsolidated silt, with sparse wood waste, debris and gravel. Shellfish, primarily

The shoreline armoring covering the property shoreline consists of one- to two-man basalt riprap. The armoring extends from the top of the slope along the entire property shoreline (approximately +17 feet MLLW) down to the toe of the slope at approximately +5 feet MLLW. Scattered timber pile stubs are present, broken off at the riprap surface, as is occasional metal and wood debris, particularly at lower elevations on the slope.

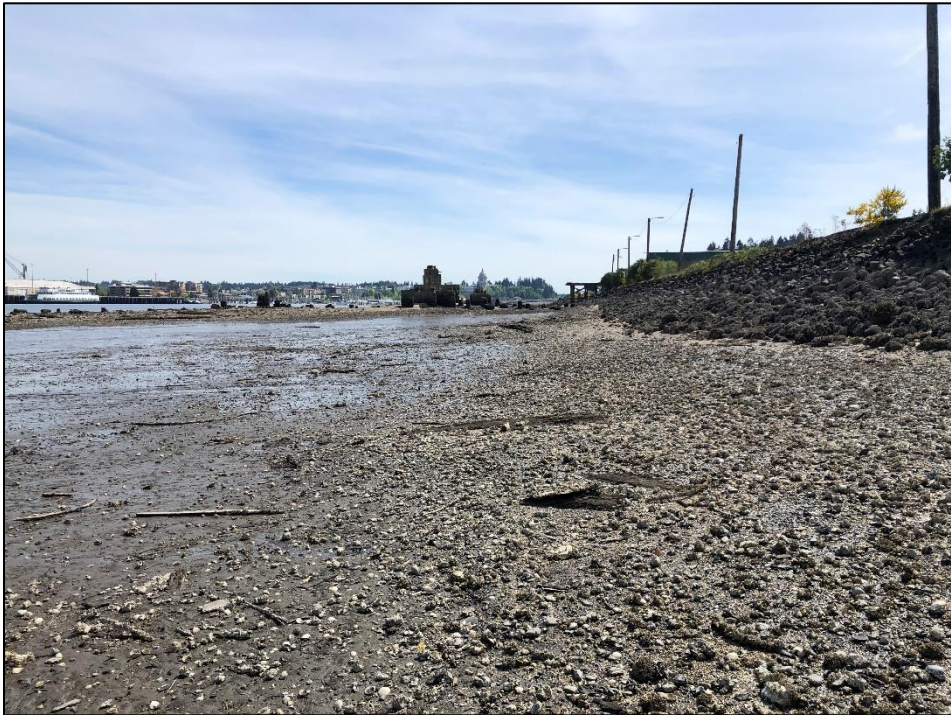
**Photograph 5. Typical mudflat conditions along property shoreline. Note presence of wood and metal debris from prior land uses.**

clams and barnacles, are present within the mudflat habitat. Several large, derelict concrete structures and sunken barge remains are present below the toe of the riprap slope. These structures appear to have been part of the former plywood manufacturing facility.

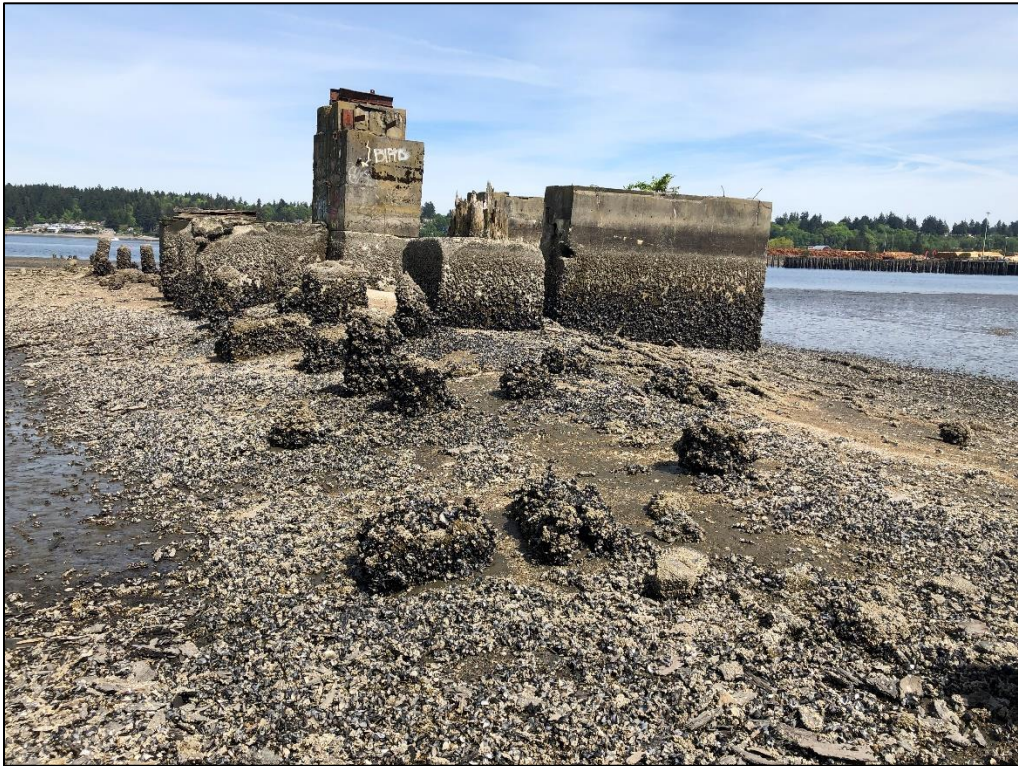
**Photograph 6. Large concrete structures, debris and piling to be removed, located immediately waterward of property shoreline.**

In addition to these structures, an area of dense wooden pilings and concrete rubble is present along the northern shoreline. This debris includes approximately 70 derelict timber pile and is located waterward of the toe of the armor slope at approximately +6 feet MLLW. Over the entire shoreline, approximately 250 creosote-treated piling are present.

Prior to shoreline restoration, derelict concrete debris, pilings and metal beams will be removed from the shoreline mudflat and disposed of at an appropriate upland facility. This will include removal of approximately 250 timber piling<sup>1</sup> along with several large concrete structures in the lower intertidal.
